Development of a Self-Sustained Wireless Integrated Structural
Health Monitoring System for Highway Bridges

Tenth Quarterly Progress Report

Field Test Status Report of MD Bridge No. 1504200 I-270 over Middlebrook Road

**Field Test Status Report
of
MD Bridge No. 1504200 I-270 over Middlebrook Road**

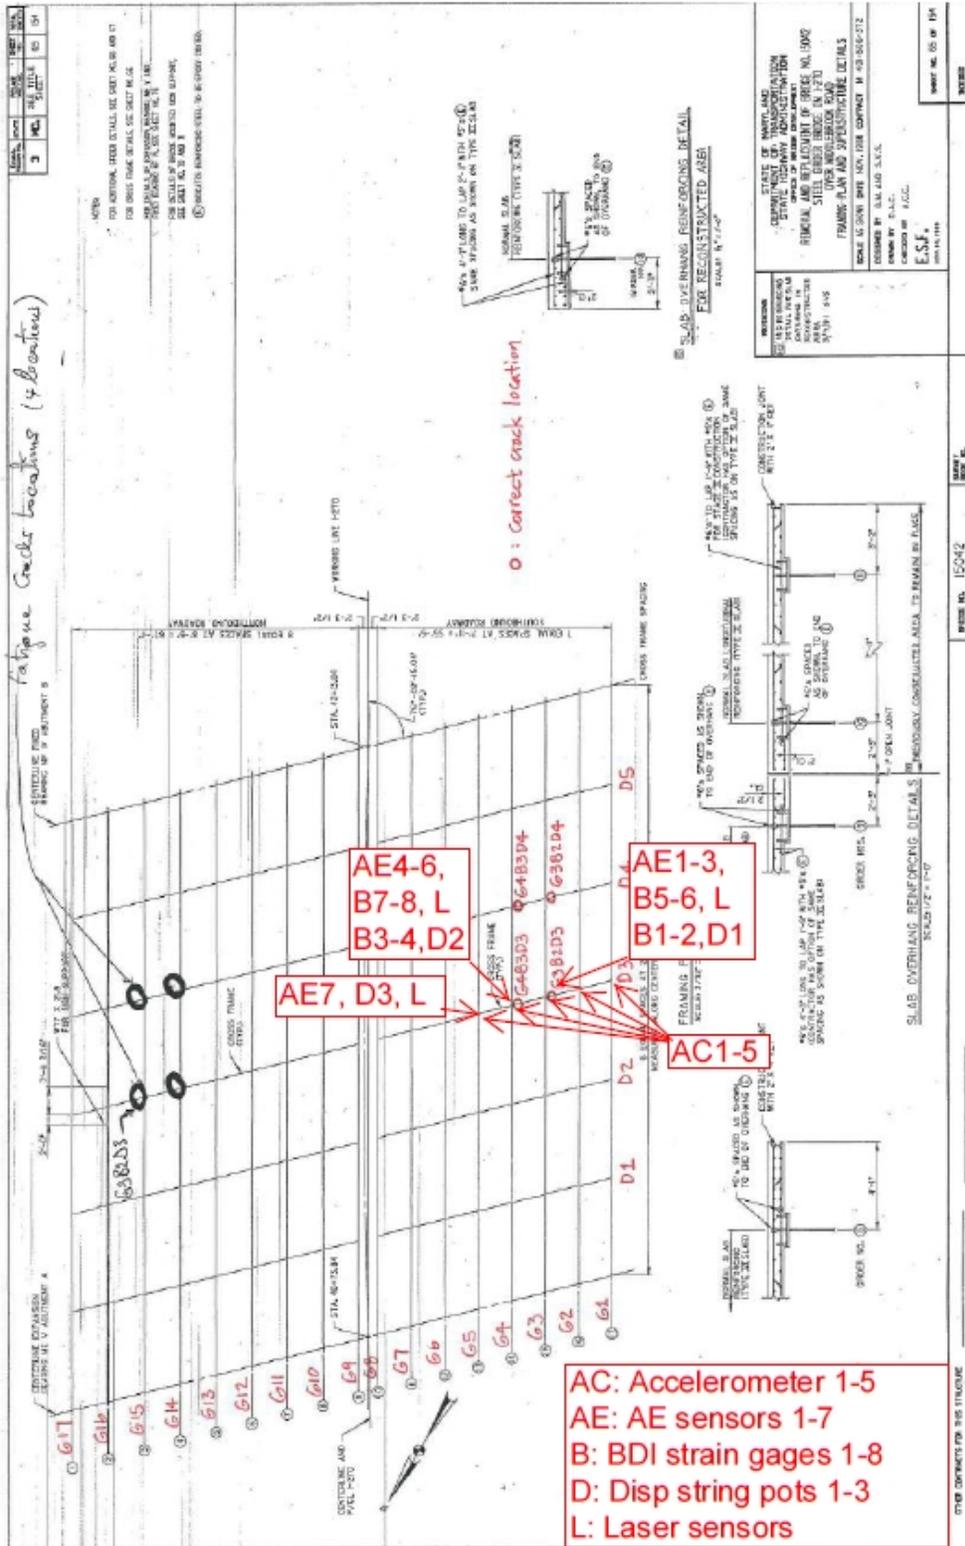
Figure 3 – Crack locations and sensor placement on the framing plan

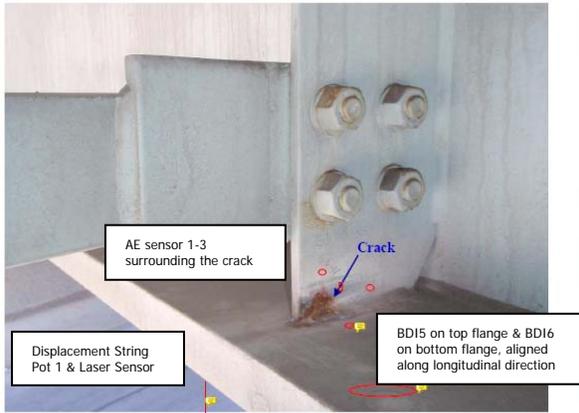
- 1) AT GIRDER #3, BAY #2, DIAPHRAGM #3 THERE IS A 2"± (PREVIOUSLY 1 1/8"±) LONG, VERY FINE, CRACK IN THE WELD THAT CONNECTS THE WEB STIFFENER TO THE TOP OF THE LOWER FLANGE AT THE SOUTH SIDE OF THE STIFFENER. THE CRACK RUNS ALONG THE TOP OF THE WELD MATERIAL NEXT TO THE STIFFENER AND BEGINS AT THE TOE OF THE WELD, AT THE TOP OF THE LOWER FLANGE. THE OVERALL LENGTH OF THE CRACK IS 2"±. THERE APPEARS TO BE A 1/4"± EXTREMELY FINE VERTICAL CRACK AT THE CENTER OF THIS CRACK. THIS CRACK APPEARS TO HAVE GROWN SLIGHTLY INTO THE BASE METAL OF THE STIFFENER.

To monitor the crack growth, three AE sensors were installed on Girder 3 at Girder #3, Bay #2, Diaphragm #3 as described above in item 1), which is the most noticeable cracks of all detected and shown in Figure 4 of Appendix A. Three piezoelectric paint AE sensors were installed on Girder 4 at the other side of Diaphragm #3, as shown in Figure 6 of Appendix A. More details of the instrumentation plan are described in Appendix A.

Figure 4. Crack at G3B2D3 (Girder 3 Bay 2 Diaphragm 3) and sensor

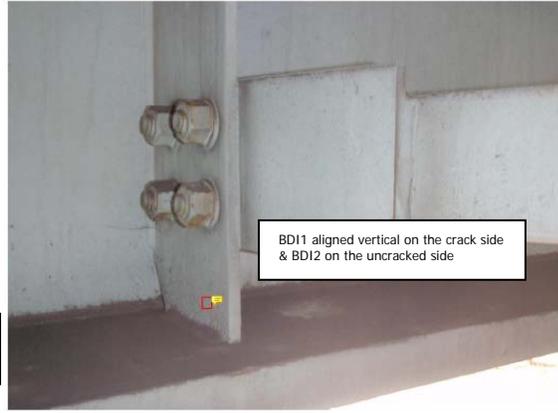
Figure 5. No Sign of Cracking at G3B3D3 (Girder 3 Bay 3 Diaphragm 3) and one

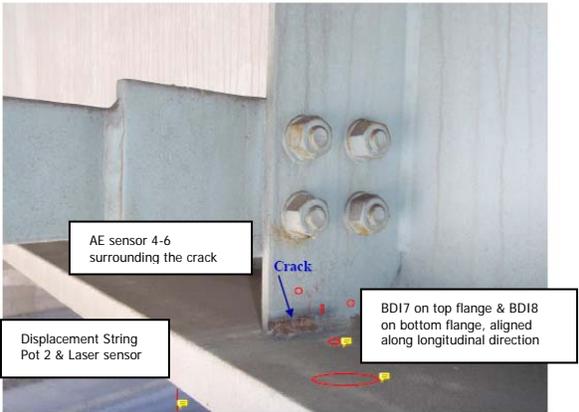
- 3) GIRDER #4, BAY #3, DIAPHRAGM #3 HAS A SIMILAR 2"± LONG (PREVIOUSLY 1 1/2"± LONG) VERY FINE CRACK IN EACH THE NORTH AND SOUTH, SIDES IN THE TOP OF THE WELD MATERIAL. BOTH OF THESE CRACKS APPEAR TO HAVE GROWN.

Figure 6. Crack at G4B3D3 (Girder 4 Bay 3 Diaphragm 3) and sensor locations

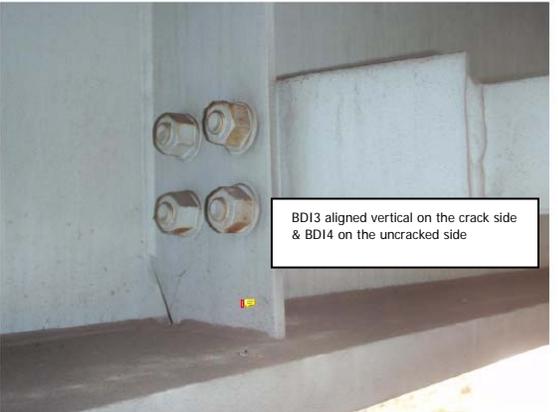
Figure 7. No Sign of Cracking at G4B4D3 (Girder 3 Bay 4 Diaphragm 3) and one sensor

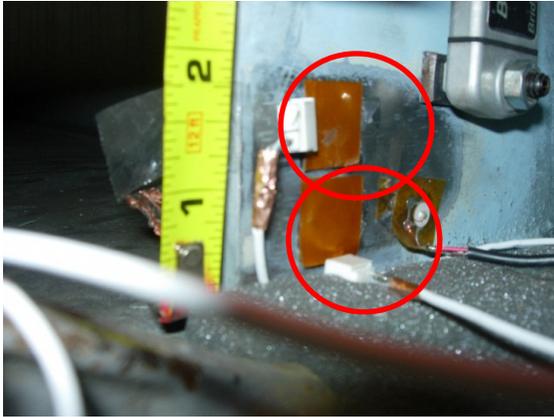
Figure 8. Piezoelectric paint AE sensor on cracked connection plate (red circled, for monitoring fatigue crack in the weld between the connection plate and lower

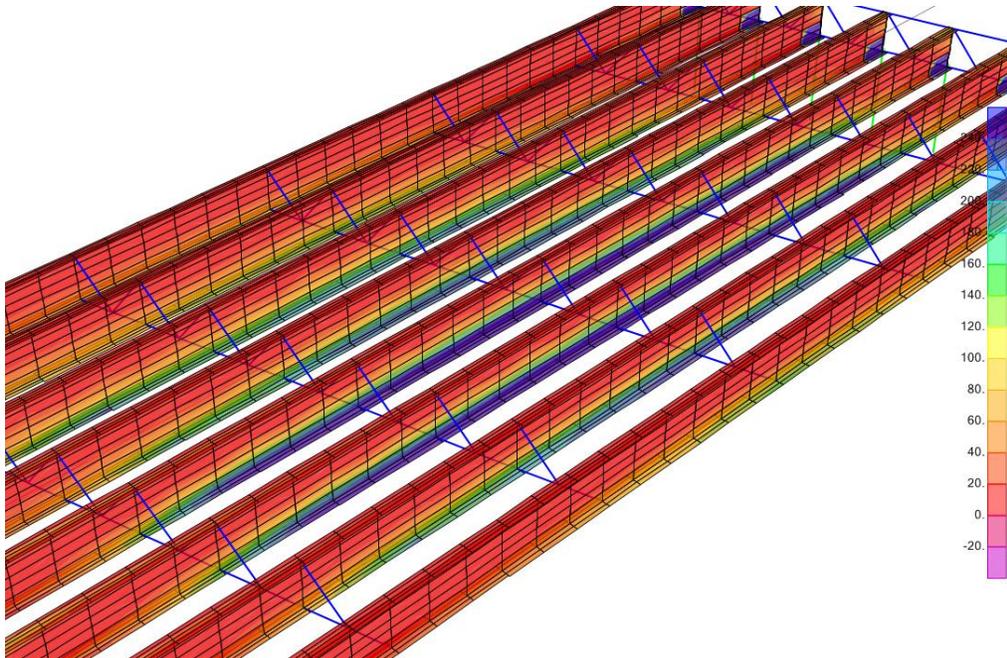
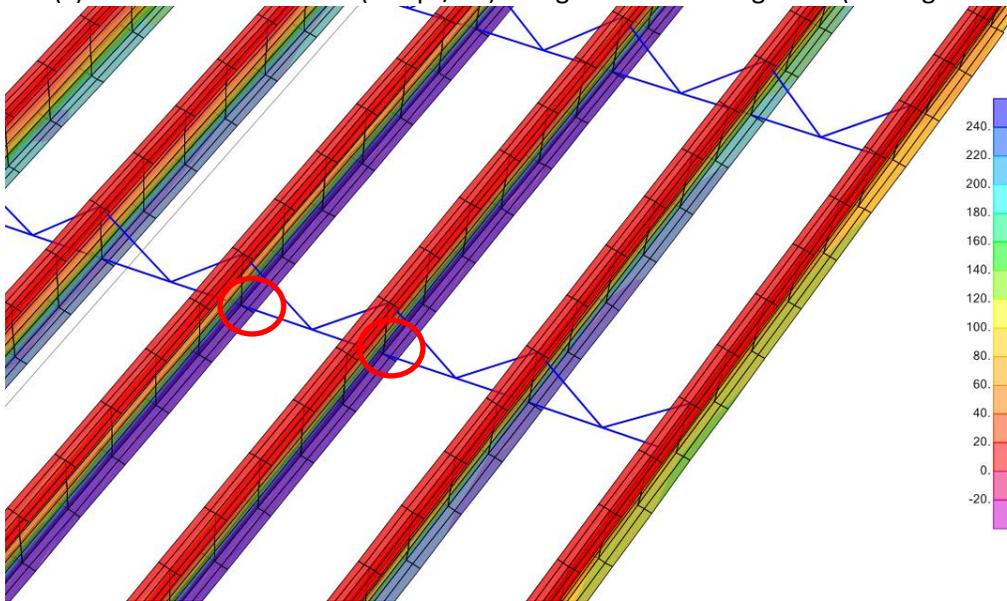
Figure 23. Live load stress contour of truck loading case 6

High tension stress on the connection plates on Girders 3 and 4

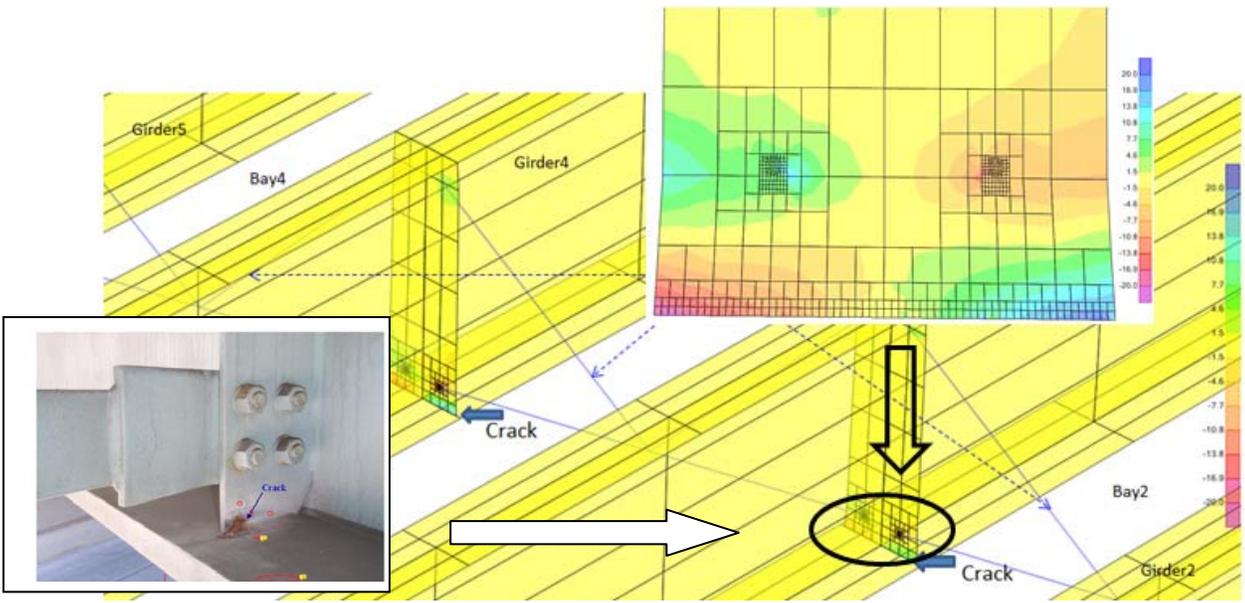
Figure 5 - Zoom-in Stress Contour of Connection Plate (Girder 3 Diaphragm 3) at T=597second

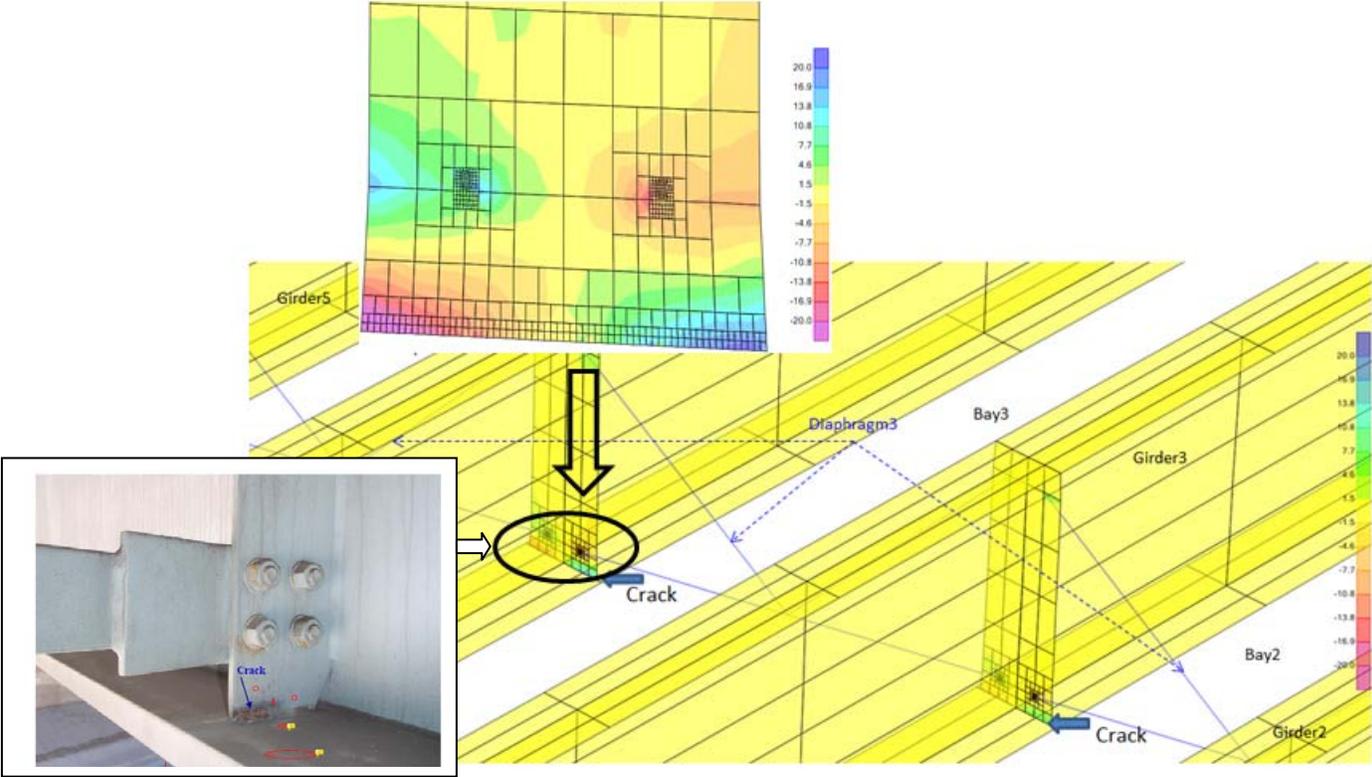
Figure 6 - Zoom-in Stress Contour of Connection Plate (Girder 4 Diaphragm 3) at T=283second

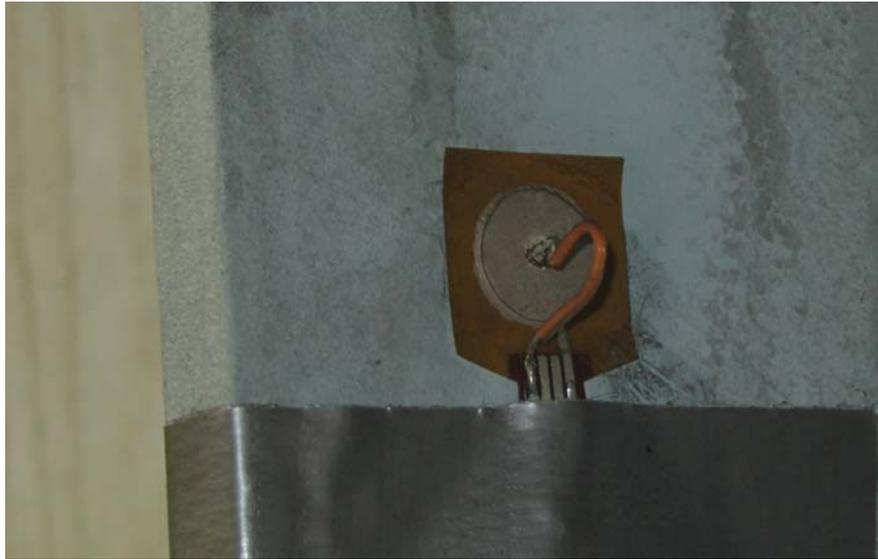
1. Guard paint sensor connection problem. The guard sensor was put on in the field tests last November 14 and 15. After exposed in the wild for the whole winter, the connection was peeled off due to lack of protection. This can be clearly seen in Figure 1.

Figure 1. Guard sensor connection peeled off.

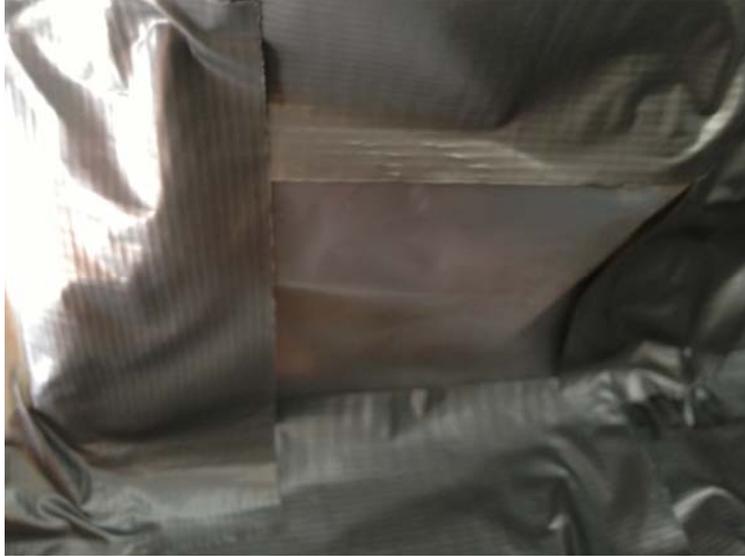
For the sensors near the fatigue crack, they were covered by plastic film as shown in Figure 2. After the whole winter, the connections between the wire and the sensor were still good. However, some sensors have short circuit between the sensor output and the ground, which results in the failure discussed before. A sample case of short circuit is shown in Figure 3 as shown by the multimeter. However, the paint sensor in the lower left was still good. According to this examination, it is confirmed that the plastic film protects the sensor from humidity at some degree.

Figure 2. AE sensors near fatigue crack were covered by plastic film to protect from humidity.

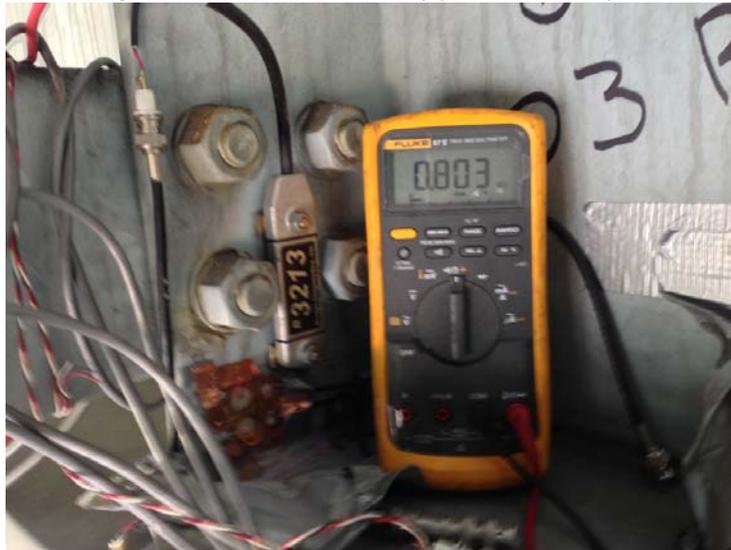
Figure 3. Short circuit of AE sensors near fatigue crack due to the humidity.

All the sensors are replaced including the guard sensor in this test. The newly replaced sensors are illustrated in Figure 4. Sensor a0 and a1 are AE sensors made of PZT5A and both have the same diameter-5mm. For sensor a2 and a3, they are made of piezo paint and they have a 1/2" diameter. Their relative positions are shown in Figure 5. In order to further protect the sensors from humidity, a layer of polyurethane coating was applied on the sensors for extra protection besides the plastic film protection as shown in Figure 6.

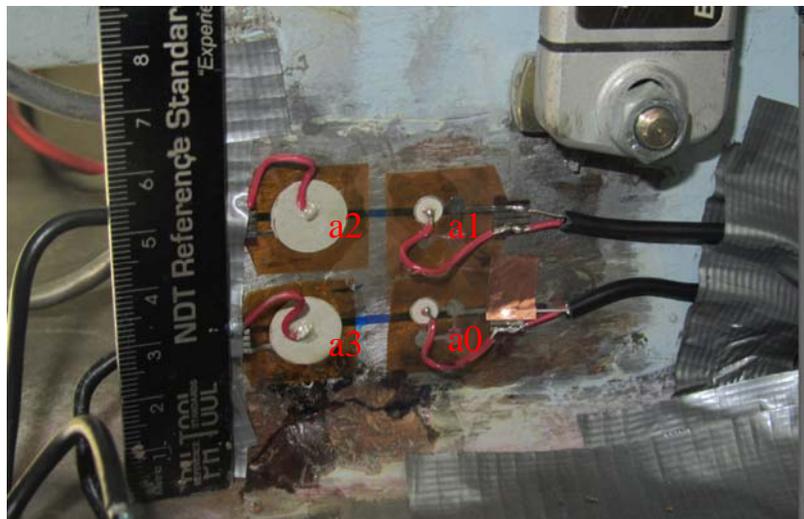
Figure 4. Newly installed sensor near the fatigue crack (a layer of polyurethane coating was applied on the sensors for extra protection of humidity).
