Development of a Self-Sustained Wireless Integrated Structural Health Monitoring System for Highway Bridges

Fourth Quarterly Progress Report

April 15, 2012 through July 14, 2012

Appendix A - Updated Field Test Report for Bridge No. 1504200 I-270 over Middlebrook Road

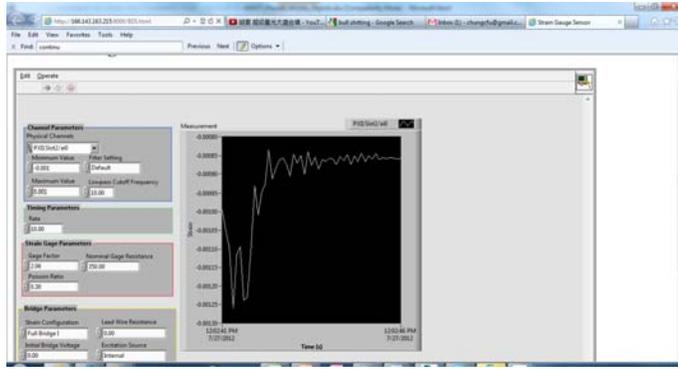
4) A captured real time strain is shown below.

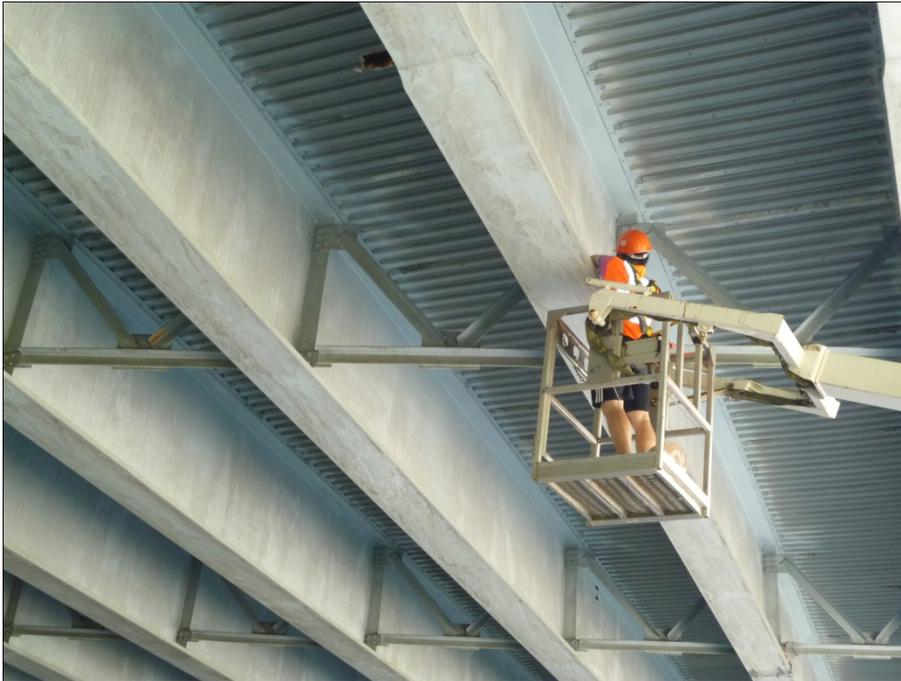
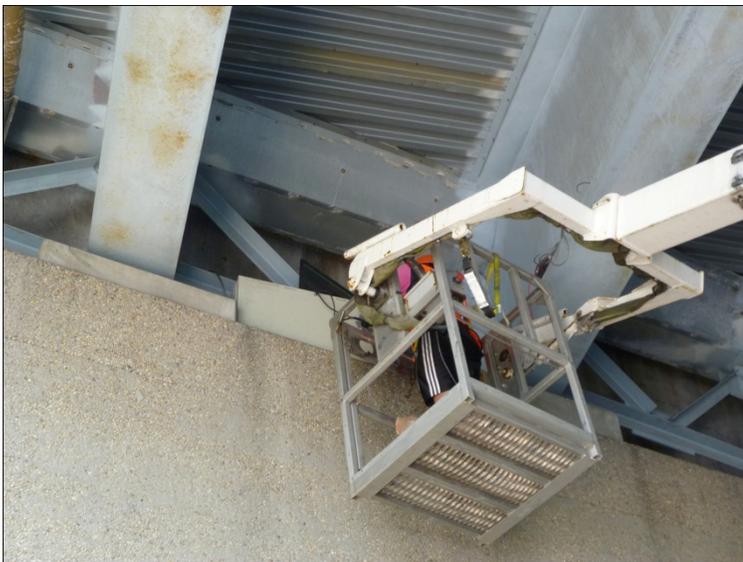
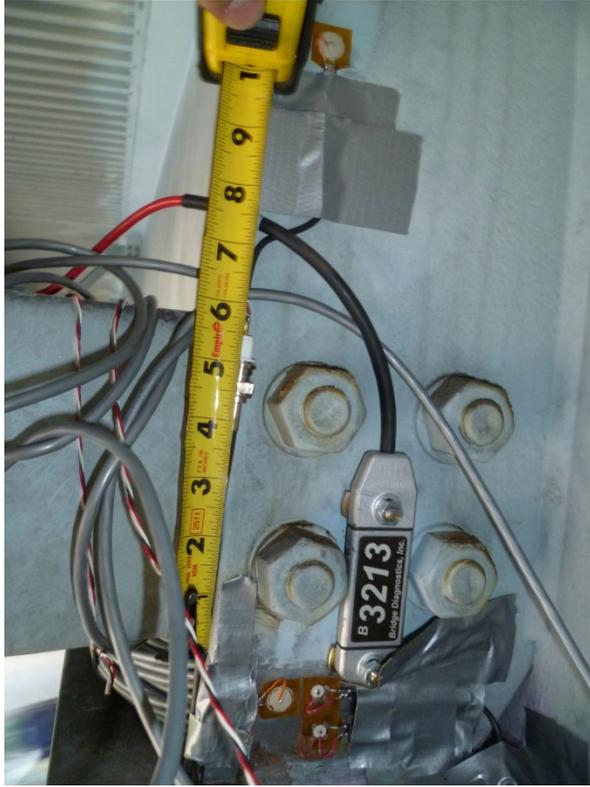
(a) Installing piezo film AE sensors on connection plate

(b) installing PXI high speed data acquisition system

(c) piezo film AE sensors installed on connection plate
Figure 1. Pictures taken during field test on I-270 bridge in June 2012

- Conduct long-term monitoring test on the I-270 bridge near Germantown, Maryland (see Figure 1) : seven piezoelectric film AE sensors including two piezo paint AE sensors were installed to monitor the growth of existing fatigue cracks on a connection plate (on Girder #3 of Southbound part) of the steel girder bridges. The sensors are connected to preamplifiers and PXI high speed data acquisition system for long term AE signal collection and fatigue crack monitoring. Also, to measure the differential deflection between adjacent girders (which is believed to be the cause for fatigue cracks in connection plate of the girders), laser distance sensor was used to measure the differential deflection between Girders #2 and #3.

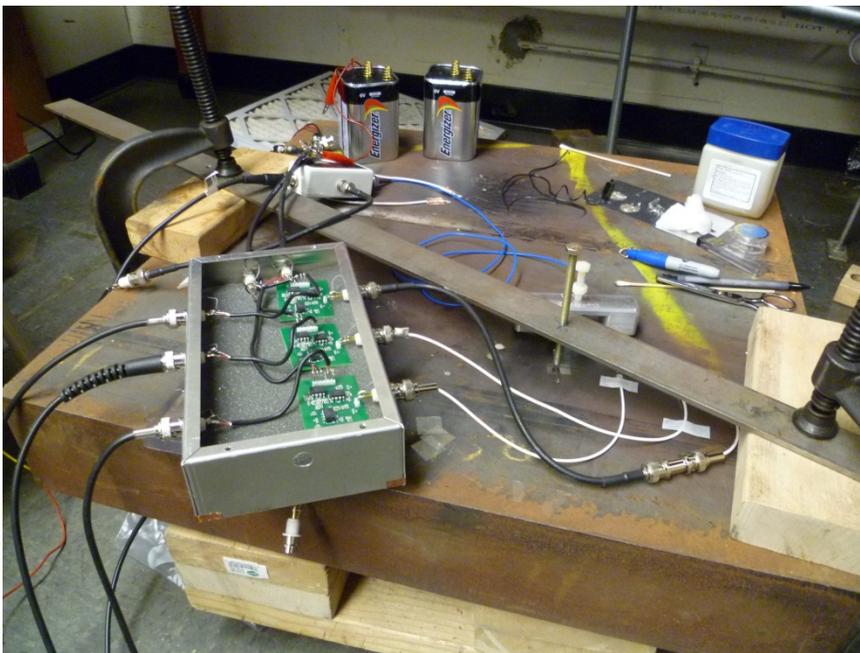
Figure 2. Calibration setup for piezo paint AE sensor

shift based crack source location algorithm was conducted on the calibration setup shown in Figure 1 and other steel plates with a 1-in thickness. This near-field AE monitoring strategy is being refined for piezo film AE sensor and has the advantage of improved representation of crack source information. and (4) A Labview-based virtual instrument software for data acquisition of AE data was enhanced by adding new functionalities including automatic link to database and remote sensing ability.

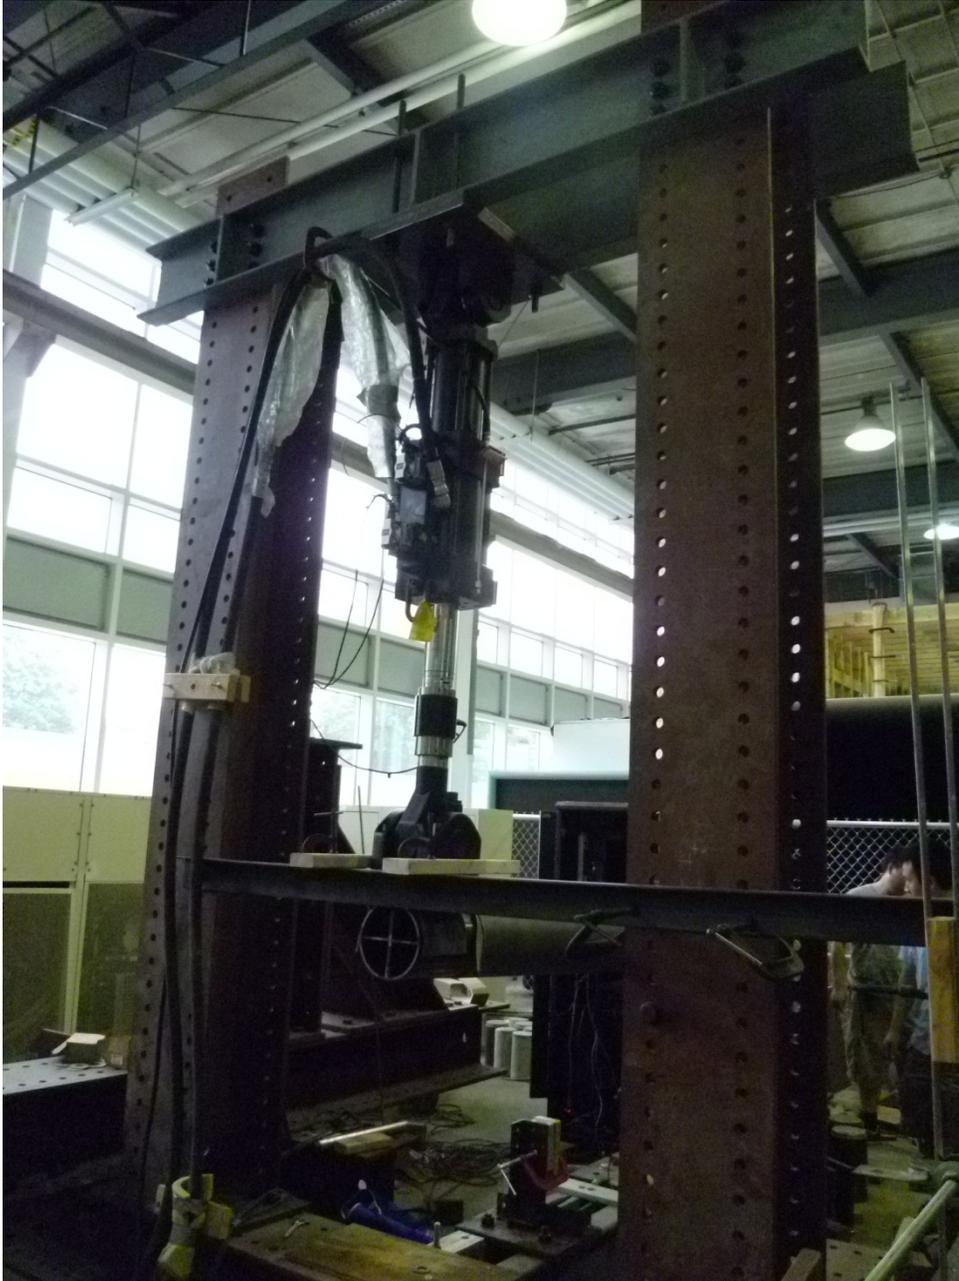
Figure 3. Fatigue test setup for full scale piezo paint sensor characterization test

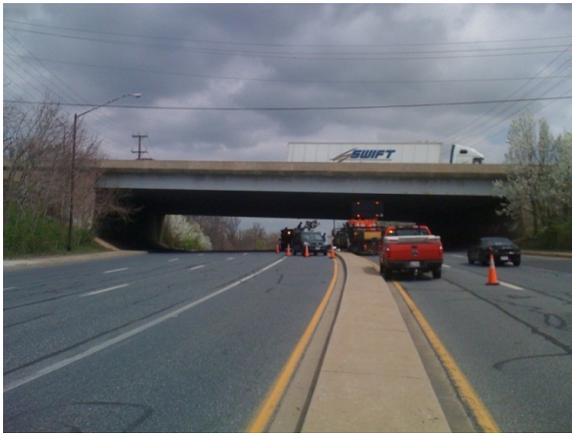
Figure 1. View of the bridge

Bridge Type: Single-span composite steel I-girder bridge (span length = 140 ft.; Figure 1)

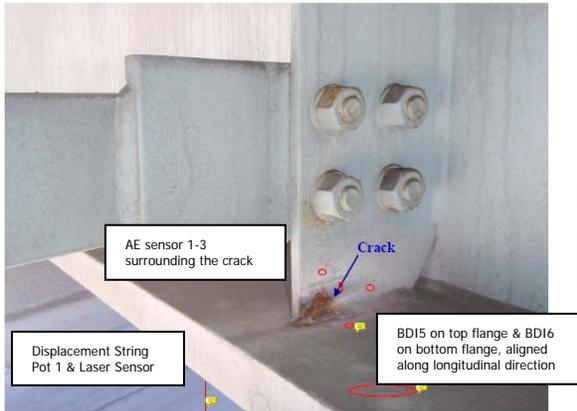
Figure 4. Crack at G3B2D3 (Girder 3 Bay 2 Diaphragm 3) and sensor

Instrumentation plan is shown in Figure 3 – Crack locations and sensor placement on the framing plan. Also shown are Figures 4-7 for cracks on Girders 3 & 4 and their respective sensor locations.

BDI 1-4 strain transducers were placed on both sides of the connection plates while BDI 5-8 were placed on the top and bottom flanges on Girders 3 and 4 (Figures 4-7). Since each transducer is unique and individually calibrated, their numbers are marked on Figure 17 for identification. Figures 18 and 19 are showing the measured live load stresses on the flanges and connection plates, respectively. The maximum longitudinal stress measured on the bottom flange is 1.604 ksi in tension from BDI 3215 on the bottom flange of Girder 3. As for the connection plates, the maximum vertical stresses are 16.18 ksi in tension from BDI 1641 on Girder 3 and 16.1 ksi in tension from BDI 1644 on Girder 4.

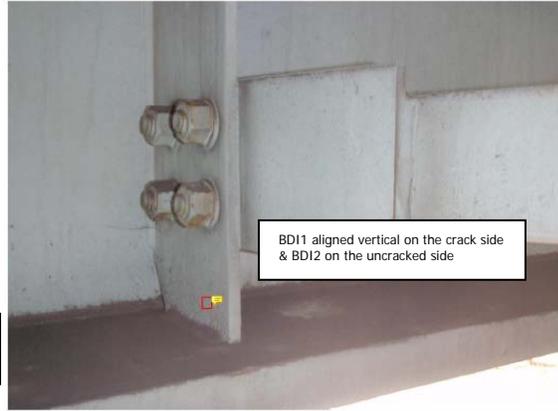
Figure 5. No Sign of Cracking at G3B3D3 (Girder 3 Bay 3 Diaphragm 3) and one

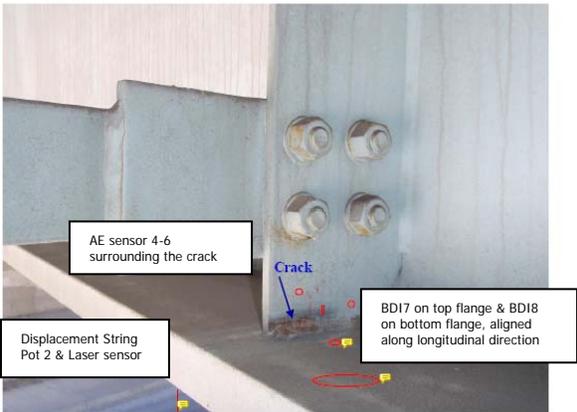
Figure 6. Crack at G4B3D3 (Girder 4 Bay 3 Diaphragm 3) and sensor locations

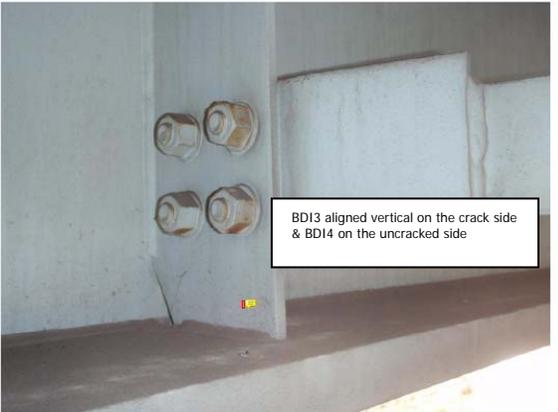
Figure 7. No Sign of Cracking at G4B4D3 (Girder 3 Bay 4 Diaphragm 3) and one sensor

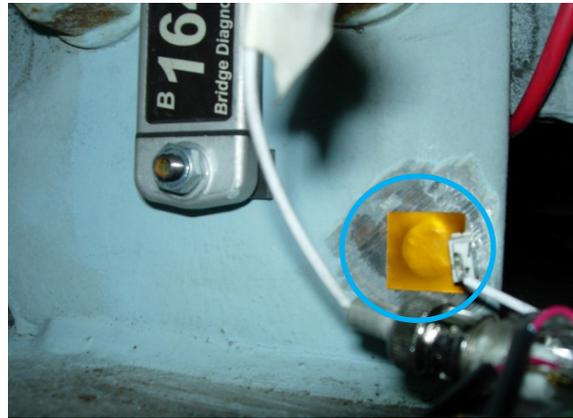
Figure 9. Piezoelectric paint AE sensor (blue circled, for monitoring ambient noise since there is no fatigue crack on this side connection plate)

A total of seven AE sensors were installed on Girder 3 and Girder 4. Three piezoelectric paint AE sensors were installed on Girder 4. Two of them were placed on the cracked connection plate (see Figure 8) while the third was placed on the uncracked connection plate to provide ambient noise AE data (Figure 9). Figure 10 shows the installation of those AE sensors. Same arrangement is for Girder 3.

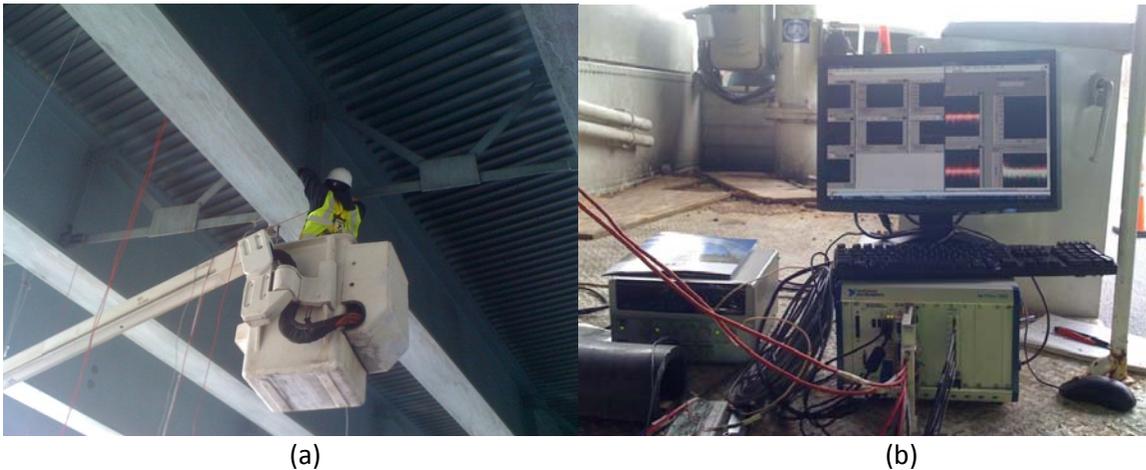
Figure 10. (a) Installing AE sensors and wiring; (b) AE data acquisition

Installing AE sensors and wiring took quite some time on March 20 and 21, 2012. The first day (March 19) of field test was spent on surface preparation for installing AE sensors and preparing additional preamplifiers for AE sensors. The second day (March 20) was on installing AE sensors and connecting wires and preamplifier for three AE sensors. During the third day (March 21), most of the time was spent on wire connection and debugging the sensors. Data were collected from all seven AE sensors. Continuous AE monitoring was carried out from approximately 1:10pm to 1:55pm on March 21, 2012. Based on past bridge monitoring experience with piezo paint AE sensor and on-site trial on AE data collection, the trigger threshold was set to be 50 mV for each AE sensor channel over this monitoring period (otherwise, if a lower threshold level is used, overly large AE data sets would be collected with much significant AE events), that is, if the AE signal for each channel exceeds 50 mV, data collection would be triggered and a total of 10,000 data points (5 msec.) will be collected for each channel at a sampling rate of 2 MHz. Over this monitoring period, no fatigue-crack-related AE signal is observed. Samples of AE data and their frequency characteristics (by applying FFT on time series data) are shown in Figure 11. This is probably due to the short AE monitoring period (only 45 minutes) during this field test during which perhaps no heavy loaded trucks crossed the bridge. It is recommended that for the

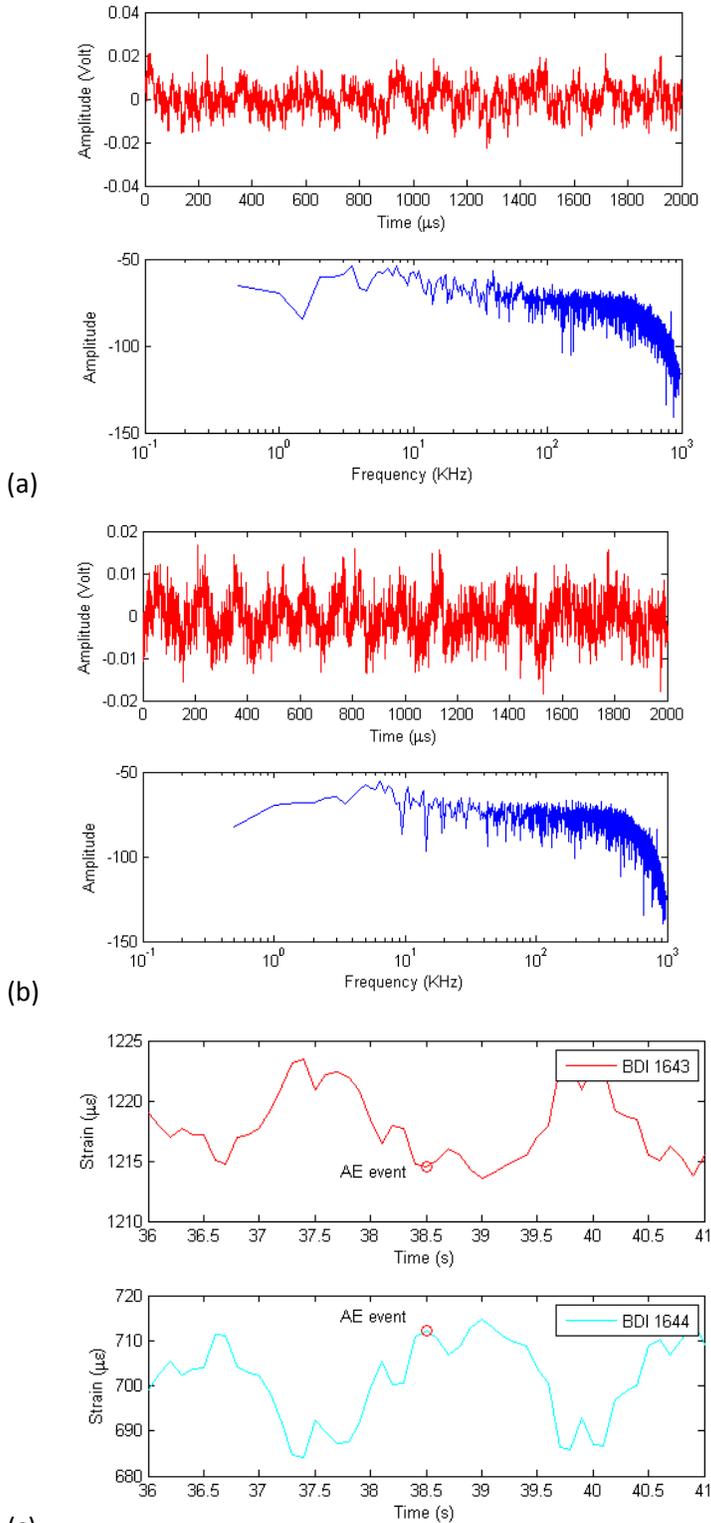
Figure 11. AE data collected by piezo paint AE sensor on Girder 4: (a) ch4 AE data on cracked connection plate; (b) ch6 AE data on uncracked connection plate ; (c) corresponding strain data

(from BDI strain gage near ch4 AE sensor), AE data acquired between 38.6 and 38.7 seconds in this figure (highlighted with red circles) (BDI 1643 strain gage on the uncracked side of Girder 4 while BDI 1644 strain gage placed on the cracked side of Girder 4).

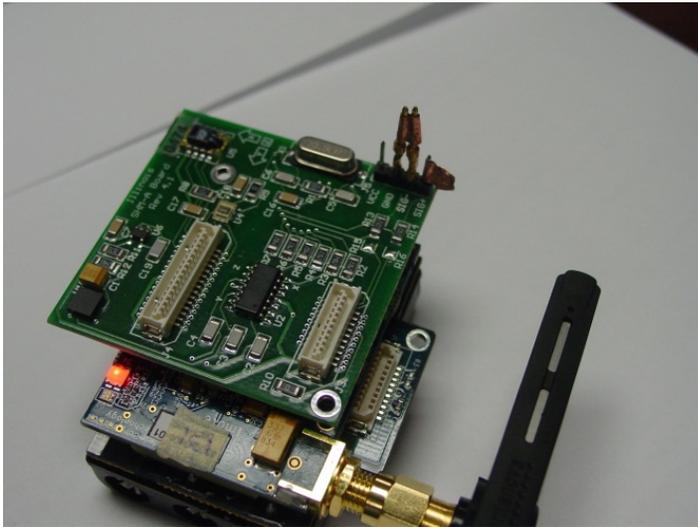
Figure 12. Wireless sensor Imote2 (measuring acceleration and temperature)

A total of four wireless accelerometers (see Figure 12) Imote2 were used to monitor the vibration responses of the bridge. One wireless sensor was installed on one of the girders (Girder 2 to 5) and acceleration data was acquired at 100 Hz sampling rate synchronically. The acceleration data was used to provide modal frequency information (Figure 13) that can be used to calibrate the finite element model of the bridge. The fundamental frequency thus measured is 3.22 Hz, which is very close to the value from finite element analysis (3.14 Hz).

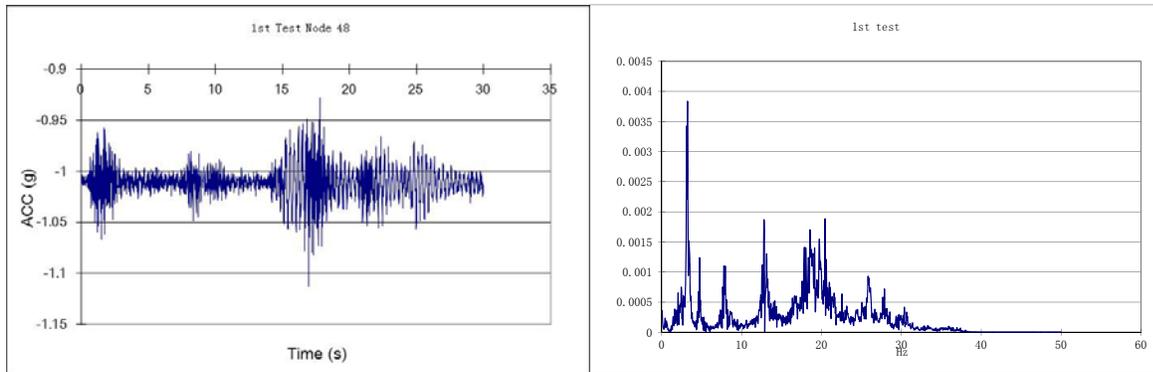
(a) Acceleration time history

(b) FFT of acceleration data (horizontal axis: frequency; vertical axis: FFT amplitude)

Figure 13. Acceleration data measured by wireless sensor

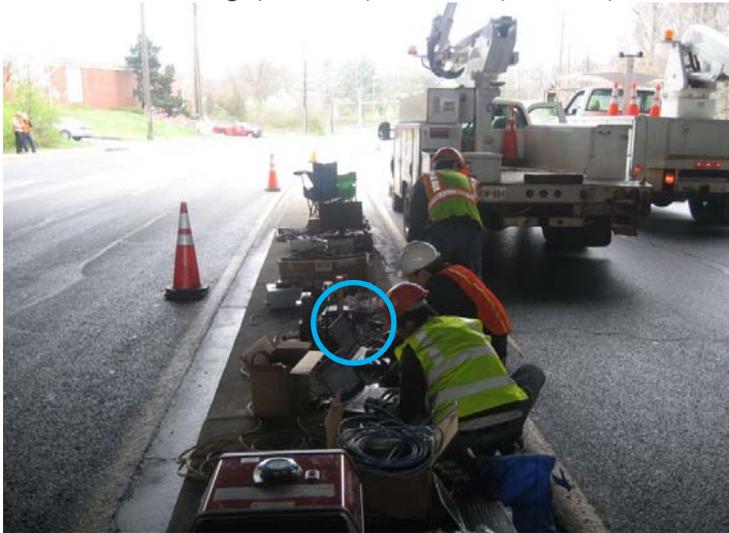
Figure 14. Bridge deflection measurement with ultrasonic distance sensor and laser distance sensor (in blue circle)

Both laser sensor and ultrasonic distance sensors were used to measure the dynamic deflection of the bridge, as shown in Figure 14. Only one laser sensor and one ultrasonic distance sensor were used each

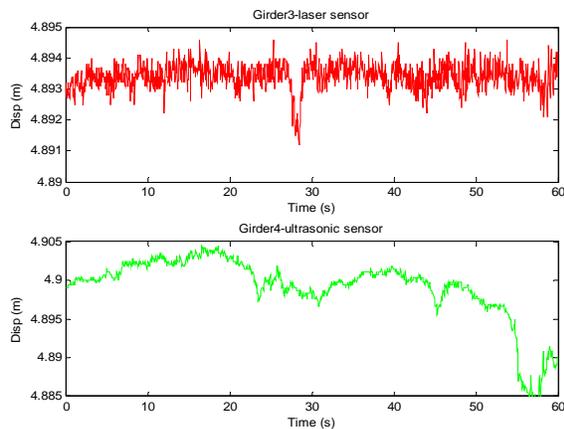
Figure 15. Bridge deflection data by laser sensor (upper) and ultrasonic sensor (lower) (The measured value is the distance between the sensor and girder bottom surface)

time. The data from laser sensor is shown in Figure 15. The measured deflection value from the laser sensor agrees well with the string pot, and its accuracy is also validated by the fundamental frequency indicated by FFT of the laser sensor measured deflection data (see Figure 16). The ultrasonic sensor data had some problems, most likely due to a high sampling rate (20 Hz seems to be too high for ultrasonic distance sensor of this particular model, next time we will lower the sampling rate to 5 Hz, which provides much better accuracy during lab calibration test) and parasitic echo signals from reflecting background such as lower surface of bridge deck (next field test we will install the ultrasonic distance sensor on the girder and let it shoot down on road surface to avoid background noise).

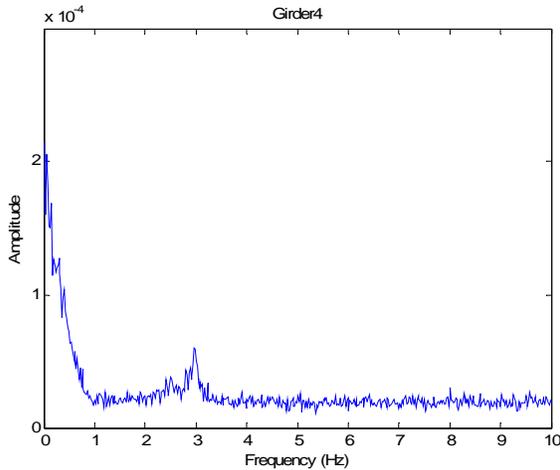
Figure 16. FFT of laser distance sensor
(note the existence of fundamental frequency of the bridge near 3 Hz)

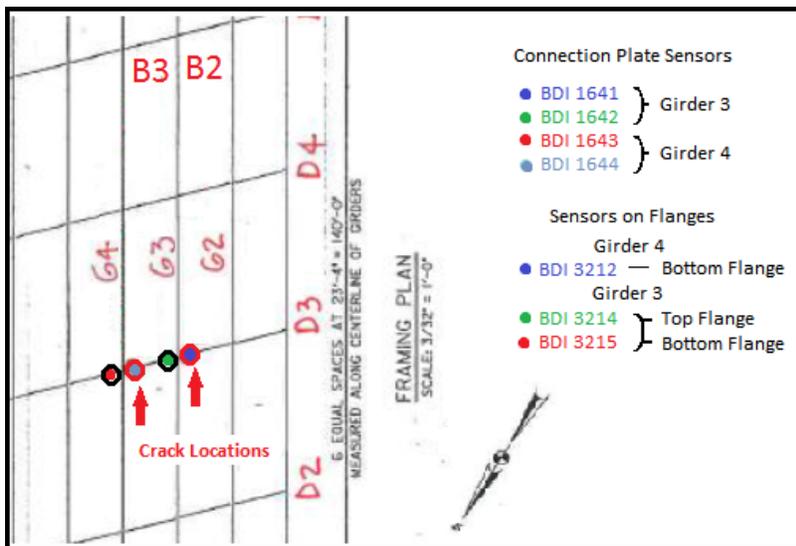
Figure 17. BDI strain transducer locations and marked numbers

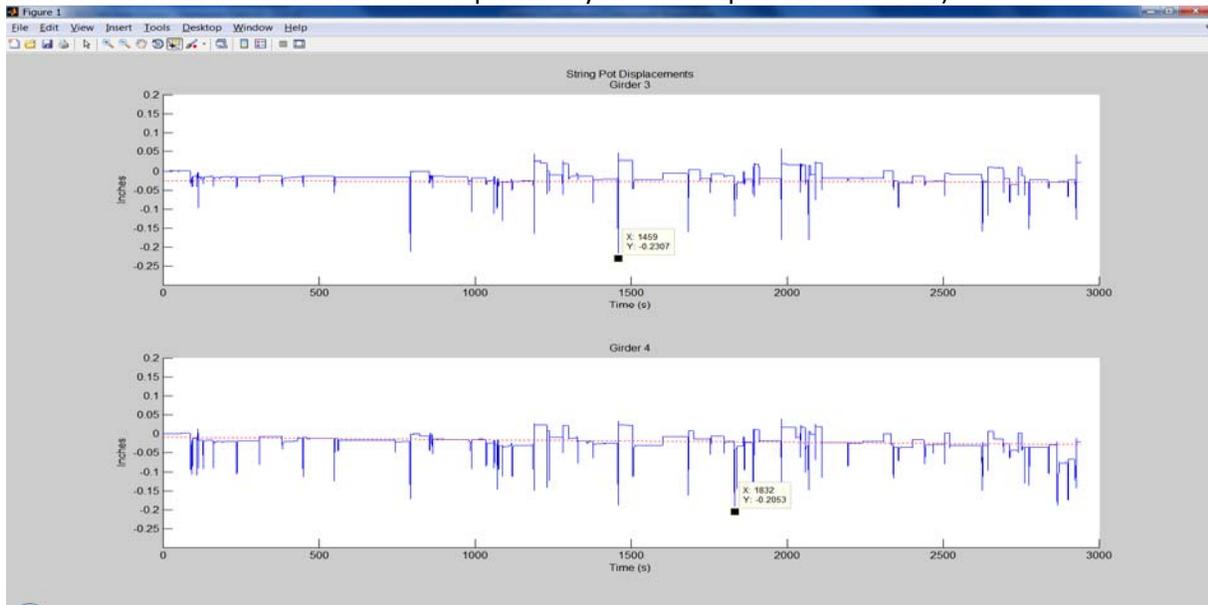
Figure 20. String pot deflection results on girders 3 and 4

String pots were placed on Girders 3 and 4, synchronized with strain and acoustic emission results. The maximum measurements within the testing period are 0.231" on girder 3 and 0.205" on girder 4, respectively, which are very closed to the laser results, though laser was independently measured. (This short-term measurement is lower than previously measure up to 0.5" or 0.75".)

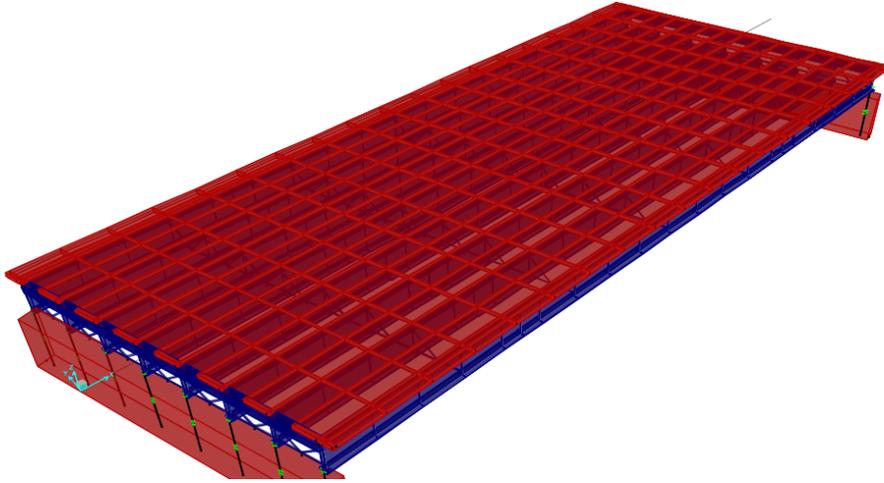
Figure 21. FEM model of the Middlebrook Road Southbound Bridge by CSI Bridge

Finite element model was generated for the bridge. Its model is shown in Figure 21 and its first natural frequency is calculated around 3.11 for a fixed-fixed boundary condition and lower for the normal analysis of fixed-free boundary condition. This is a skewed bridge and the x-translational direction is along the longitudinal direction of the bridge. Fixed-fixed boundary condition represents all x-, y- and z-translational degrees-of-freedom of the five nodes at the bottom flange for each girder on both ends are fixed while fixed-free boundary condition represents x-translational degree-of-freedom of one end is freed (as a roller end). For comparing the first mode, fixed-fixed condition is more realistic where the test result is 3.22 Hz and FEM result for fixed-fixed condition is 3.14 Hz (Table 2).

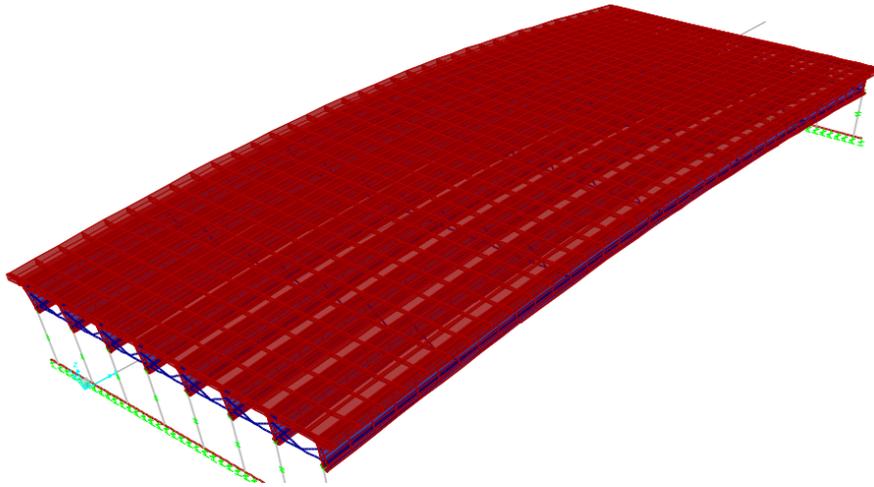
Figure 22. Modal shape of the first mode ($f = 3.136 \text{ Hz}$) by CSI Bridge

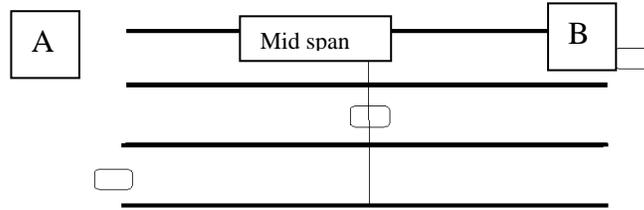
Case 2: the 3rd truck entered the bridge when the 1st truck just left the bridge (only two trucks on the bridge at the same time)

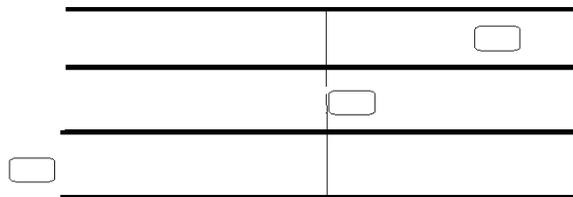
Case 3: the 3rd truck entered the bridge when the 1st truck and 2nd truck just left mid span

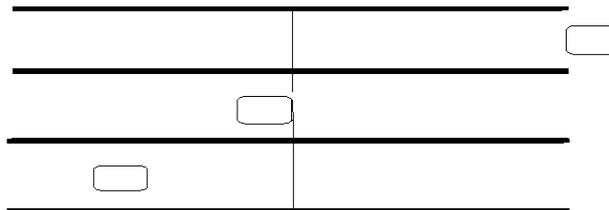
Case 4: the 1st truck left the bridge when the 2nd truck and 3rd truck just entered the right span one after the other

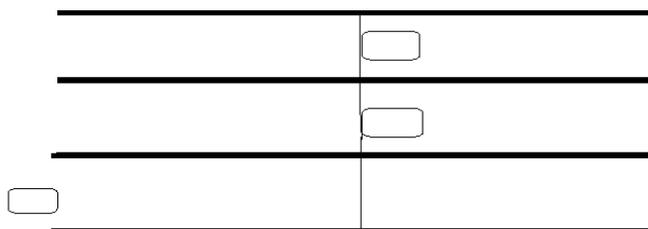
Case 5: the 1st truck and the 2nd truck passed the bridge parallel

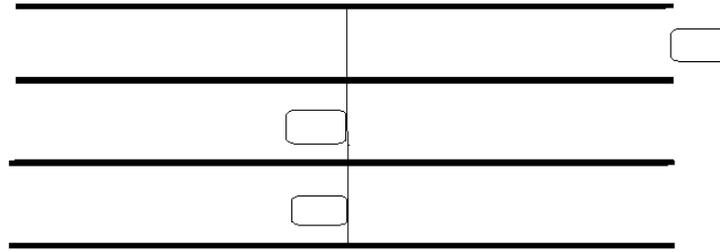
Case 6: the 1st truck just left when the 2nd & 3rd truck is @ mid span

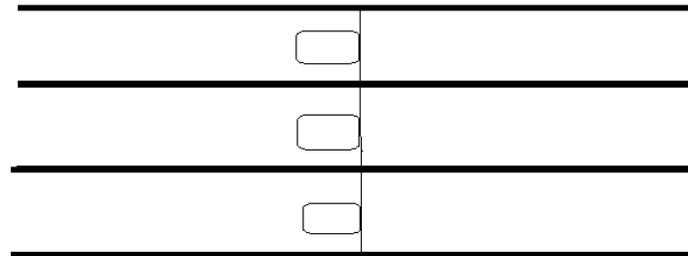
Case 7: 3 trucks passed the bridge at the same time, no truck load reduction is applied

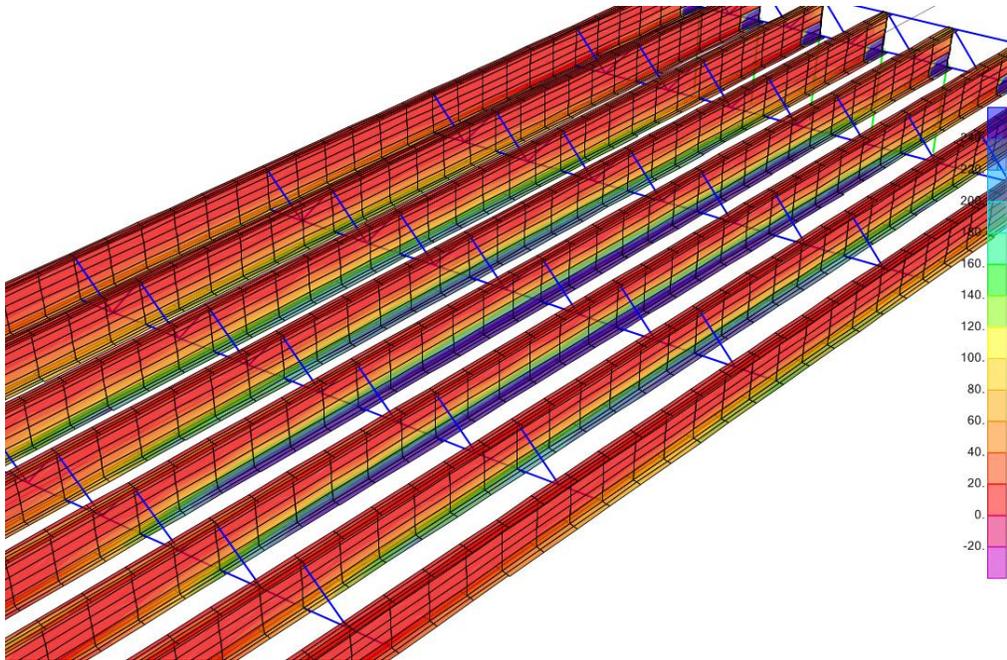
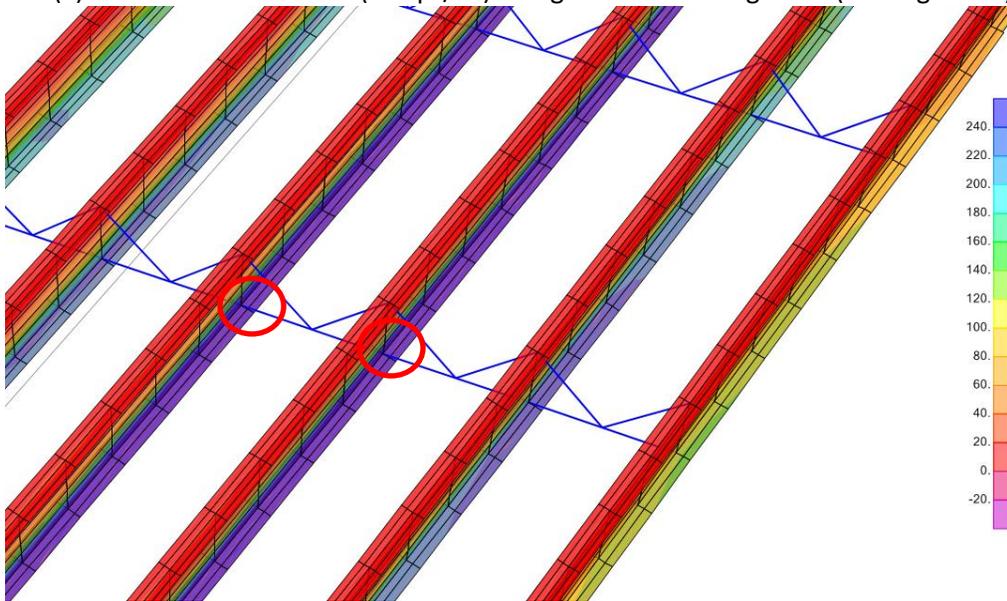
(a) Global stress contour (in kips/ft²) of eight southbound girders (looking south)

(b) Close-up view of girders 3 and 4 with fatigue cracks

Figure 23. Live load stress contour of truck loading case 6

High tension stress on the connection plates on Girders 3 and 4

Since this is a simple-span bridge, the maximum stress ranges at the bottom flange are close to the maximum stresses, which are demonstrated in Figure 18. The maximum stress measured on the bottom flange of girder 3 is 1.604 ksi where the FEM maximum stress ranges for case 4 for two HS-20 loaded subsequently on two near lanes is 1.507 ksi and case 6 for two HS-20 loaded on two near lanes is 1.926 ksi, respectively. Case 7 for three lane simultaneously loaded, based on AASHTO LRFD Specifications that can be reduced by a multiple presence factor of 0.85, yields 1.908 ksi (0.85×2.245 ksi). Global stress contour and its close-up view (in kips/ft²; divided by 144 to convert the scale to ksi) are shown in Figure 23 (a) and (b). Due to program limitation, the connection plates were not modeled.

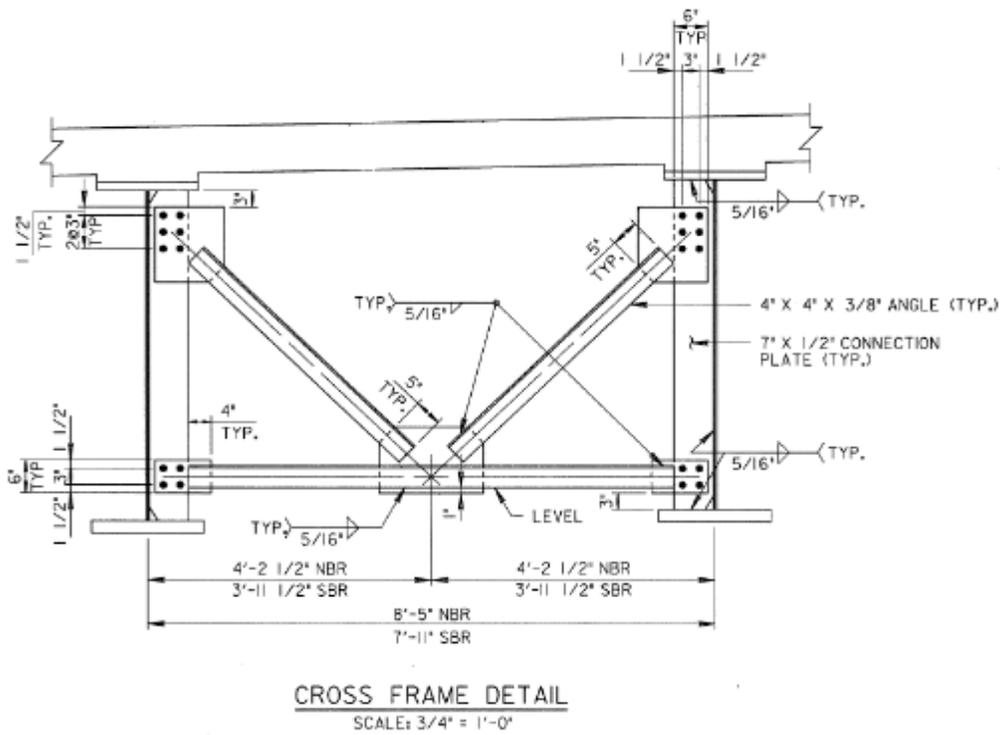
Figure 24. Typical cross frame detail

Out of all types of cross-frames, X-type with top and bottom chords is the stiffest of all, then the K-type with top and bottom chords, then the X-type with bottom only and the flexible one is the K-type with bottom chord only. Differential displacement between girders will cause one diagonal in tension and one in compression. Since the working point of the diagonal is not at the junction of girder web and top flange plus no help from the top chord, one side of the connection plate will be under tension and one under compression. Measured 16.1 ksi in tension is not surprising with the flexibility of the cross-frame and the girder system (with up to 0.5" to 0.75" vertical deflections due to live load observed.)

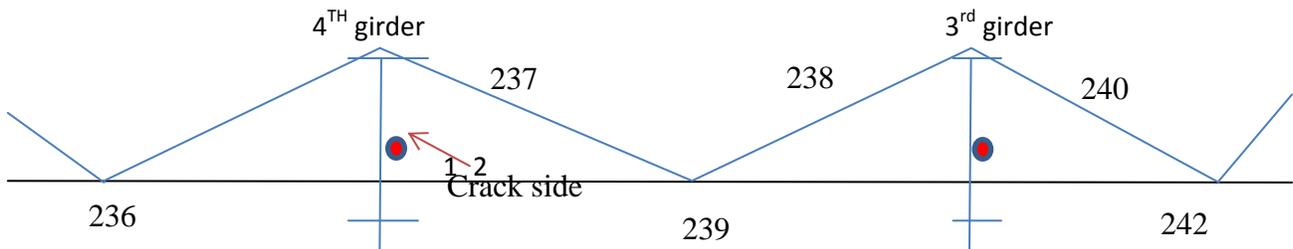
Figure 25. FEM numbering for the cross-frames near the crack locations

Figure 25 shows the numbering for the cross-frames near the crack locations. Table shows their corresponding forces.

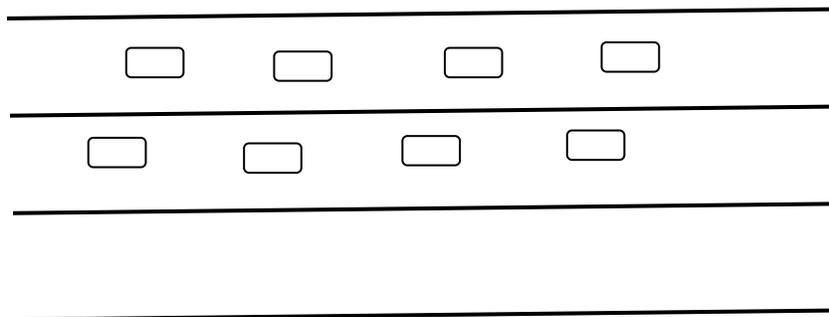
Case 16: the 1st group trucks passed the bridge side-by-side on fast lanes and 2nd group 25' behind

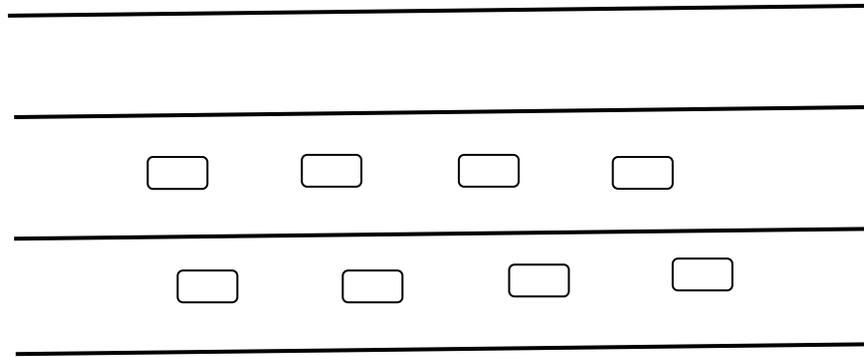
Case 17: the 1st group trucks passed the bridge side-by-side on slow lanes and 2nd group 25' behind

girder 3 crack location connected with the bottom chord between girder 2 and 3	girder 4 crack location connected with the bottom chord between girder 3 and 4
Max. stress		
case 16_LL	7.32ksi	17.95ksi
case 17_LL	19.59ksi	21.68ksi

Maximum differential displacement of -0.316584 inches is found between girders 2 and 3 under live load case 16 (-0.303624 inches between girders 3 and 4).

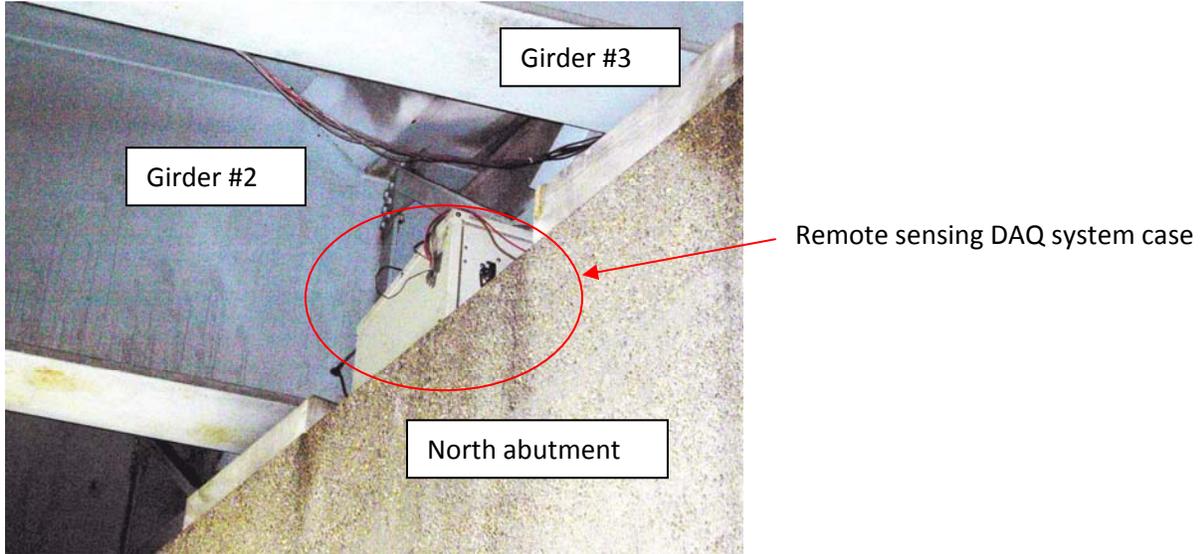
Figure 1 – Case containing remote sensing DAQ system on the top of the bridge pier

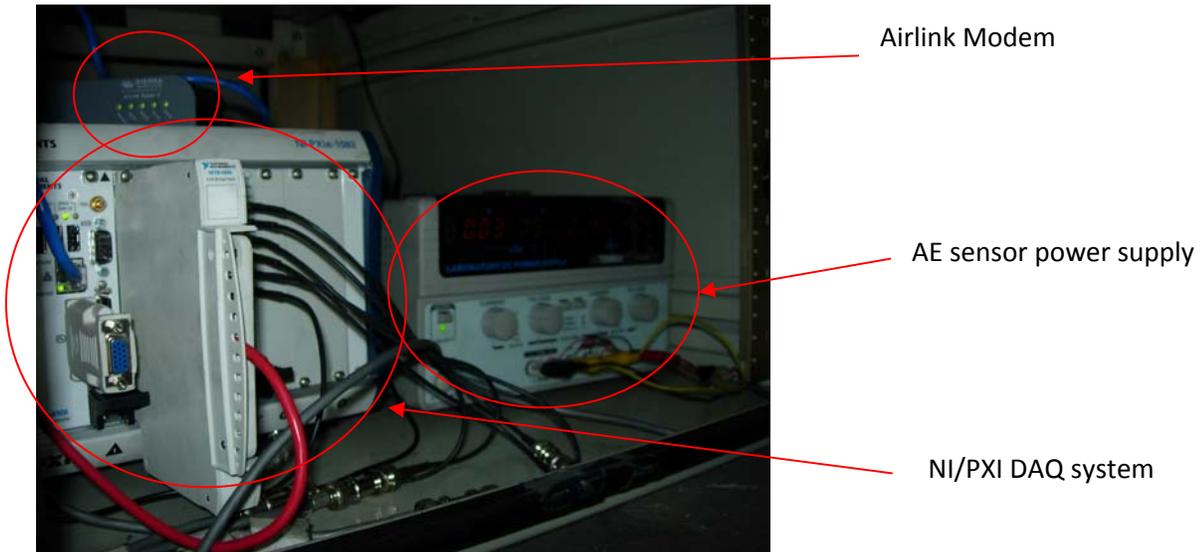
Figure 2 – Close look of the remote sensing DAQ system inside the case

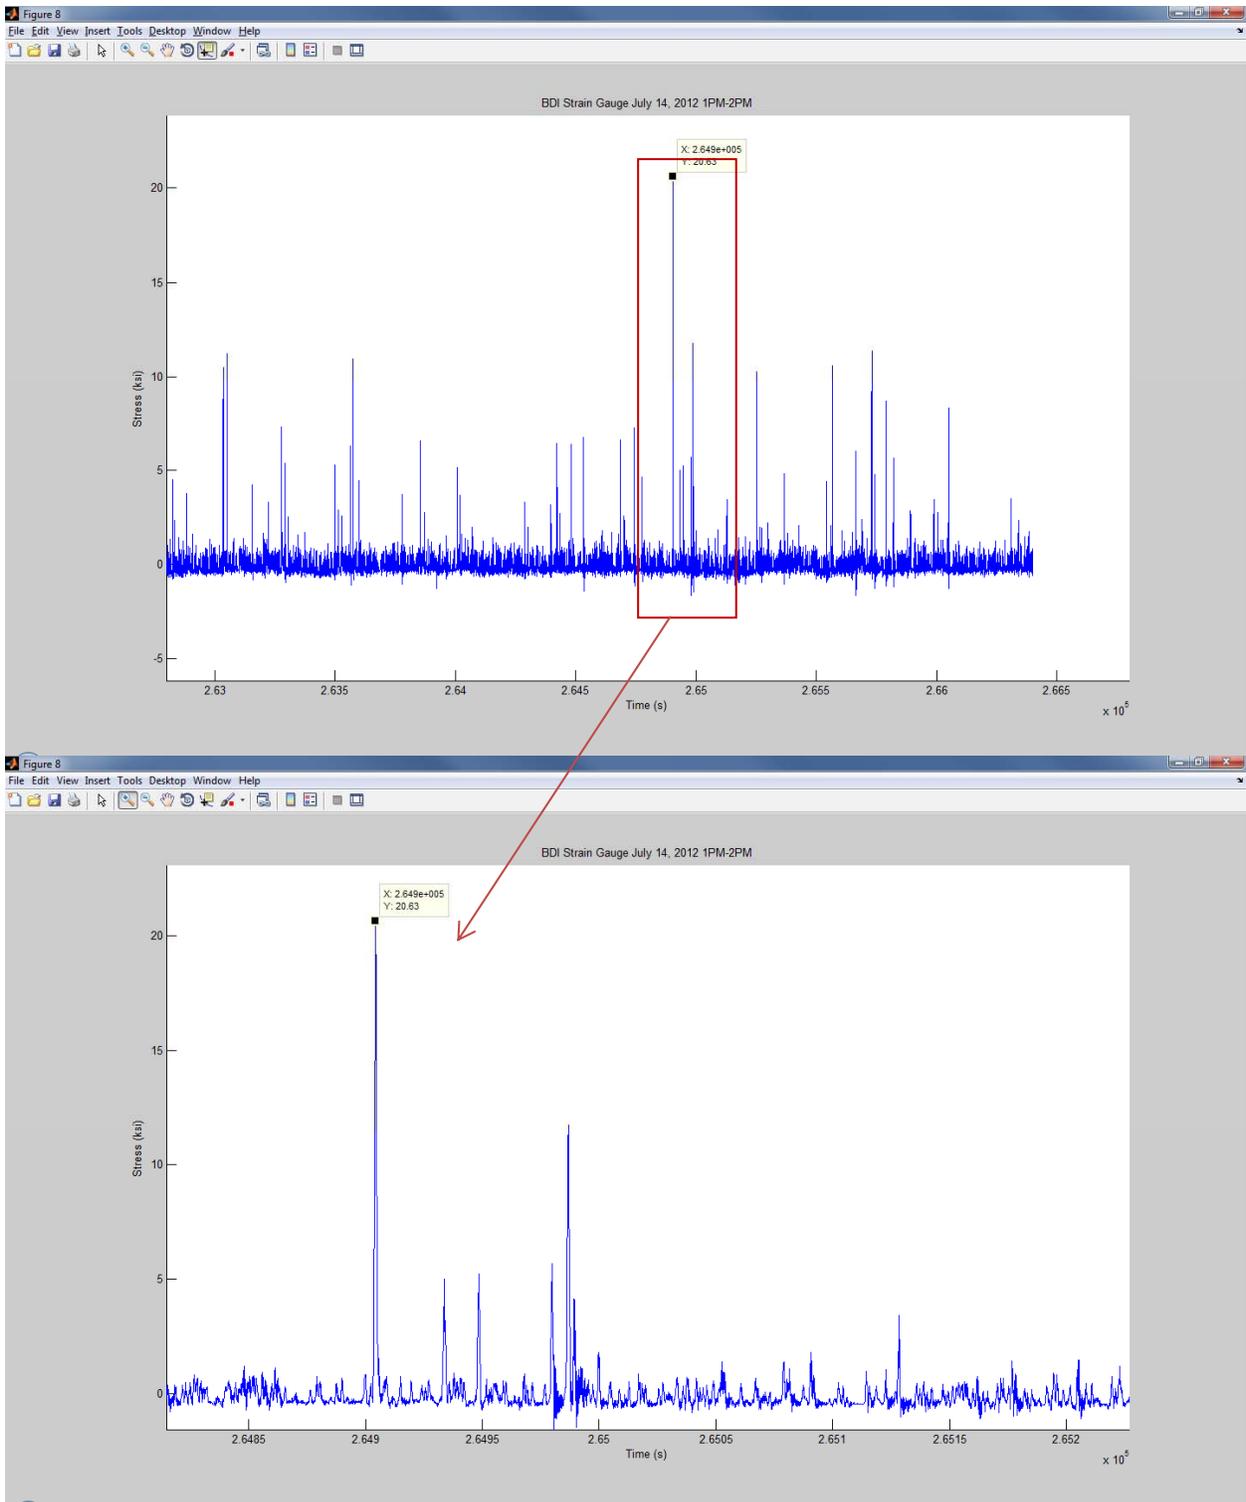
Figure 3 – Sample segment 1 of the continuously monitored strain data

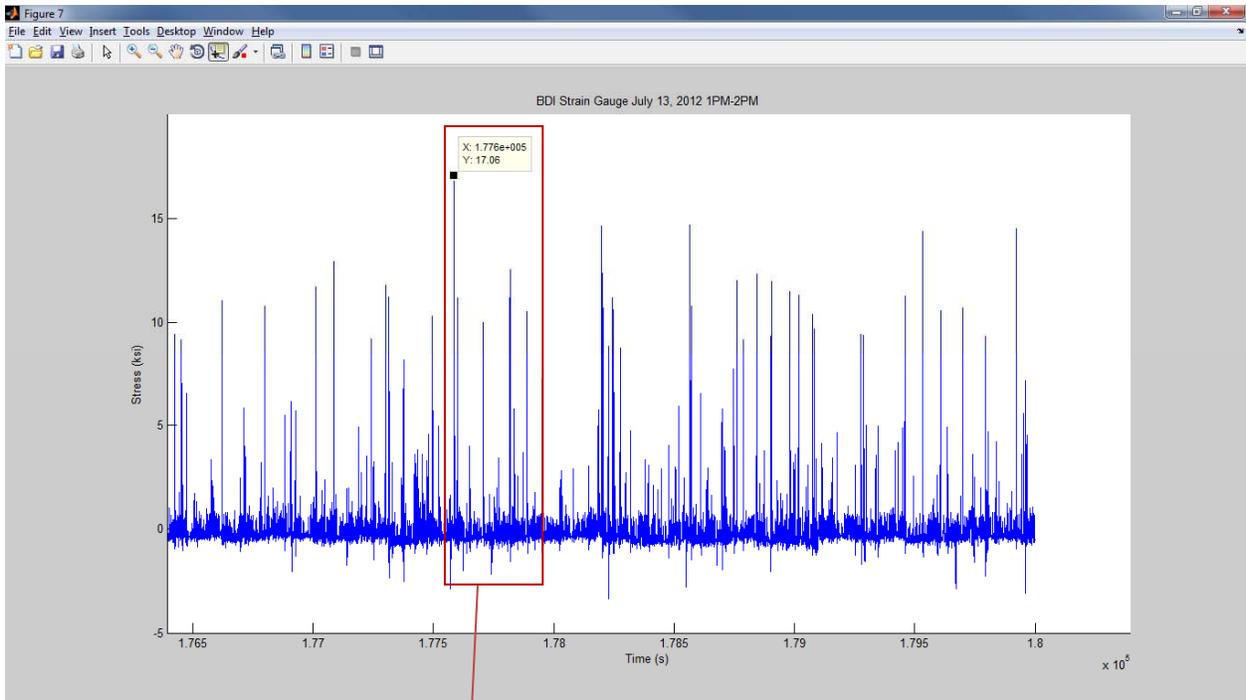
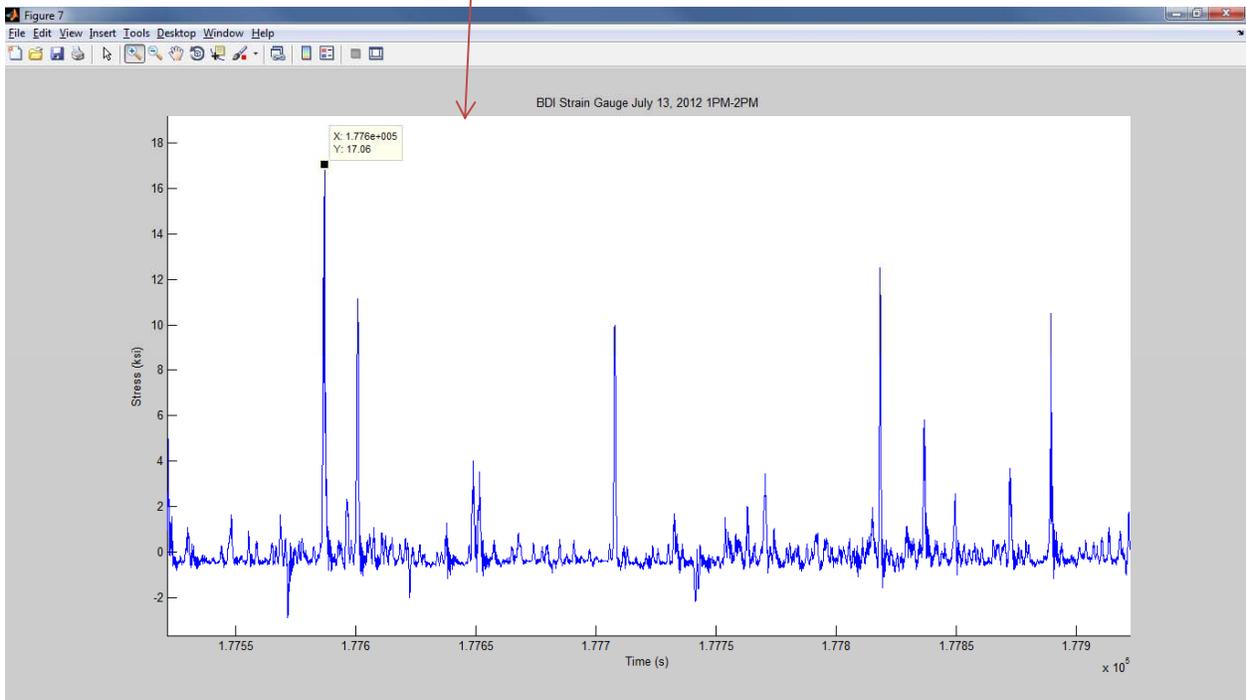
Figure 4 – Sample segment 2 of the continuously monitored strain data
