Development of a Self-Sustained Wireless Integrated Structural Health Monitoring System for Highway Bridges

Fourth Quarterly Progress Report

April 15, 2012 through July 14, 2012

Appendix A - Updated Field Test Report for Bridge No. 1504200 I-270 over Middlebrook Road

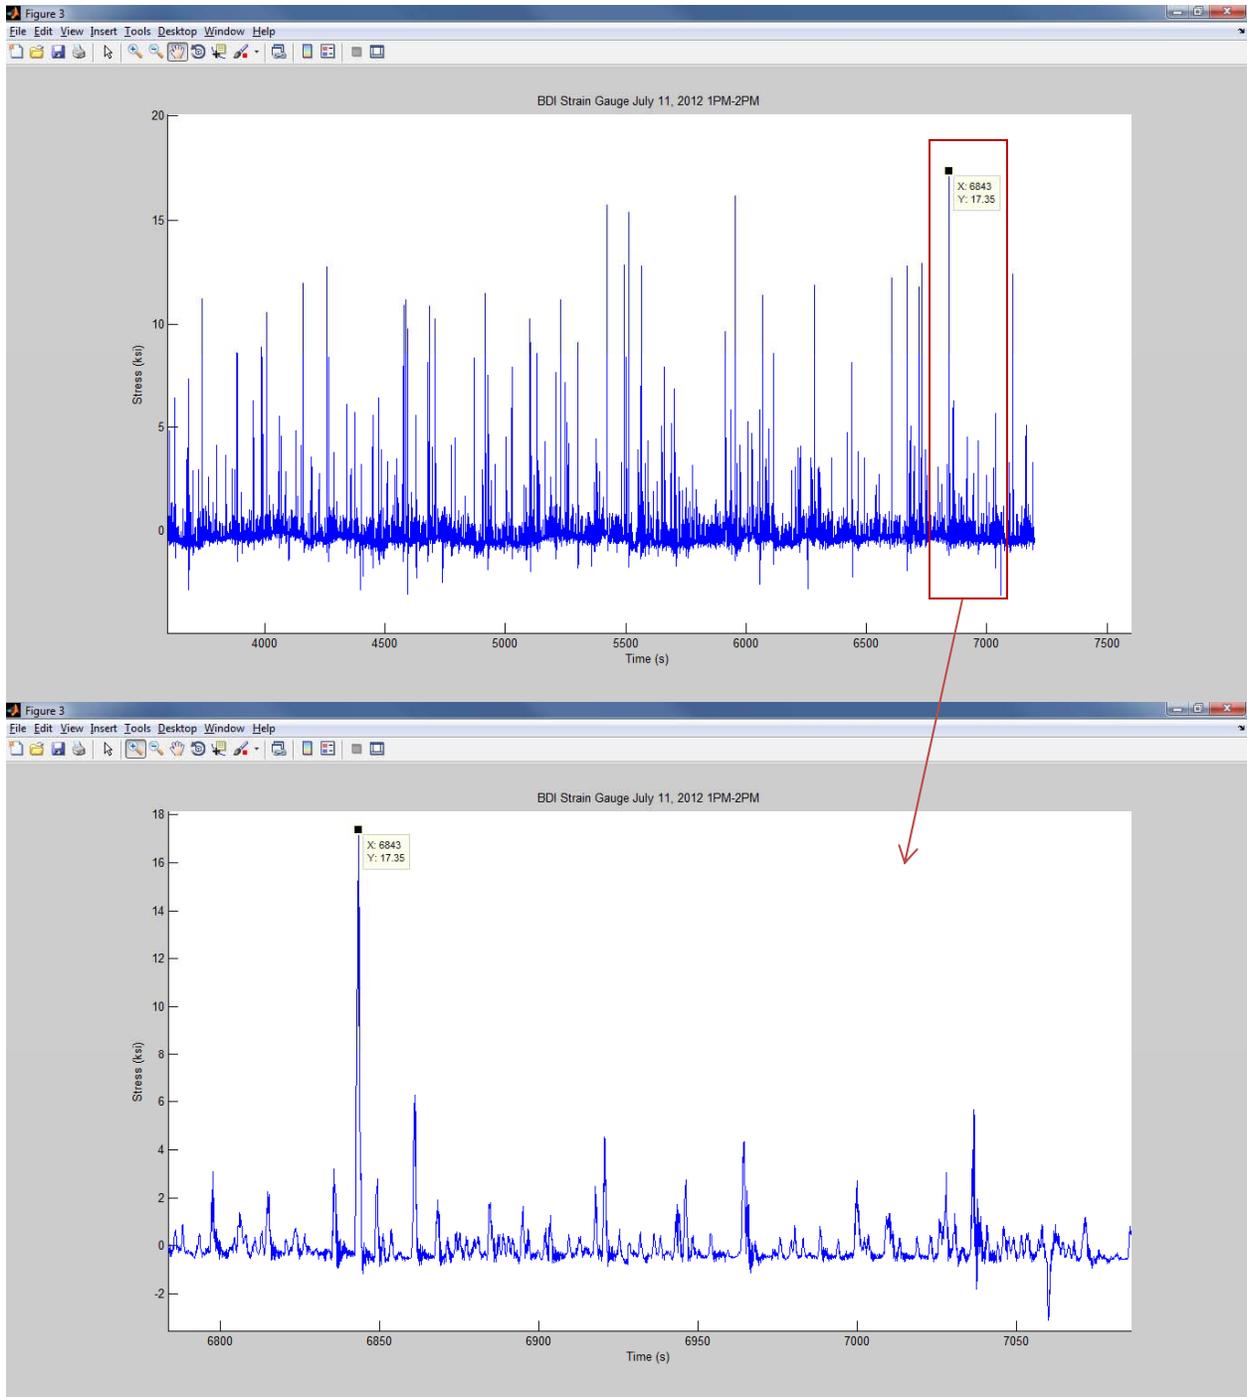
Figure 5 – Sample segment 3 of the continuously monitored strain data

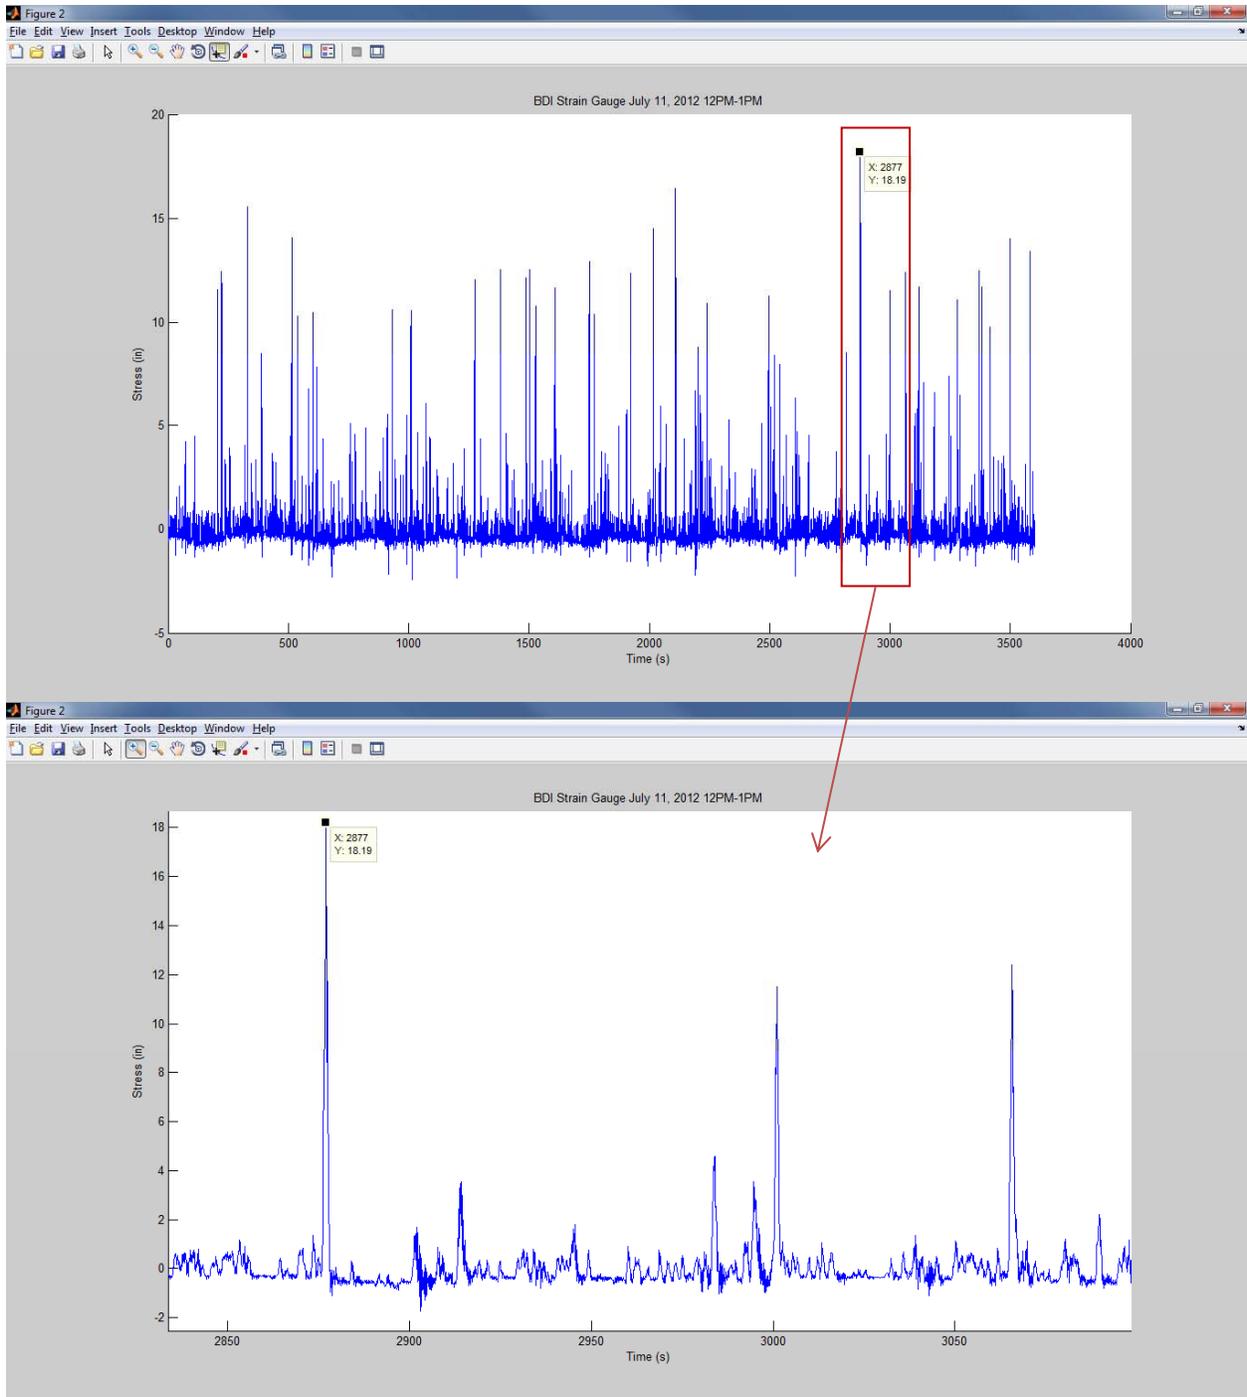
Figure 6 – Sample segment 4 of the continuously monitored strain data

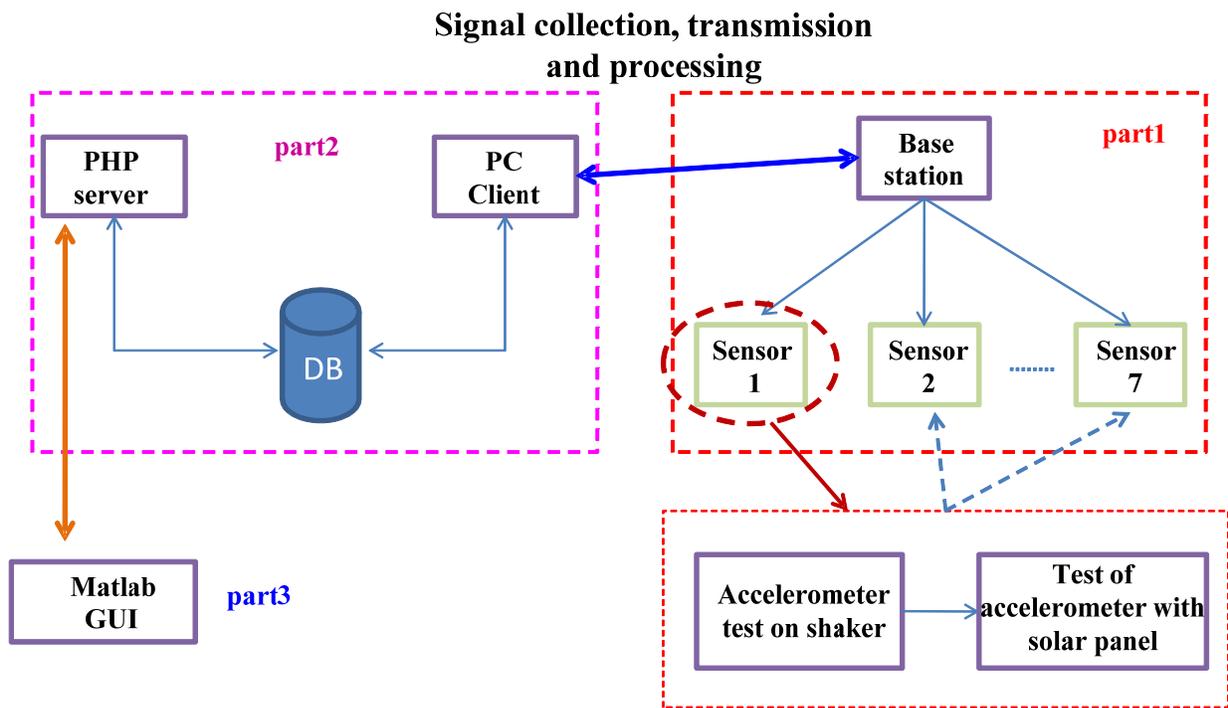
Fig. 1 overview diagram of signal processing

- Established the signal processing system
There are three aspects in this part: signal collection, signal transmission and signal processing. Fig. 1 is the overview diagram of the signal processing for the structural health monitoring system by wireless sensors.

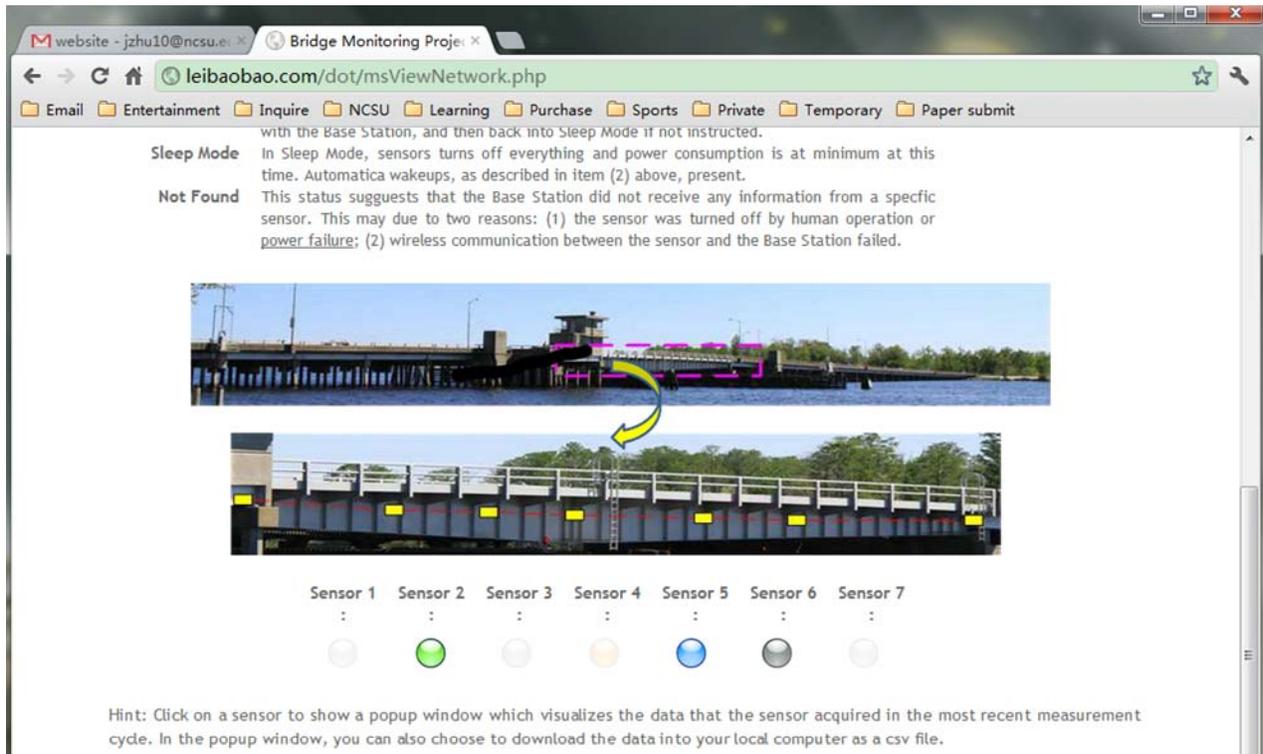
Fig. 2 The website for structural health monitoring system

In the part of signal transmission, the signals collected by the sensors will be uploaded to our server or website by using the internet, and the server or website would provide the download service, that is to say, we can get signal from the server or website. The following link is our website about our work: <http://leibaobao.com/dot/msViewNetwork.php>. Fig. 2 is the website we built on the internet, and Fig. 3 is the base station which we can use it to upload the

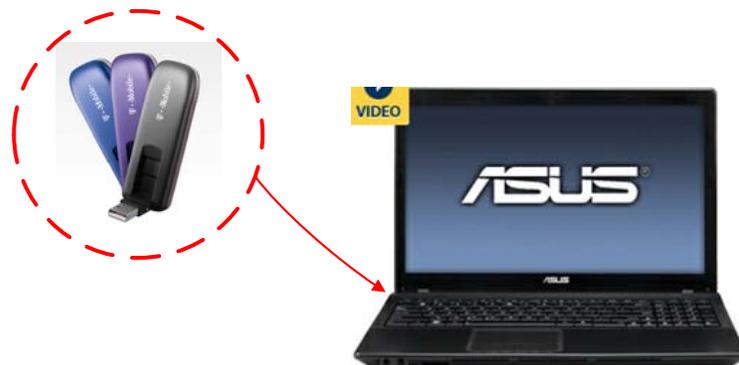
Fig. 3 the base station for transmitting signals

signals. The work has been done in this part includes: the base station has been built, the website has been built, the program between base station and server is compiling.

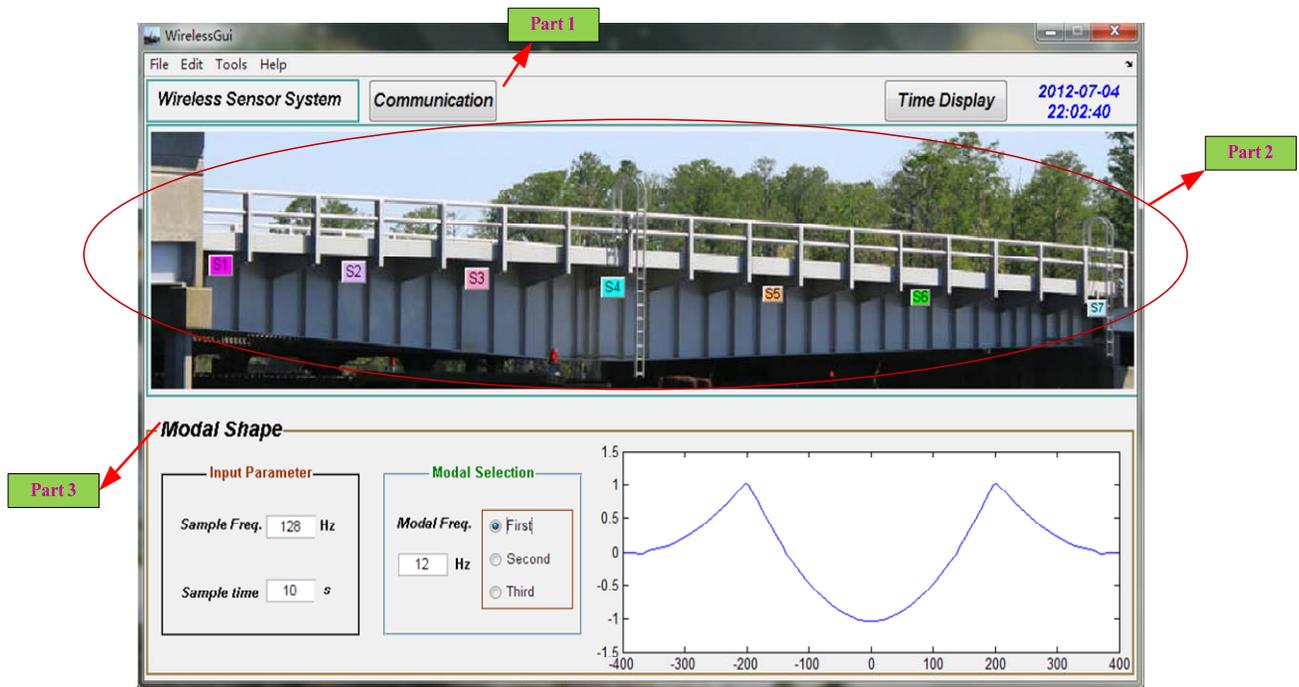
Fig. 4 GUI panel

The signals will be processed and displayed in the signal processing part. So we built the GUI to dispose the signal which can be downloaded from the server or website. Fig. 4 is the GUI panel, which can be divided into three parts: communication, signal display and modal shape. Fig. 5 is the panel to display how to obtain the signals from the communication part.

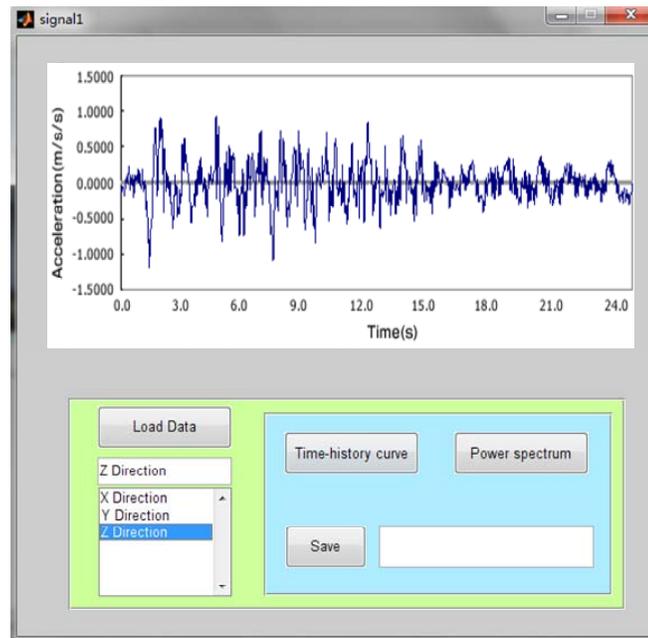
Fig. 5 Signal display panel

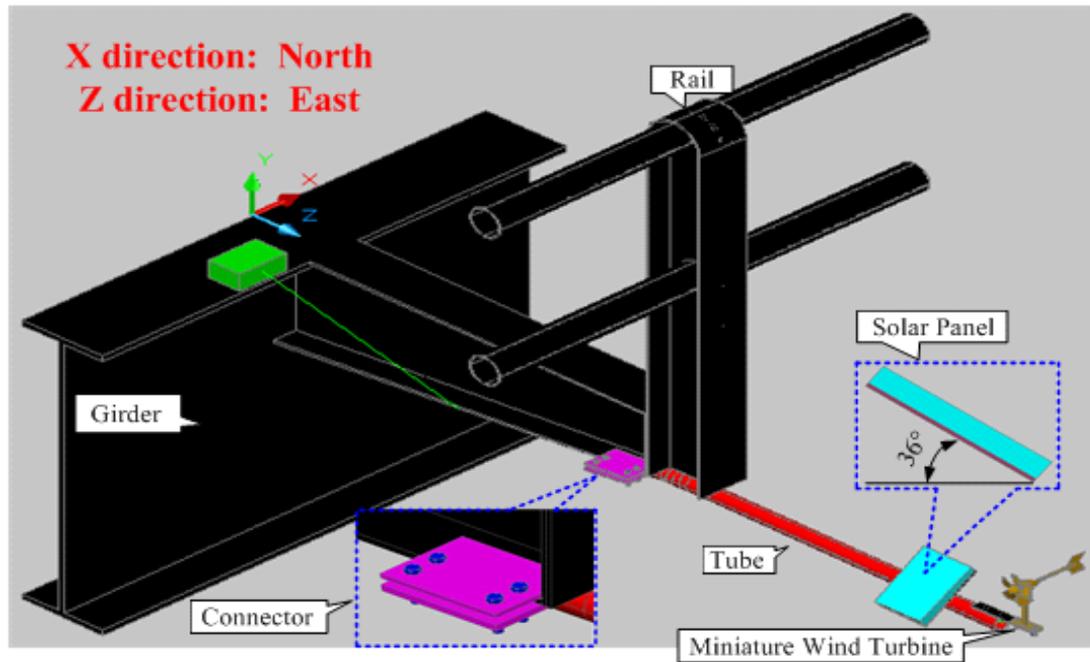
Fig. 6 Polysilicon solar power system

- The polysilicon solar power system for bridge health monitoring, which mainly consists of solar panel, miniature wind turbine, support and box, has been designed, as shown in Fig. 6.

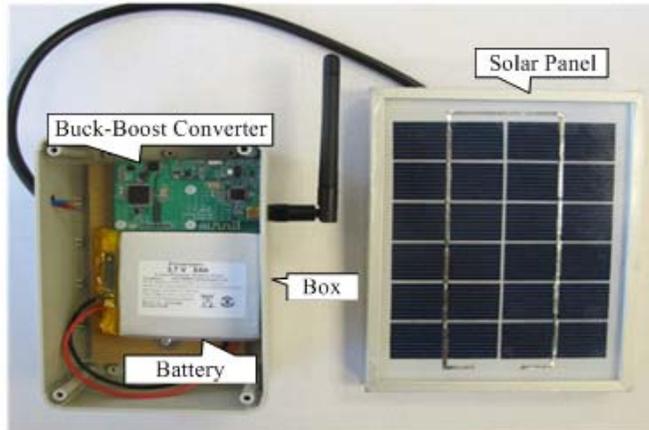
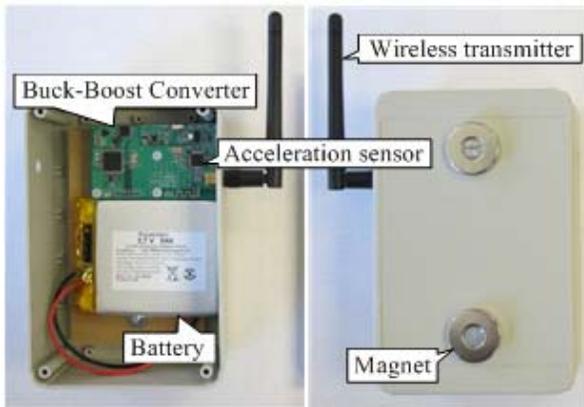
(a) Front

(b) Back

Fig. 7 Solar panel and Buck-Boost Converter

- The output power of the selected solar panel has been calculated and tested. A Buck-Boost Converter (Fig. 7) has been designed and manufactured, and a rechargeable battery with a capacity of 5 amp hour was selected for storing the energy from the solar panel. The effectiveness of the Buck-Boost Converter has been experimentally verified. The calculated output power of the solar panel can be seen in Table 1, the tested output power of the solar panel and efficiency of the Buck-Boost Converter can be seen in Table 2.

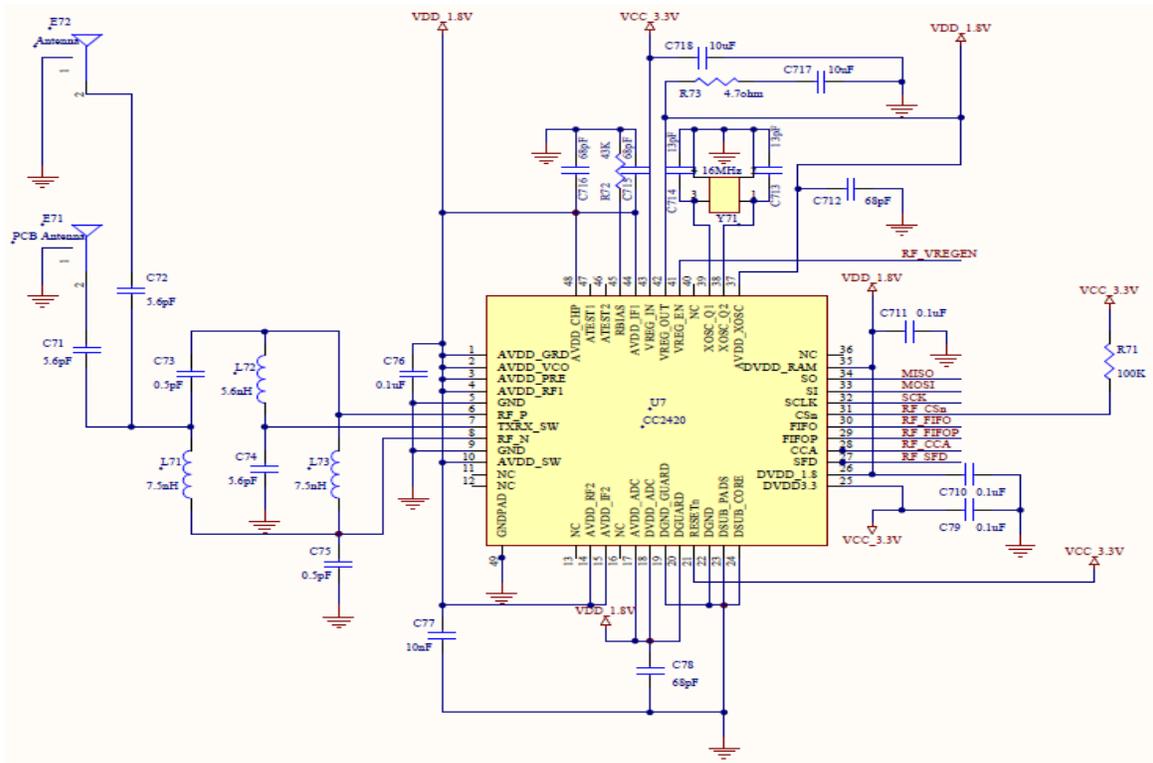
Fig. 9 The Schematic of CC2420

- A box in Fig. 8 with battery, Buck-Boost Converter, wireless transmitter and acceleration sensor has been manufactured, and it will be installed in the bridge.
- Finish the design of a wireless accelerometer board. This board use CC2420 IC for wireless communication in Fig. 9. The CC2420 is a true single-chip 2.4 GHz IEEE 802.15.4 compliant RF transceiver designed for low-power and low-voltage wireless applications. It can provide an effective data rate of 250 kbps.

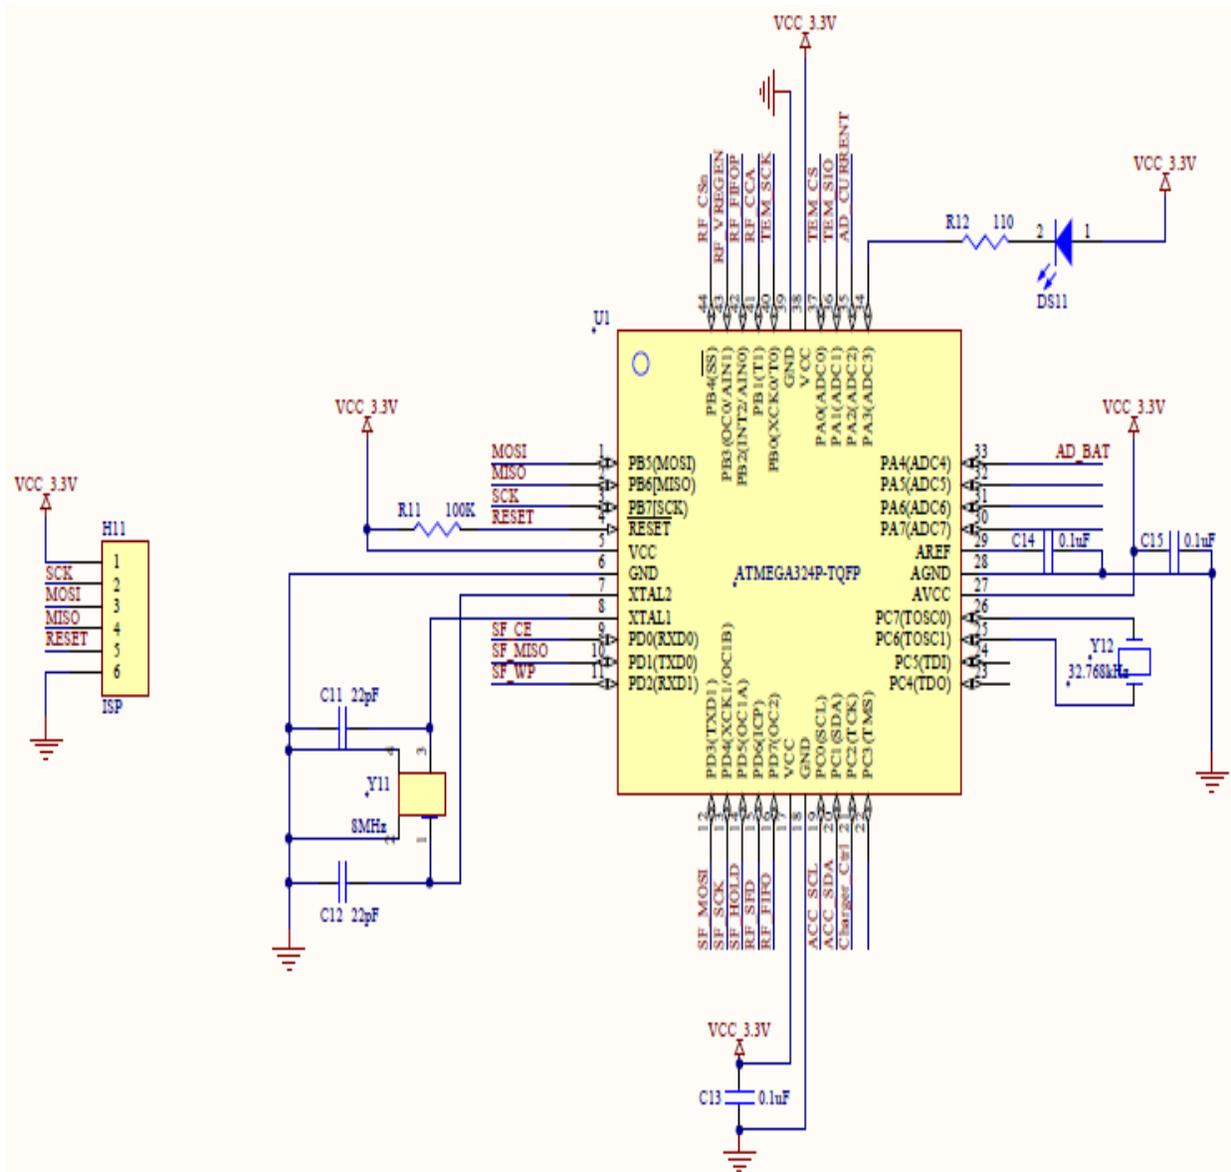
Fig. 10 The Schematic of ATmega324P

In Fig. 10, ATmega324P is for the micro controller unit on this board. It's a 8-bit AVR RISC-based microcontroller combines 32KB ISP flash memory with read-while-write capabilities, 1KB EEPROM, 2KB SRAM, 32 general purpose I/O lines, real time counter, three flexible timer/counters with compare modes and PWM, 2 USARTs, byte oriented 2-wire serial interface, 8-channel/10-bit A/D converter with optional differential input stage with programmable gain, programmable watchdog timer with internal oscillator, SPI serial port, JTAG (IEEE 1149.1 compliant) interface for on-chip debugging and programming, and six software selectable power saving modes. It can operate between 2.7-5.5 volts.

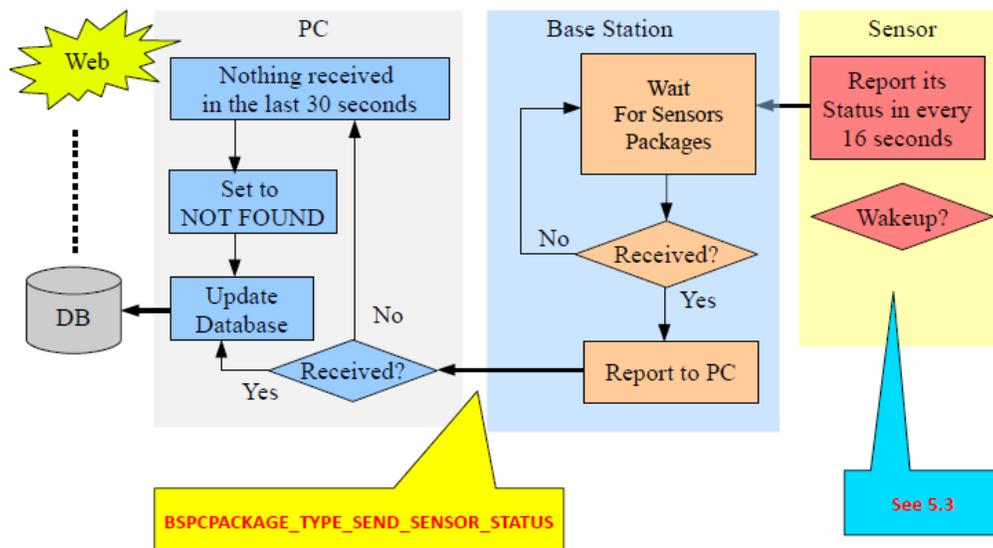
- PC to Base Station Time Synchronization

- Designed the communication protocol of the new wireless accelerometer board. The program include five parts:
- Automatically report network status;
