1 **Paper Title: FIELD MONITORING OF FATIGUE CRACK ON HIGHWAY STEEL I-**
2 **GIRDER BRIDGE**

39
40 **Call Title:**
41 Structural Health Monitoring for Cost-effective Management of Specific
42 Bridge Management and Operational Issues such as Damage or Load Capacity

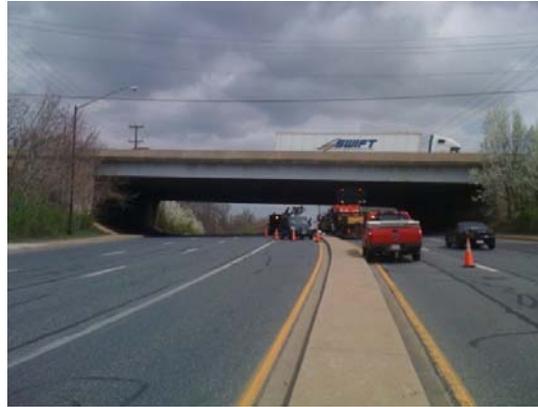
FIGURE 1 Field test on a steel I-girder bridge in Maryland.

30 Field test was conducted on a multiple steel I-girders bridge in Maryland. The bridge is a
31 single-span structure of a span length of 46.76 m (140 ft.), as shown in Figure 1. The bridge was built
32 in 1980's and fatigue cracks were identified in some of the diaphragm connection welds. Types of
33 sensors used in the field test include piezoelectric film AE sensors, wireless accelerometers, laser
34 distance sensors and strain transducers. A total of five piezoelectric film AE sensors including three
35 piezoelectric paint AE sensors were installed to monitor the growth of existing fatigue cracks in the
36 connection weld. Here, the piezoelectric paint AE sensor is a type of piezoelectric film AE sensor ((9))
37 The sensors are connected to preamplifiers and a PXI high speed data acquisition system for long-
38 term AE signal collection and fatigue crack growth monitoring. Also, to measure the differential

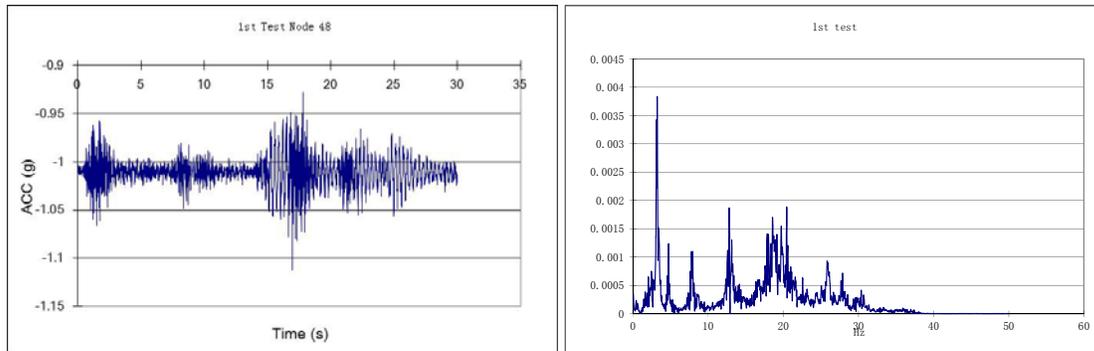
FIGURE 2 Acceleration data measured by wireless sensor: (a) Acceleration time history; (b) Frequency spectrum (horizontal axis: frequency (Hz); vertical axis: FFT amplitude).

In addition, a total of four wireless accelerometers - Imote2 from MEMSIC were used to monitor the vibration responses of the bridge. One accelerometer was installed on each of the girders (Girder 2 to 5) and acceleration data was acquired at a 100 Hz sampling rate synchronically. The acceleration data was used to provide modal frequency information (Figure 2-b) that can be used to calibrate the finite element model of the bridge as well as a side-by-side comparison with laser distance data for accuracy cross-check. The fundamental frequency identified from the measured acceleration data was 3.22 Hz.

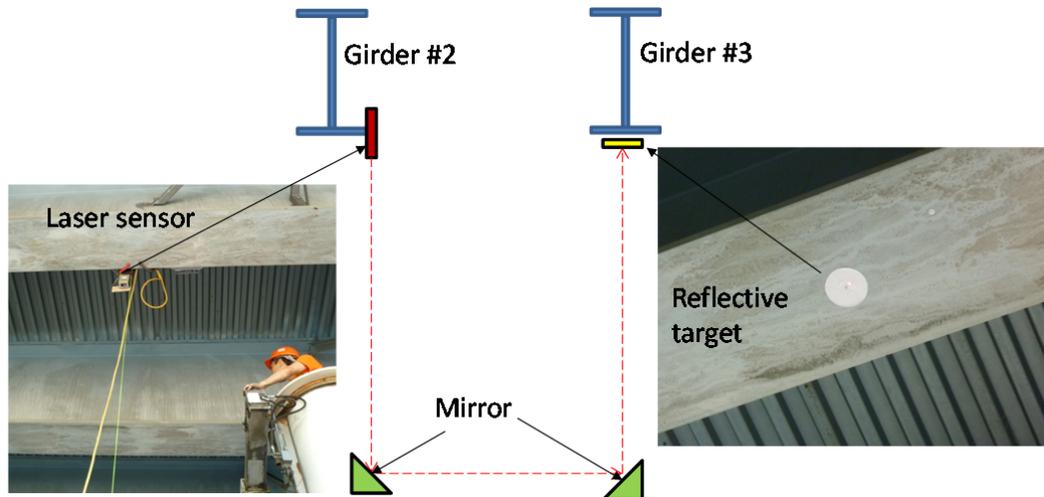
2 **FIGURE 3 Laser system for measuring differential deflections between two adjacent girders**
 3 **(not to scale).**

A major cause for the fatigue crack is believed to be live load induced stresses in the diaphragm connection welds resulting from differential deflections between adjacent girders. A laser system was used to monitor the differential deflections between two adjacent girders. The system includes a laser distance sensor mounted on one girder, two reflective mirrors on the ground, and a reflective target on the other girder, as shown in Figure 3.

22 Figure 5 shows the differential deflection time series between Girders #2 and #3 measured
 23 during this field test. This data was collected at a sampling rate of 10 Hz using the set up described in
 24 Figure 3.

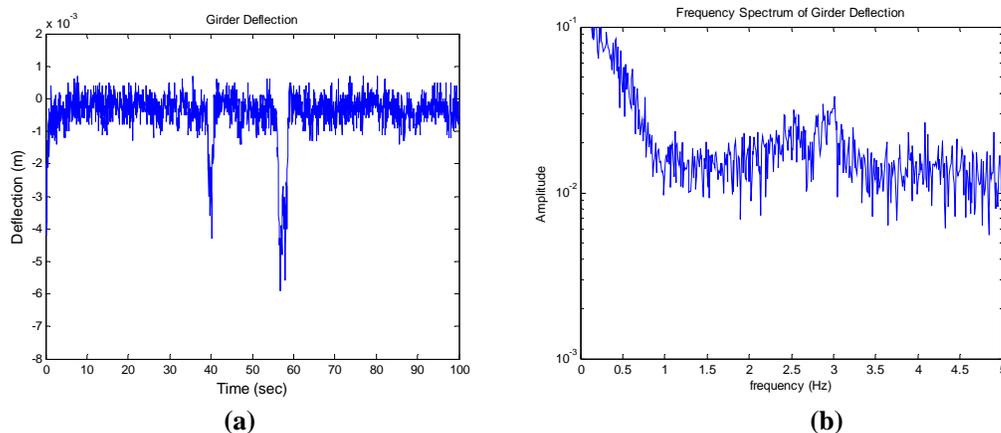
20 **FIGURE 4 Measured girder deflections: (a) sample time series; (b) FFT spectrum (average of**
 21 **four time series)**

4 A Model FLS-C series laser distance sensor made by Dimetix was used for this field test. The
 5 measurement principle of this laser distance sensor is based on comparative phase measurements,
 6 which uses a laser diode as its source to send out a laser beam and the amount of phase shift is
 7 reflected back to determine the distance. Under normal operation condition with good reflective target,
 8 an accuracy of 1 mm can be achieved with a sampling rate up to 10 Hz. But higher sampling rate up
 9 to 100 Hz can be used at the price of reduced accuracy. The laser distance sensor was calibrated with
 10 both a static and moving target in the lab before the field test. Single girder deflections were first
 11 measured by pointing the laser sensor to the natural road surface without a reflective target at a
 12 sampling rate of 20 Hz. Although there were noises in the frequency spectrum (two causes for the

13 noise: sampling rate higher than 10 Hz and natural road surface without the use of a reflective target),
 14 the fundamental natural frequency of the bridge can still be identified around 3 Hz. This 3 Hz natural
 15 frequency was also verified by other laser sensor data and the frequency identified using acceleration
 16 data (i.e., Figure 2). A sample time history of girder deflection is shown in Figure 4(a) along with its
 17 frequency spectrum.

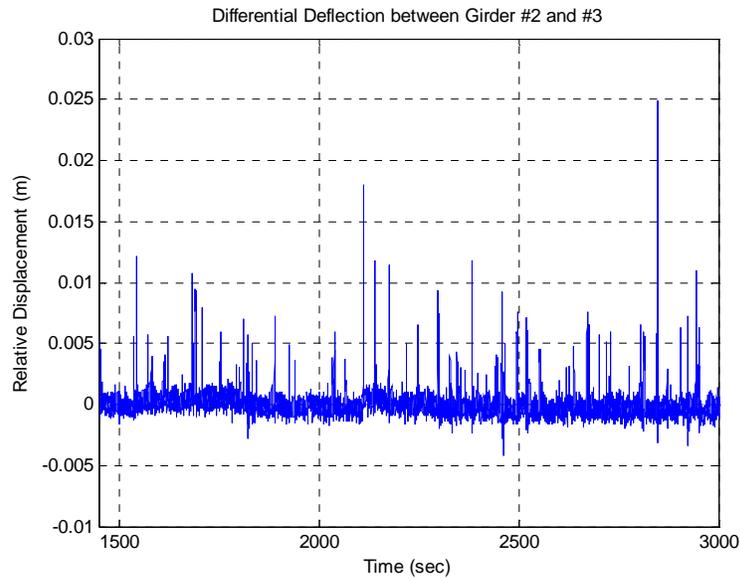
1
2 **FIGURE 5 Differential deflections between Girders #3 and #2 measured by laser distance**
3 **sensor.**

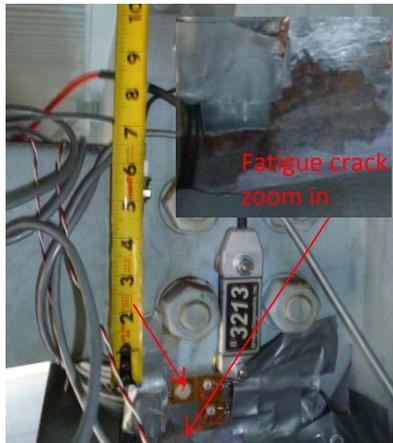
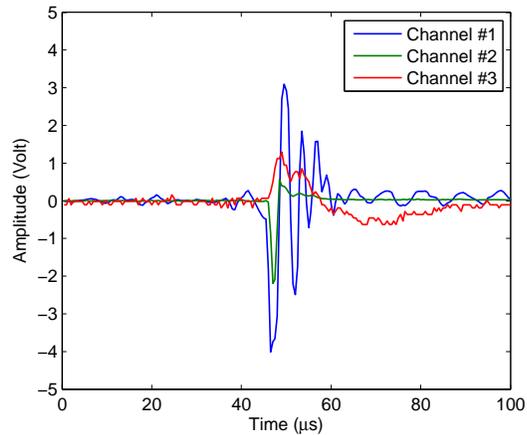
3 **FIGURE 6 (a) Three piezoelectric film AE sensor near fatigue crack tip on the connection plate;**
 4 **(b) Typical AE event measured by the three piezoelectric AE sensors.**

16 In this field test, four piezoelectric film AE sensors were used. Three were placed near the
17 fatigue crack tip. Figure 6 shows the test set up as well as sample AE signals measured by the three
18 piezoelectric film AE sensors. Two of these three piezoelectric film AE sensors (channel #1 and #2)
19 are made using PZT-5A discs and thus have a higher sensitivity (about 30 times higher) than the other
20 sensor (channel #3, made of piezoelectric paint). This signal is triggered by channel 3. Note that in
21 order to make visual inspection of the waveform easy, the signal from channel #3 is scaled up by ten
22 times since piezoelectric paint AE sensors have lower sensitivities compared with the PZT-5A AE
23 sensors. Close examination of these three signals reveals that some phase shift occurs between the
24 signals, suggesting this AE event must be induced by near-field source.
25

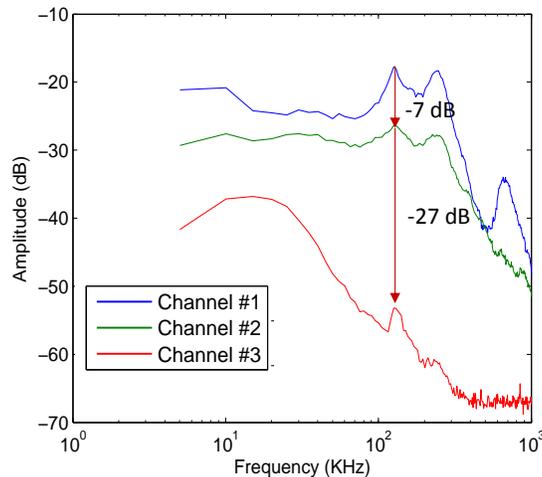
1 **FIGURE 7 Average frequency spectrum of triggered AE signals by three piezoelectric film AE**
 2 **sensors.**

5 Figure 7 shows the average frequency spectra of the triggered AE signals from these three
 6 piezoelectric film AE sensors. Ninety-two AE events similar to that shown in Figure 6(b) were used
 7 for this averaging so that ambient noise effect could be canceled out. It is seen that there is an
 8 attenuation of 7 dB from the channel #1 signal to the channel #2 signal. This is consistent with the $r^{-1/2}$
 9 Rayleigh wave attenuation relationship reported by Mooney (11), where r is the distance from AE
 10 source. It is calculated that from $r_1 = 0.98$ inches to $r_2 = 1.67$ inches, the attenuation is about -5.4 dB.
 11 The actual attenuation of -7 dB from field test data is close to this $r^{-1/2}$ Rayleigh wave
 12 attenuation relationship, especially considering the fact additional attenuation might be caused by inherent
 13 material damping (which is not accounted for by the $r^{-1/2}$ Rayleigh wave attenuation). This

14 attenuation relationship verifies that the triggered signal is not due to far field traffic induced noise (e.g., friction
 15 between tire and bridge deck) since for far field signal the attenuation between these two signals
 16 (channel #1 and #2) would be much smaller based on the dimensions of this bridge and sensor
 17 location, the attenuation would be around -0.47 dB. Also, since Channel #3 and Channel #2 are at
 18 similar distance to the crack tip, the attenuation (-27 dB in Figure 7) is close to the value (-30 dB)
 19 due to sensor sensitivity difference (note that this calculation is based on original data, not the one
 20 presented in Figure 6 which has been scaled up ten times for ease of waveform identification).
 21 Considering this attenuation relationship reflected in the measured AE signals, it is very likely that the
 22 AE event in Figure 6(b) was triggered by AE activities associated with fatigue crack growth.

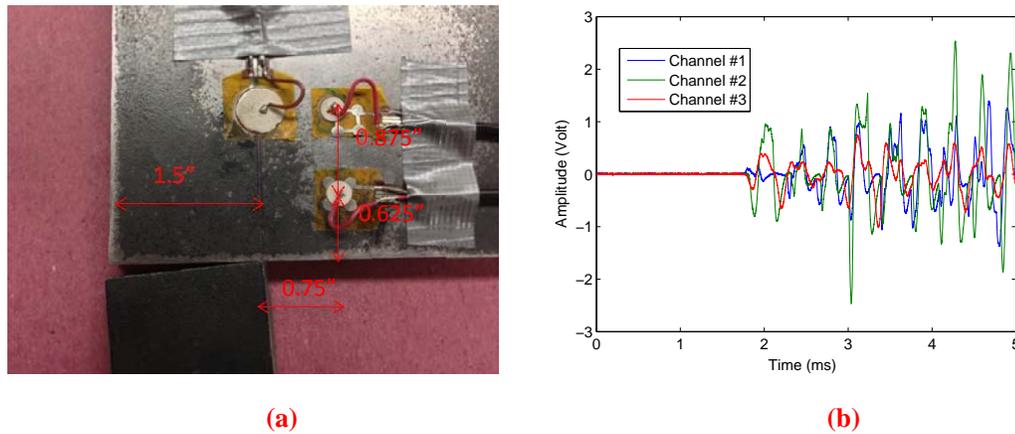
12 **FIGURE 8 (a) Experimental set up for lab test; (b) Typical AE event due to surface impact**
 13 **measured by the three piezoelectric AE sensors.**

3 In order to eliminate possibilities of signals due to friction or impact of the cracked surface, a
 4 laboratory simulation was carried out with similar configurations on a 7/16"-thick steel plate. The
 5 detailed setup is shown in Figure 8 (a). It can be seen that the test results presented in Figure 8 (b) are
 6 considerably different from the AE signals obtained from the field test on the field test bridge, in both
 7 waveform characteristics and frequency contents. Therefore the AE signals collected in field are
 8 unlikely to be caused by the opening and closing of the fatigue crack. This further verifies the
 9 judgment that those AE events were very likely to be associated with fatigue crack growth.
