## **Quarterly Report**

**Development of a Self-Sustained Wireless Integrated Structural  
Health Monitoring System for Highway Bridges**

**Eleventh Quarterly Progress Report**

**January 15, 2014 through April 14, 2014**

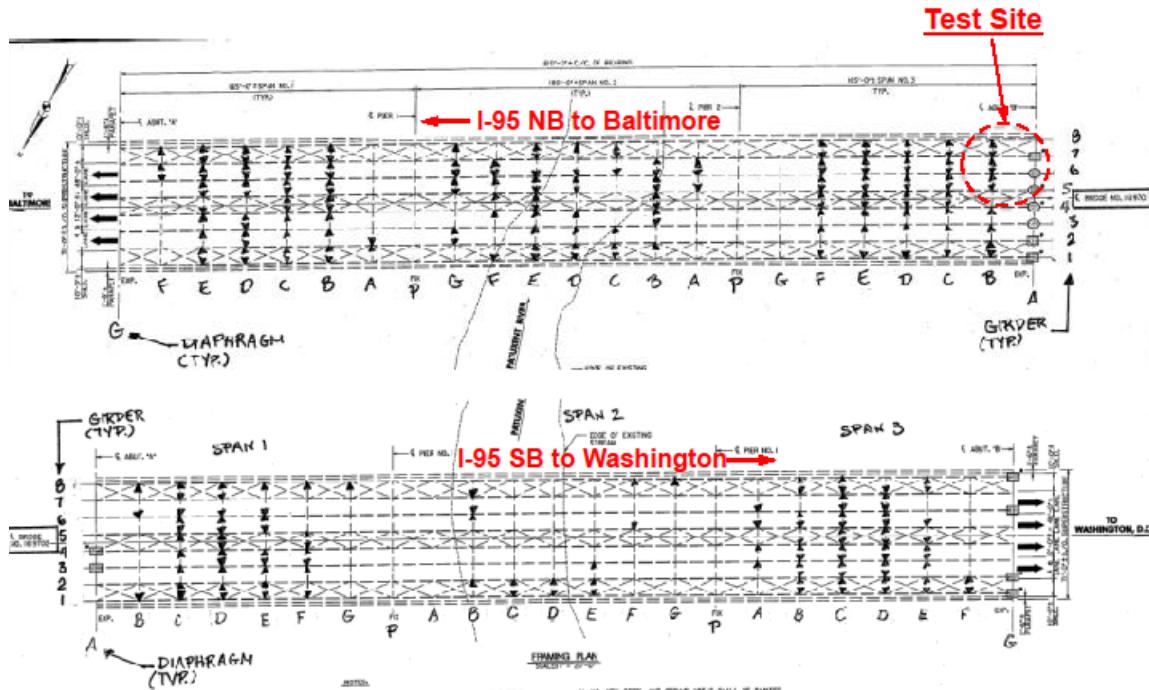
Figure 1 -- I95 bridge testing site and sensor locations

- Setup Data Acquisition and Sensing equipment on I95 Bridge with test site shown in Figure 1.

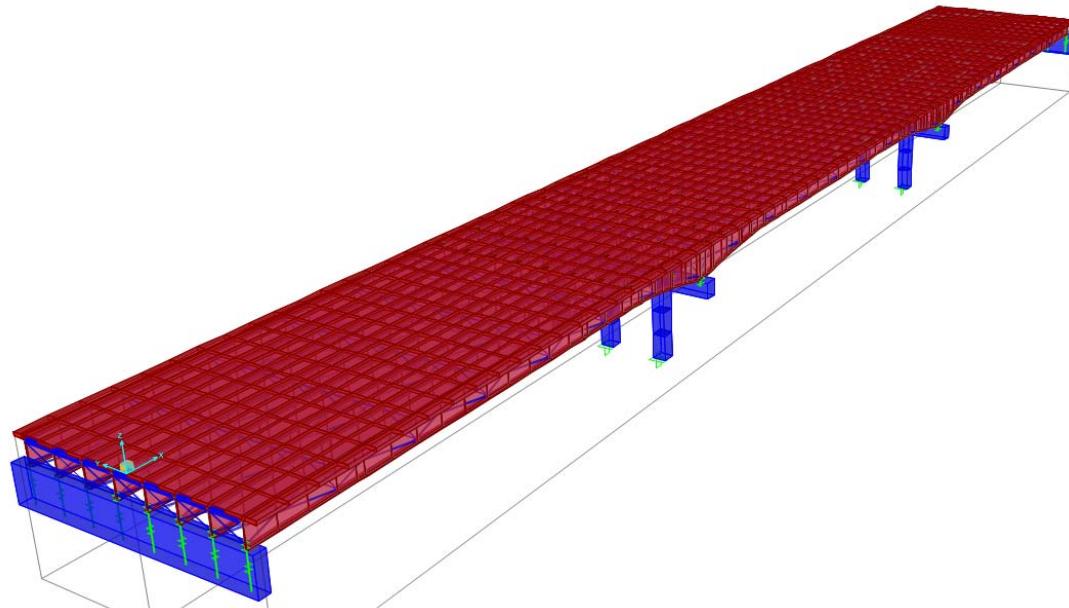
Figure 2 -- FEM model of I95 bridge

- Ran accelerometer data into Fast Fourier Transform function to find the frequency of the bridge due to the traffic loading
- FEM analysis of Bridge No.1619701 I-95 NB over Patuxent River - The bridge No. 1619701 on I-95 over Patuxent River was built in 1965. It is a continuous three-span bridge with the middle span of 510 ft and two side spans of 165 ft. To investigate the fatigue performance of the bridge, a three-dimensional (3D) finite element model (Figure 2) is developed by using the CSiBridge™ for linear-elastic structural analyses. The model consists of eight I-girders. The depth of girder web is varied 6 ft at the abutment to 10 ft at the pier. The diaphragms are X-type bracing with top and bottom chord. The concrete deck, the girders were modeled by shell elements, while all the diaphragms and framing were modeled by truss element. The translations of x-, y-, z-directions are fixed at the abutments representing actual characteristics of support and continuity. The natural frequency of this model to match the field results is still under study.

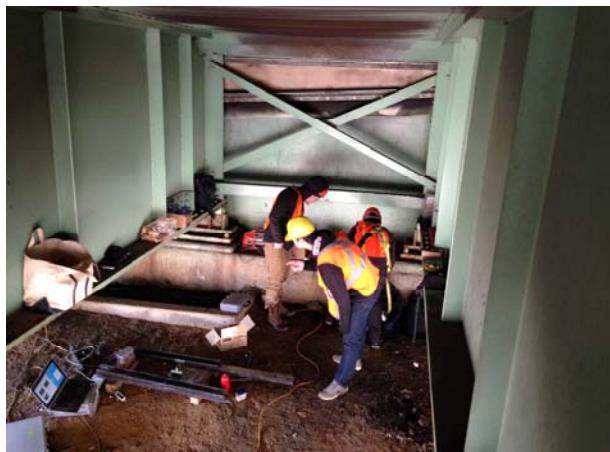
Figure 3 - Acoustic emission sensor test using portable fatigue test setup: (a) field test at I-95 Bridge in Maryland; (b) close up view of piezo film AE sensors on test specimen

- A portable fatigue test setup has been designed and fabricated to test the piezo film AE sensor performance for fatigue crack induced AE signal monitoring. Figure 3(a) shows the portable test setup (laid on the ground) in the field test (conducted on March 14, 2014) at the I-95 Bridge. Figure 3(b) shows the test specimens after significant deformation was imposed on the test specimen, as evidenced by the tearing of the strain gage. Figure 4 shows the AE signals measured by piezo AE film sensor (Channel 0) and commercial AE sensor (SE1000-HI from Dunegan Engineering). Clearly, the piezo film AE sensor has a comparable level of sensitivity as the commercial wideband AE sensor. It is noted that commercial AE sensor measures out-of-plane displacement while piezo film AE sensor measures the in-plane strain and this explain why they have different waveforms.

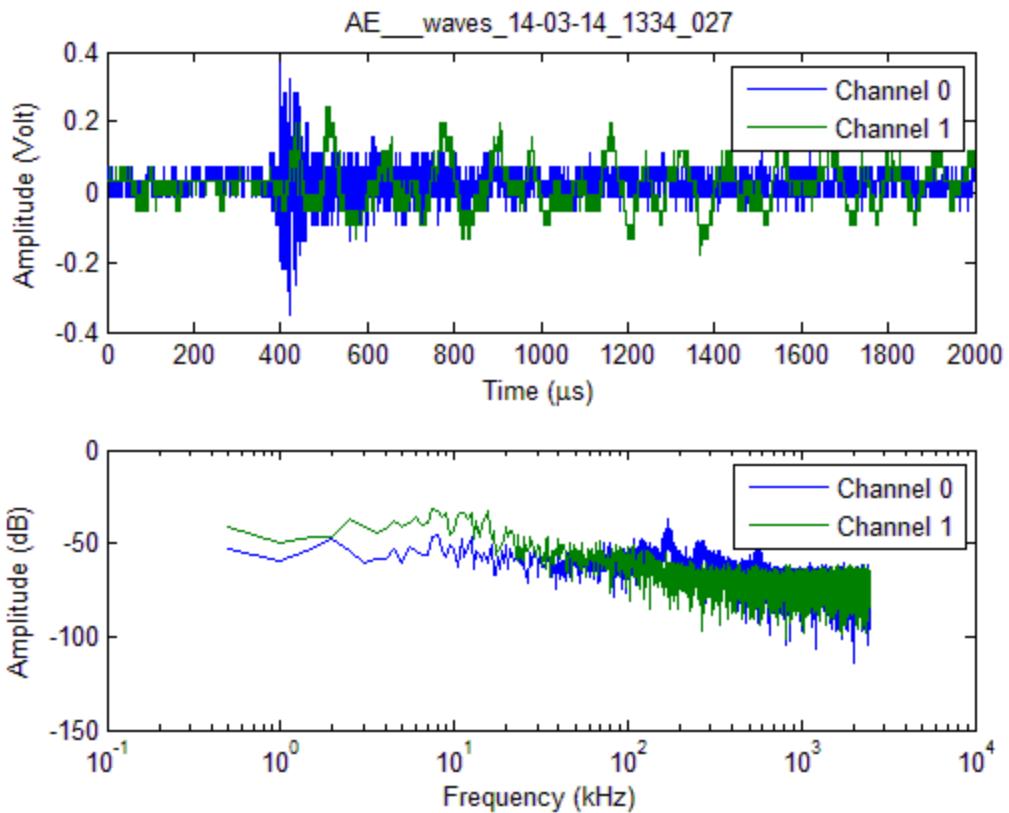
Figure 4 - Acoustic emission signal recorded by the piezo film AE sensor (channel 0) and commercial wideband AE sensor (HI-1000 by Dunegan Engineering) when the notched steel plate test specimen underwent significant deformation

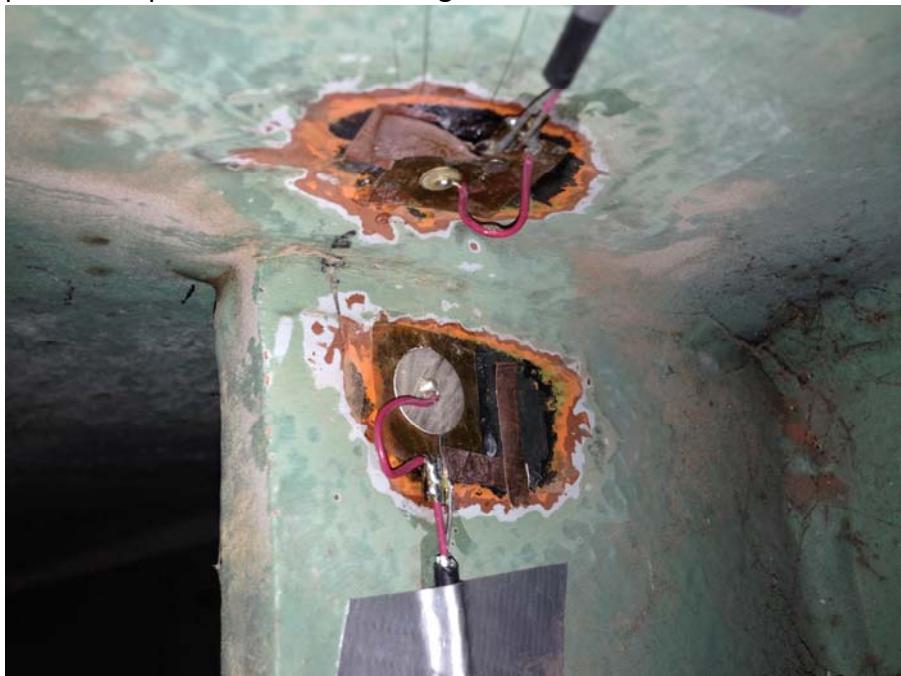
Figure 5 - Piezo film AE sensors installed on Girder #2 of I-95 Bridge to monitor existing fatigue crack

- Field test of the piezo film acoustic emission sensors was carried out on the I-95 Bridge: Four piezo film AE sensors were surface mounted at locations near the existing fatigue cracks, as shown in Figure 5. The waveforms of AE signals acquired by these piezo film AE sensors and wireless sensor nodes show significant lower frequency contents but lacked higher frequency content (from 100 kHz to 300 kHz) typically associated with fatigue crack propagation. This observation confirmed the engineers' speculation with monitoring data, that is, the existing fatigue is inactive, and most likely the acquired AE signals were due to fracture surface rubbing and friction. Laser distance sensors were used to measure bridge girder deflection of Girder #2 and Girder #3 (girders where fatigue cracks were monitored). The locations of the girders where deflections were measured were approximately 48'-10" from the south bridge abutment. Peak displacement of 5 mm and 6 mm were recorded for Girder #2 and Girder #3 respectively during a 1-hour recording for each of these two girders.

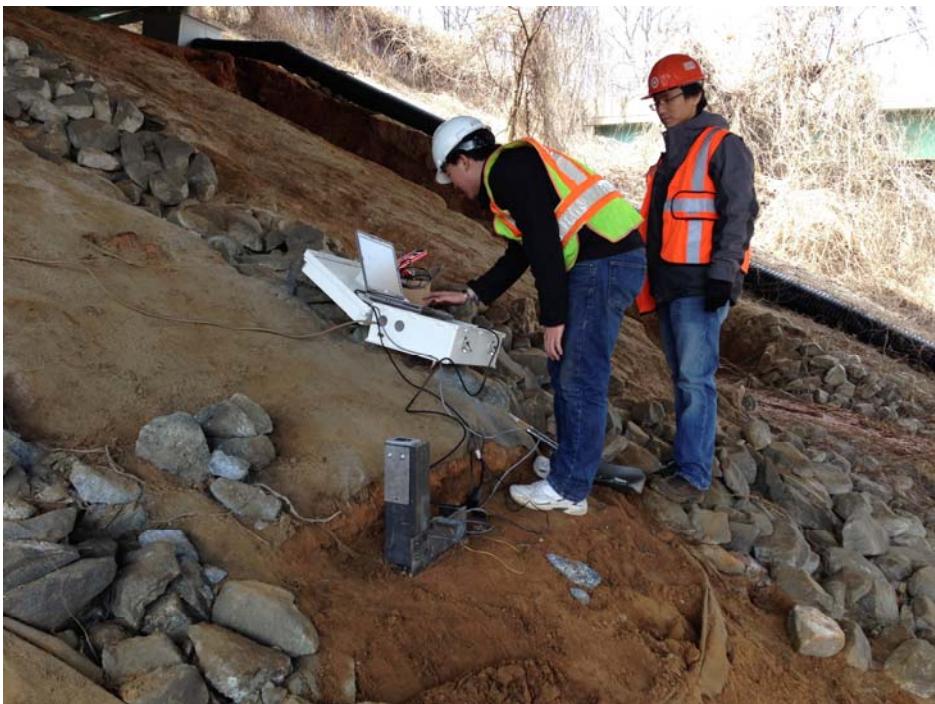
Figure 6 - Laser distance sensor to measure deflection of Girder #2 of I-95 Bridge

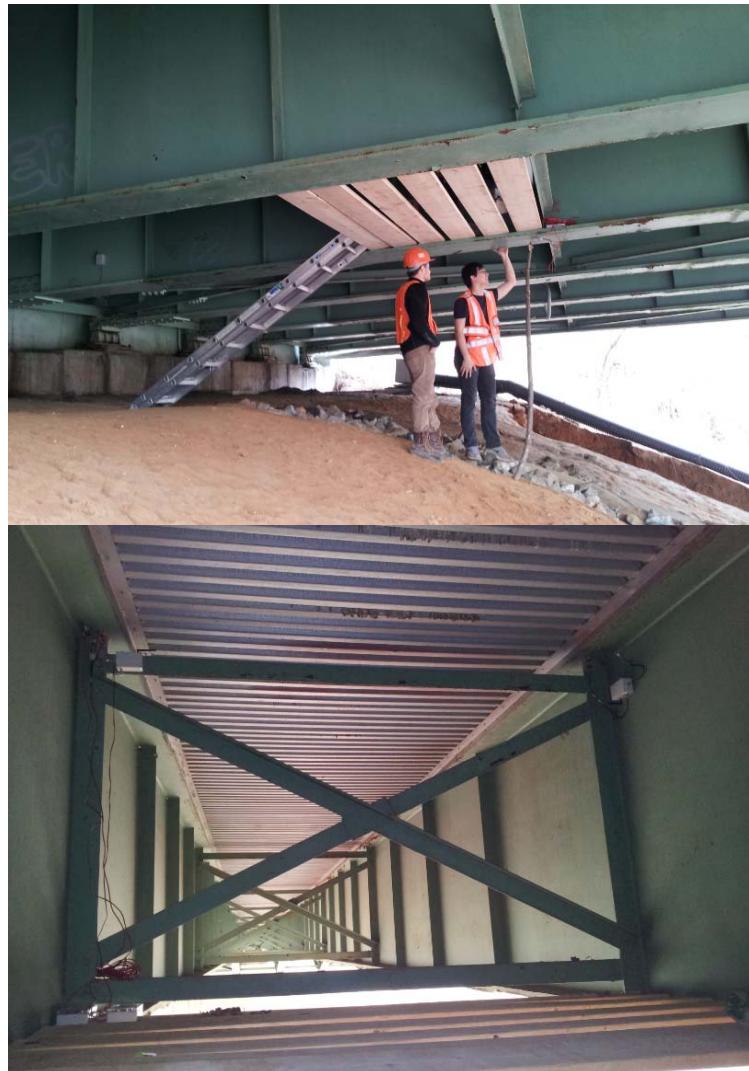
Figure 10 - Test Platform under the Bridge

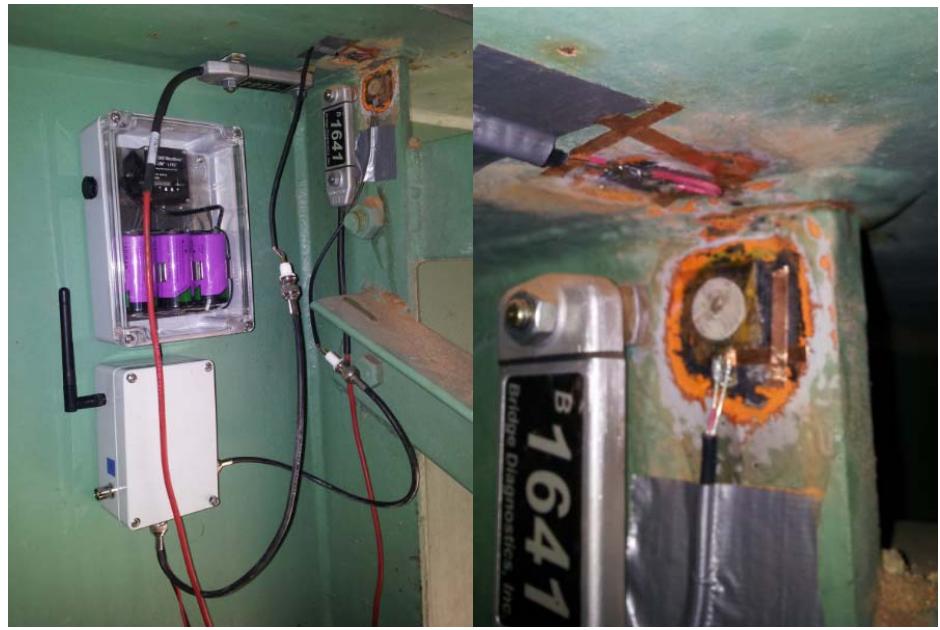
Figure 11 - Wireless AE Sensor (Left) and Crack (Right)

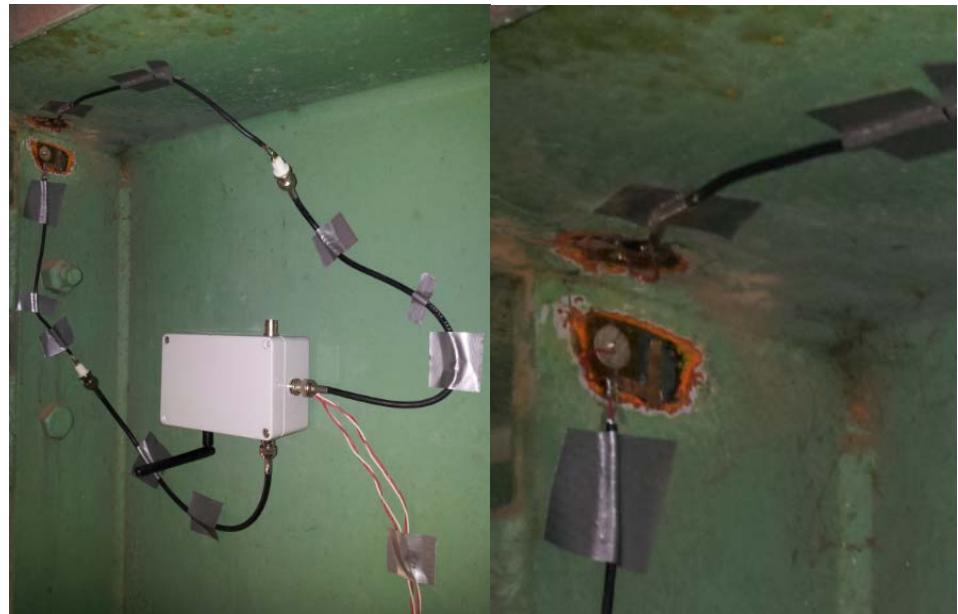
Figure 12 - Wireless AE Sensor (Left) and Crack (Right)

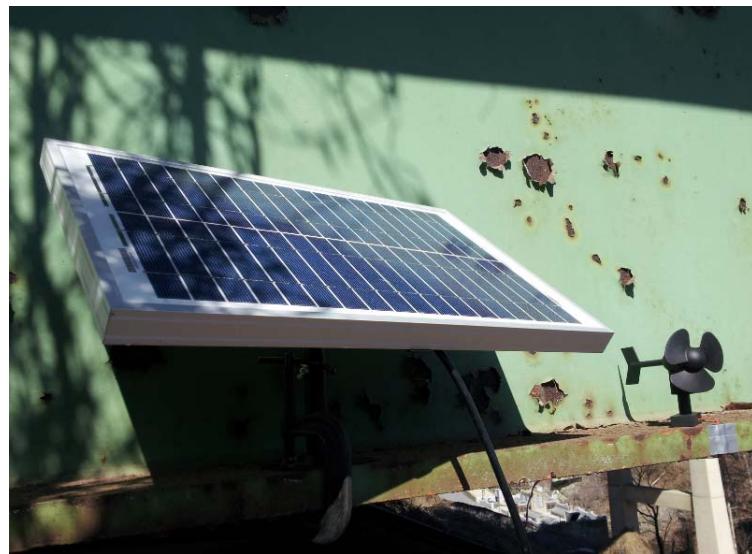
Figure 13 - Solar Panel (Left) and Wind Turbine (Right)

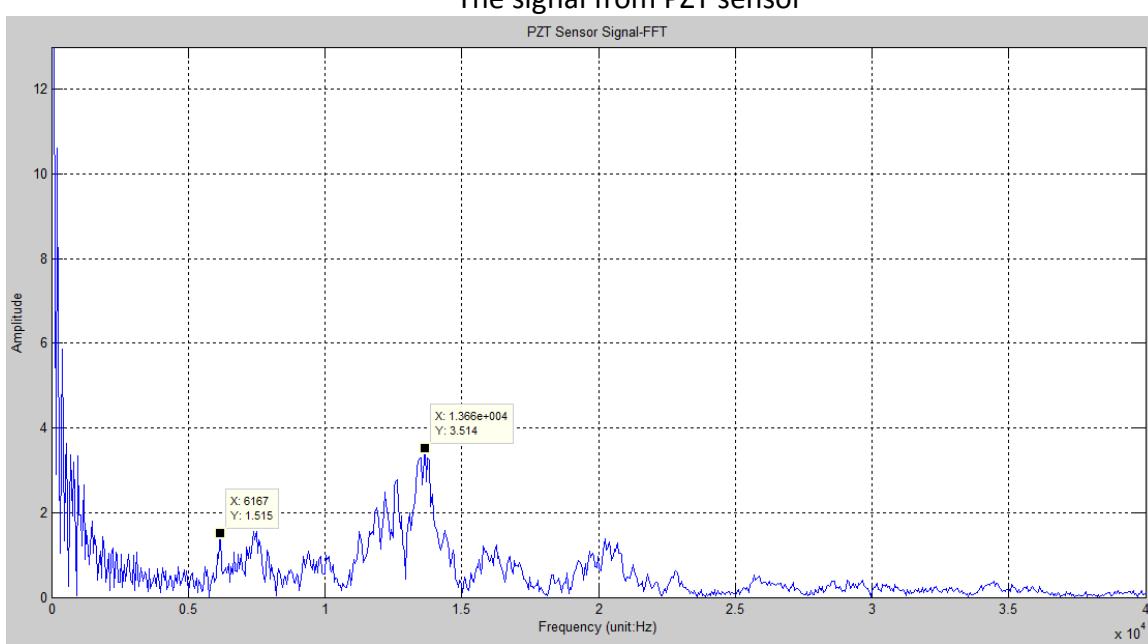
Figure A.1 - The FFT result of the PZT sensor's signal

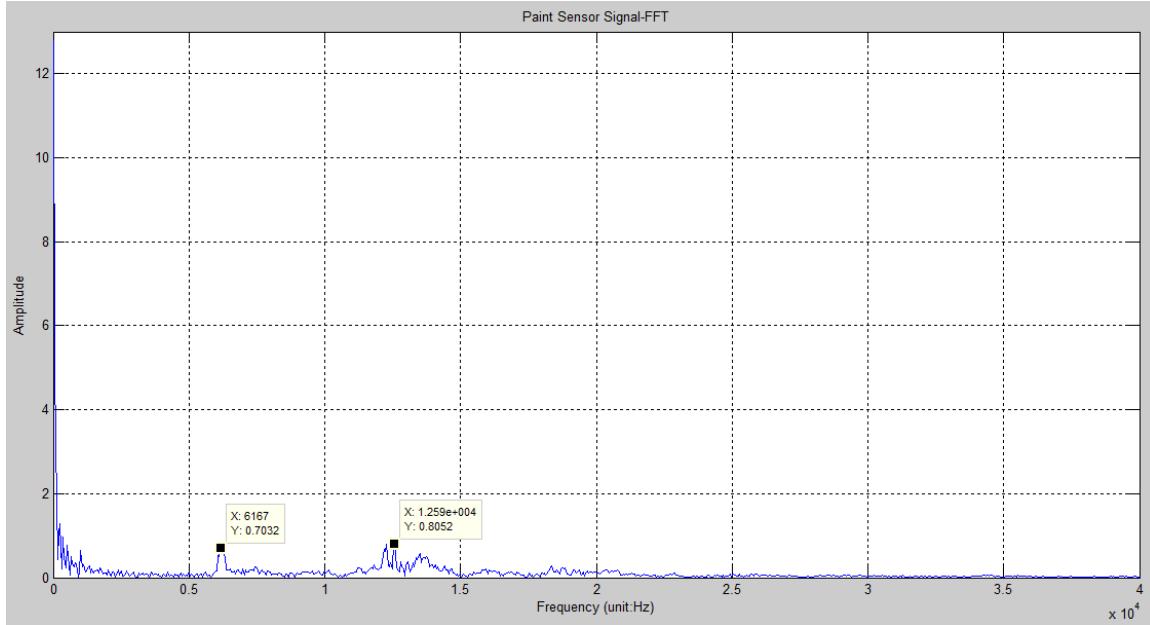
Figure A.2 - The FFT result of the Paint sensor's signal

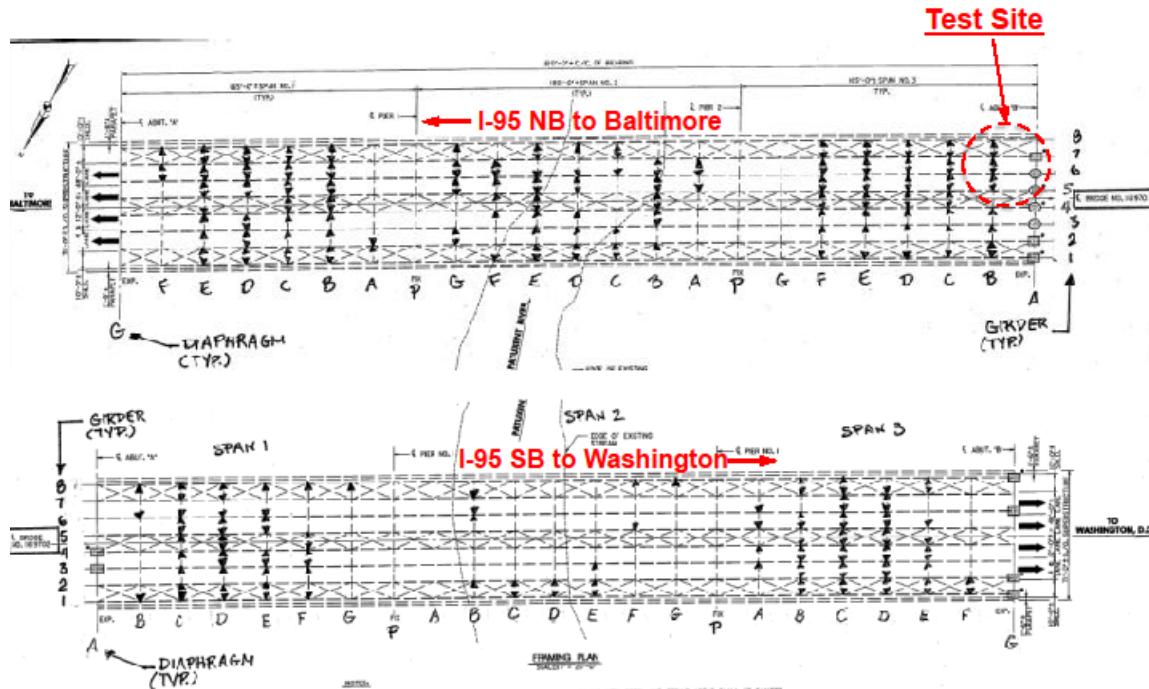
Figure B.1 – I95 Bridge testing site and sensor locations

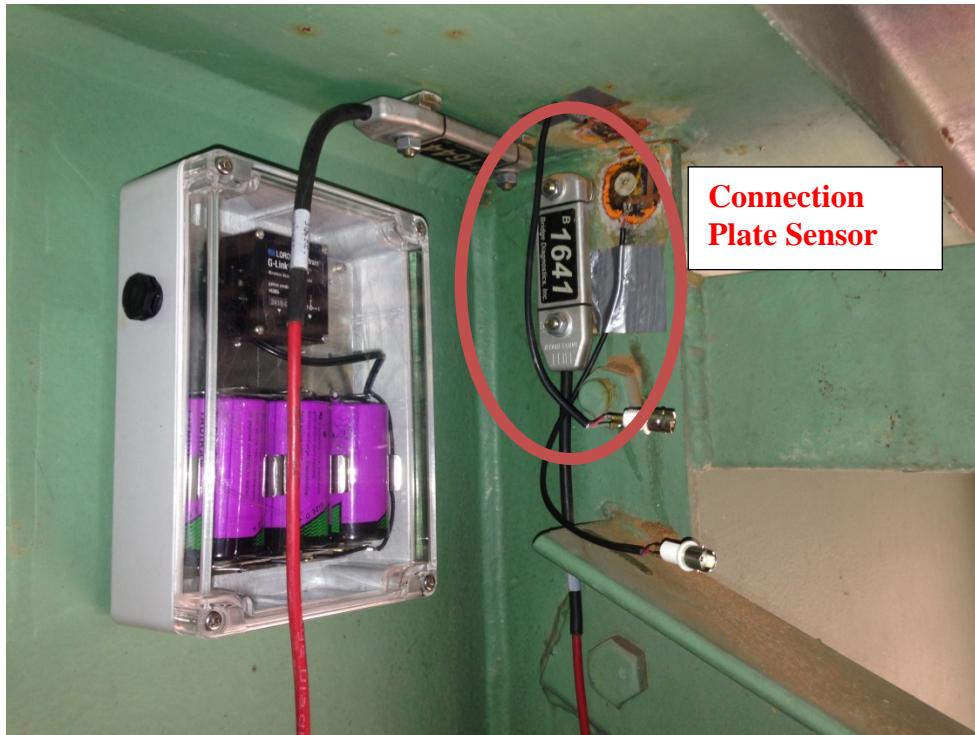
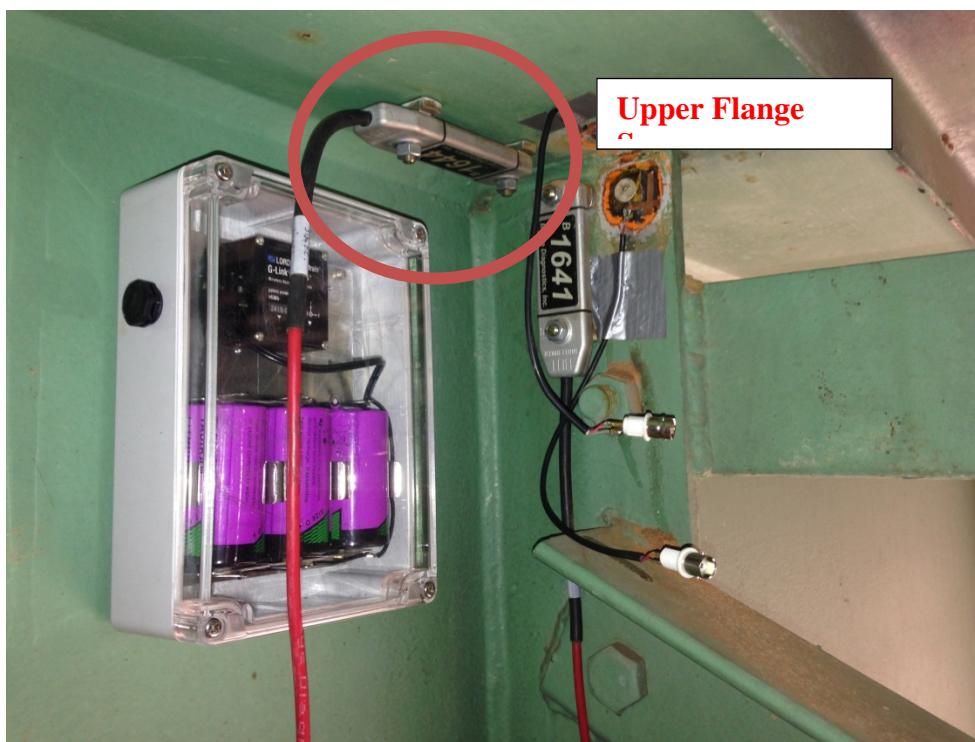
Figure B.3 – Wireless strain sensor placement on (a) the connection plate and (b) the top flange

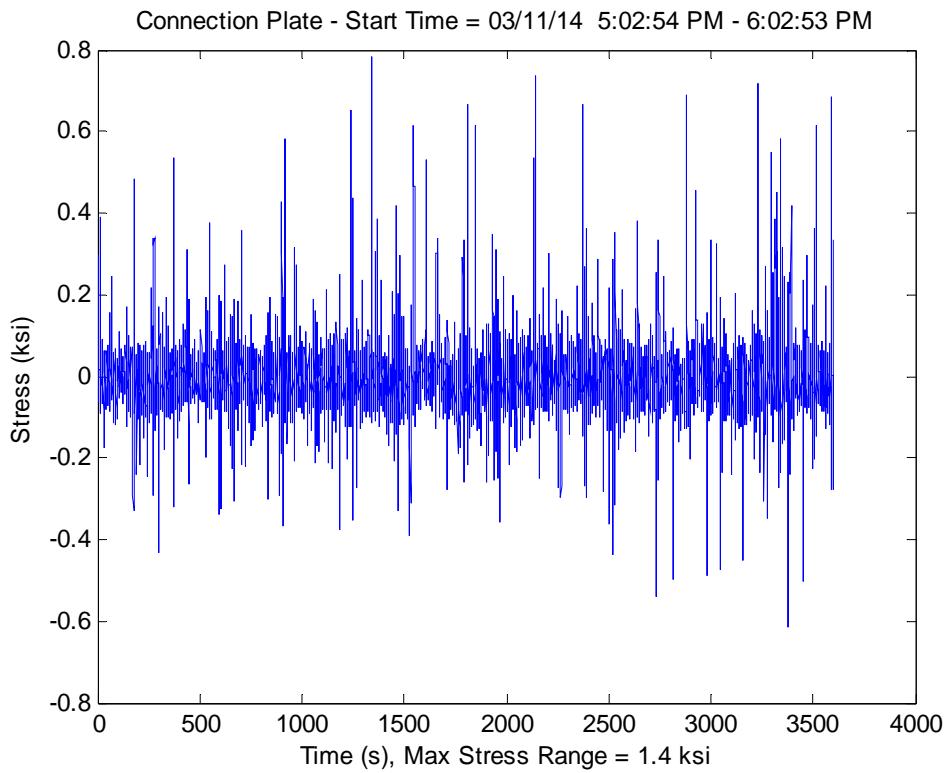
Figure B.4 – Sampling strain sensor data of the connection plate
