Development of a Self-Sustained Wireless Integrated Structural
Health Monitoring System for Highway Bridges

Tenth Quarterly Progress Report

Field Test Status Report of MD Bridge No. 1504200 I-270 over Middlebrook Road

**Field Test Status Report
of
MD Bridge No. 1504200 I-270 over Middlebrook Road**

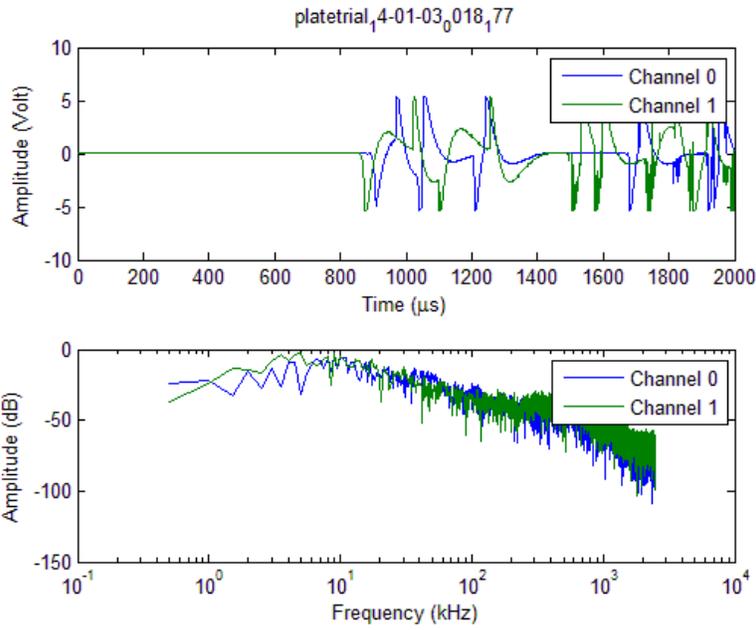
- Test of the piezo film acoustic emission sensor was carried out on full scale steel plate fracture tests: The test specimen is a full scale steel plate wall under low cycle fatigue loading. At the end of its low-cycle fatigue life, the steel plate fractured at the slot corner location. Acoustic emission monitoring of steel plate low cycle fatigue induced crack with piezo film acoustic emission sensor was performed on steel plate wall and results are shown in Figure 1. Fatigue crack growth monitoring with piezo film AE sensor was terminated on I-270 bridge on September 27, 2013 and all field test equipment were removed from the bridge.

Figure 1. Acoustic emission signal recorded by the piezo film AE sensors when the steel plate fractured

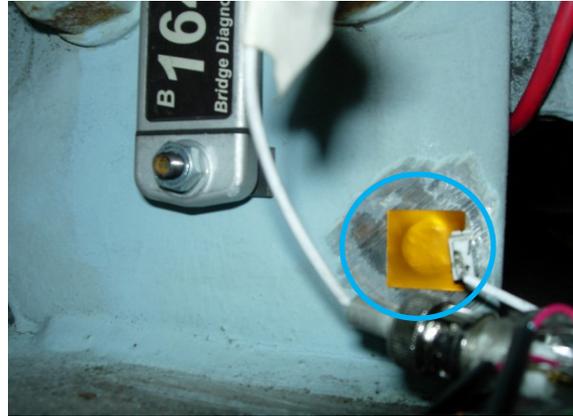
Figure 9. Piezoelectric paint AE sensor (blue circled, for monitoring ambient noise since there is no fatigue crack on this side connection plate)

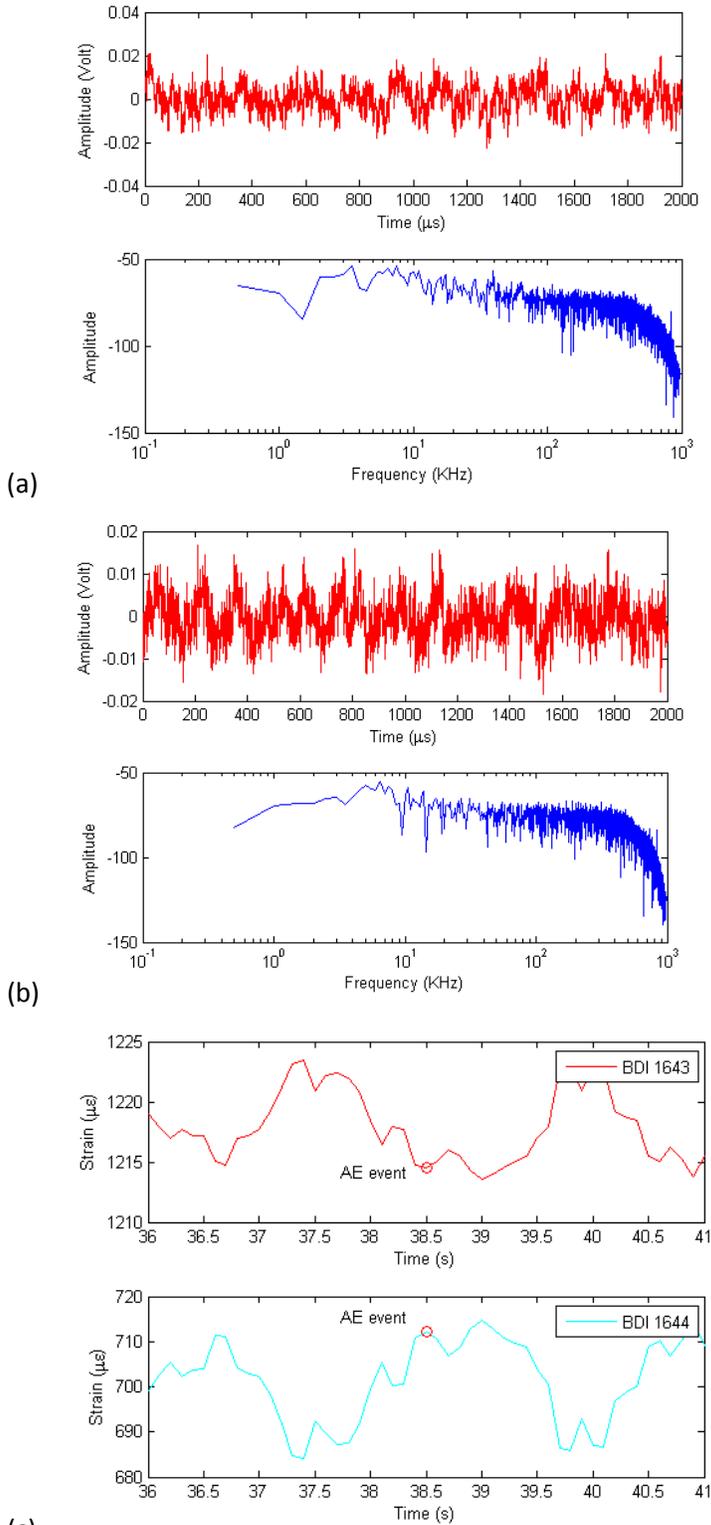
Figure 11. AE data collected by piezo paint AE sensor on Girder 4: (a) ch4 AE data on cracked connection plate; (b) ch6 AE data on uncracked connection plate ; (c) corresponding strain data

(from BDI strain gage near ch4 AE sensor), AE data acquired between 38.6 and 38.7 seconds in this figure (highlighted with red circles) (BDI 1643 strain gage on the uncracked side of Girder 4 while BDI 1644 strain gage placed on the cracked side of Girder 4).

next field test, a longer monitoring period (e.g., at least three consecutive days) be arranged to collect AE signals related to fatigue crack growth.

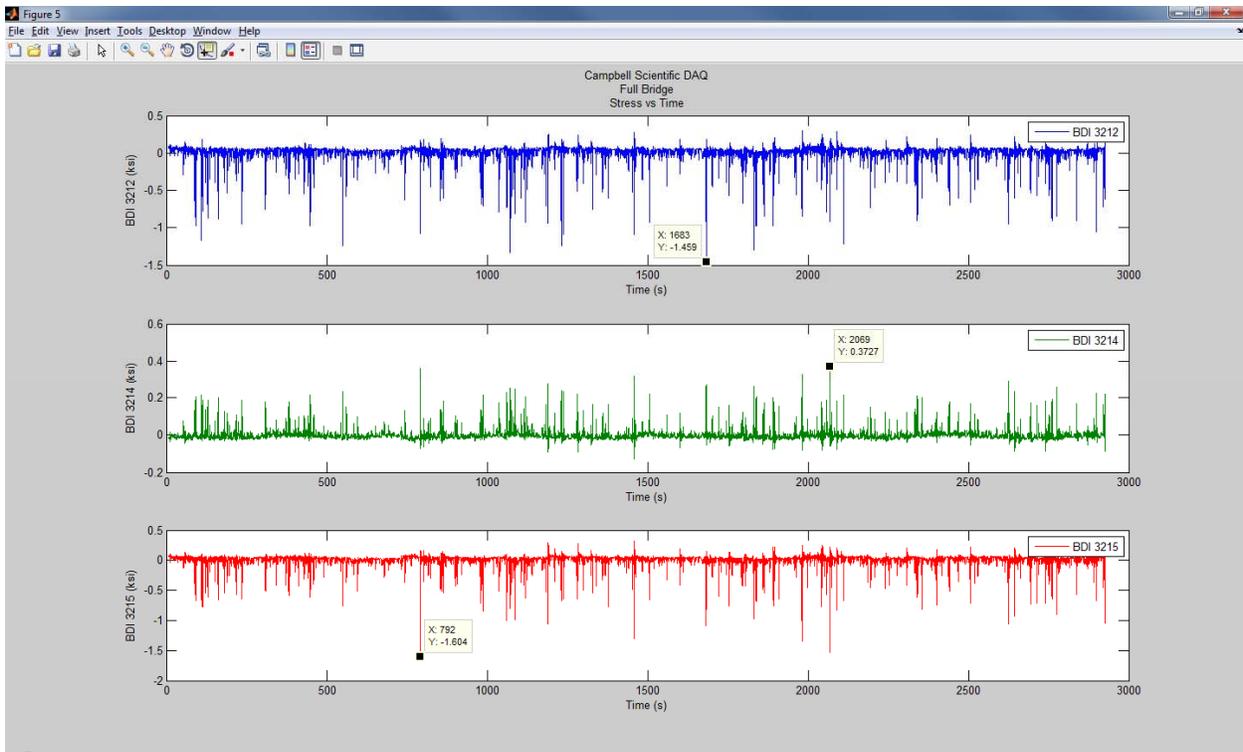
The maximum longitudinal stress measured on the bottom flange is 1.604 ksi in tension from BDI 3215 on the bottom flange of Girder 3. As for the connection plates, the maximum vertical stresses are 16.18 ksi in tension from BDI 1641 on Girder 3 and 16.1 ksi in tension from BDI 1644 on Girder 4.

Figure 18. BDI strain transducer flange measurements on Girders 3 and 4 (Positive indicates tension; 3212 G4 bottom flange; 3214 G3 top flange and 3215 G3 bottom flange)

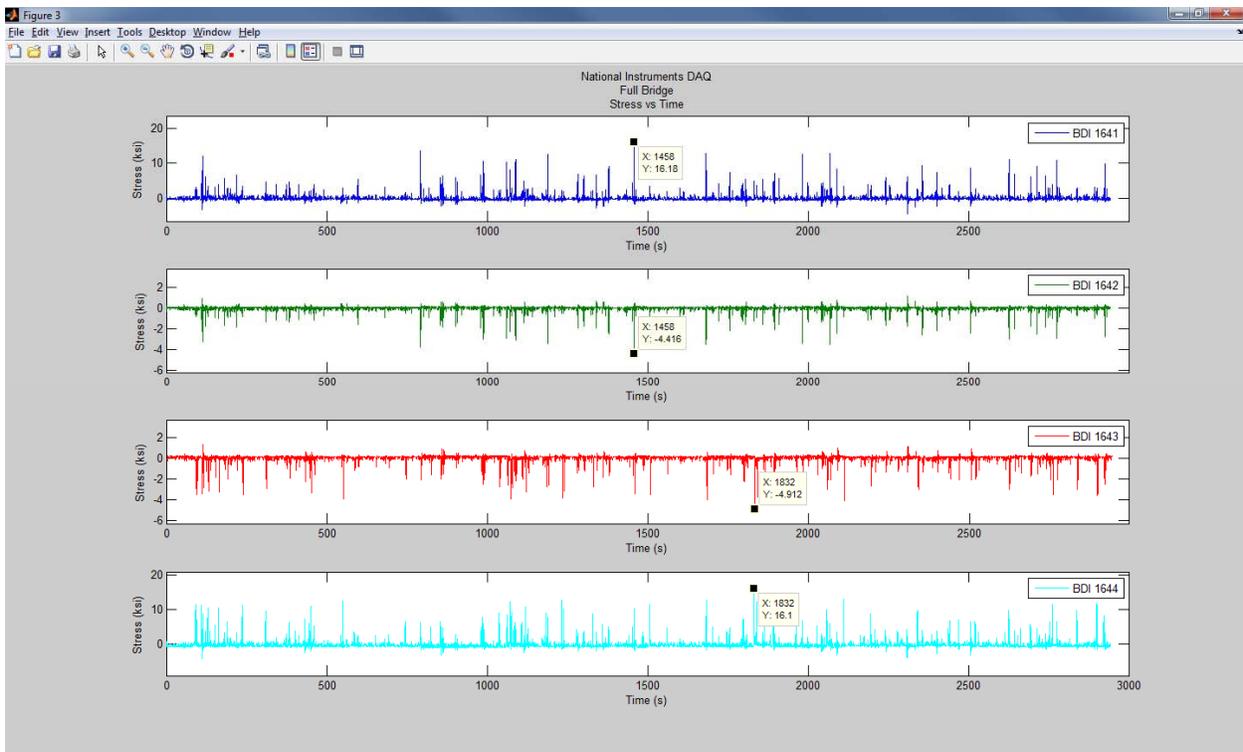
Figure 19. BDI strain transducer connection plate measurements (Positive indicates tension; 1641 G3 cracked side; 1642 G3 uncracked side, 1643 G4 uncracked side and 1644 G4 cracked side)

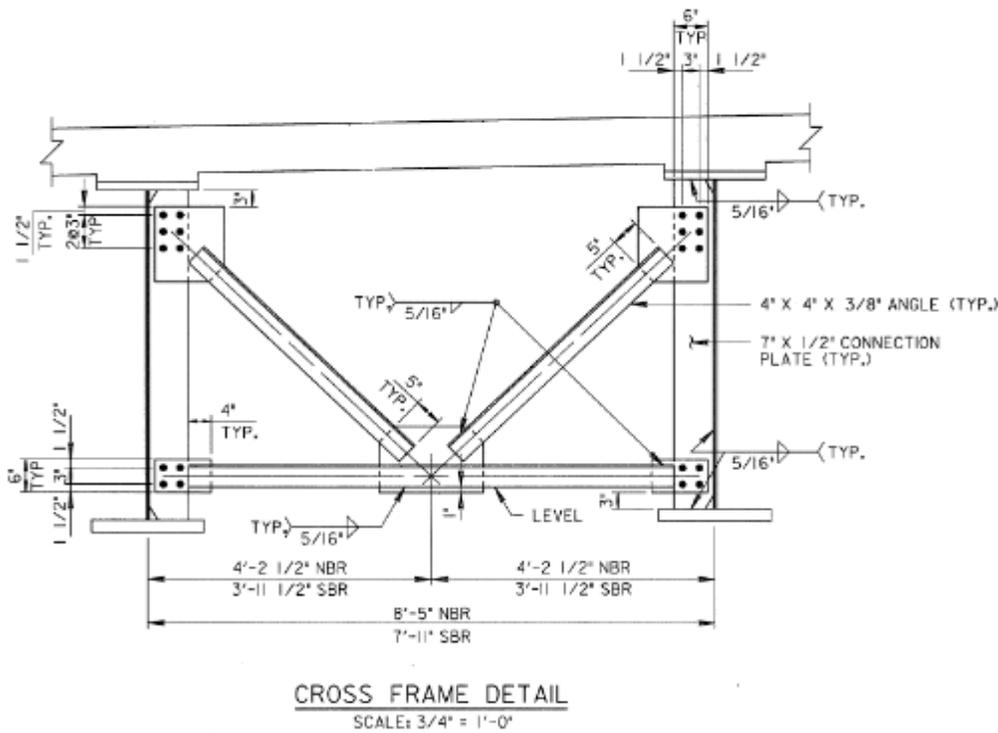
Figure 24. Typical cross frame detail

Out of all types of cross-frames, X-type with top and bottom chords is the stiffest of all, then the K-type with top and bottom chords, then the X-type with bottom only and the flexible one is the K-type with bottom chord only. Differential displacement between girders will cause one diagonal in tension and one in compression. Since the working point of the diagonal is not at the junction of girder web and top flange plus no help from the top chord, one side of the connection plate will be under tension and one under compression. Measured 16.1 ksi in tension is not surprising with the flexibility of the cross-frame and the girder system (with up to 0.5" to 0.75" vertical deflections due to live load observed.)

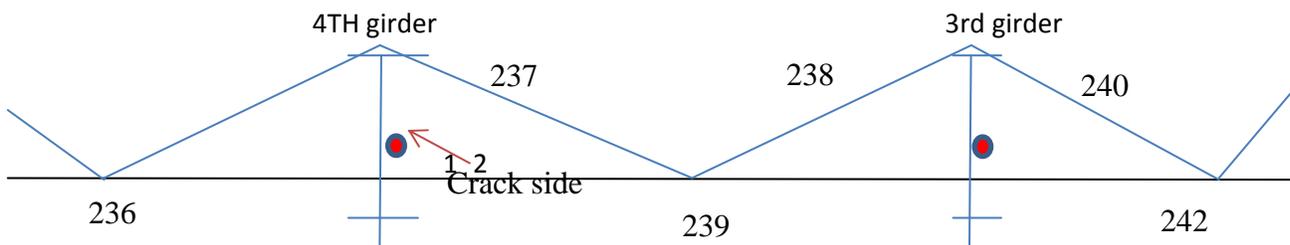
Figure 25. FEM numbering for the cross-frames near the crack locations

Figure 25 shows the numbering for the cross-frames near the crack locations. Table shows their corresponding forces.

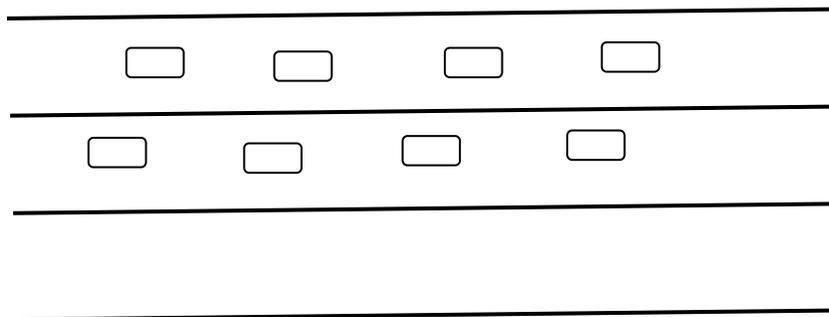
Case 16: the 1st group trucks passed the bridge side-by-side on fast lanes and 2nd group 25' behind

girder 3 crack location connected with the bottom chord between girder 2 and 3	girder 4 crack location connected with the bottom chord between girder 3 and 4
Max. stress		
case 16_LL	7.32ksi	17.95ksi
case 17_LL	19.59ksi	21.68ksi

Maximum differential displacement of -0.316584 inches is found between girders 2 and 3 under live load case 16 (-0.303624 inches between girders 3 and 4).

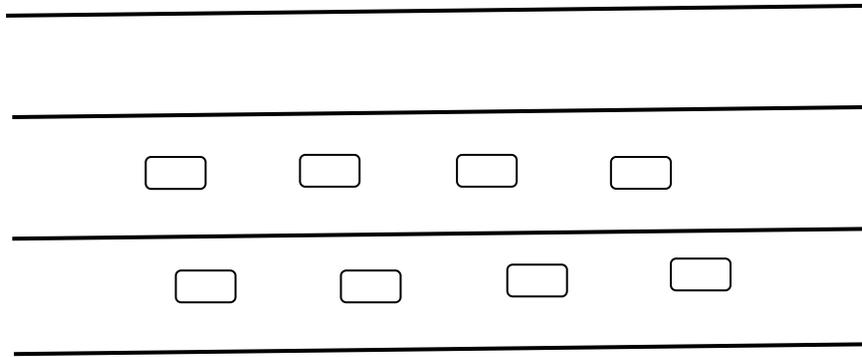
Case 17: the 1st group trucks passed the bridge side-by-side on slow lanes and 2nd group 25' behind

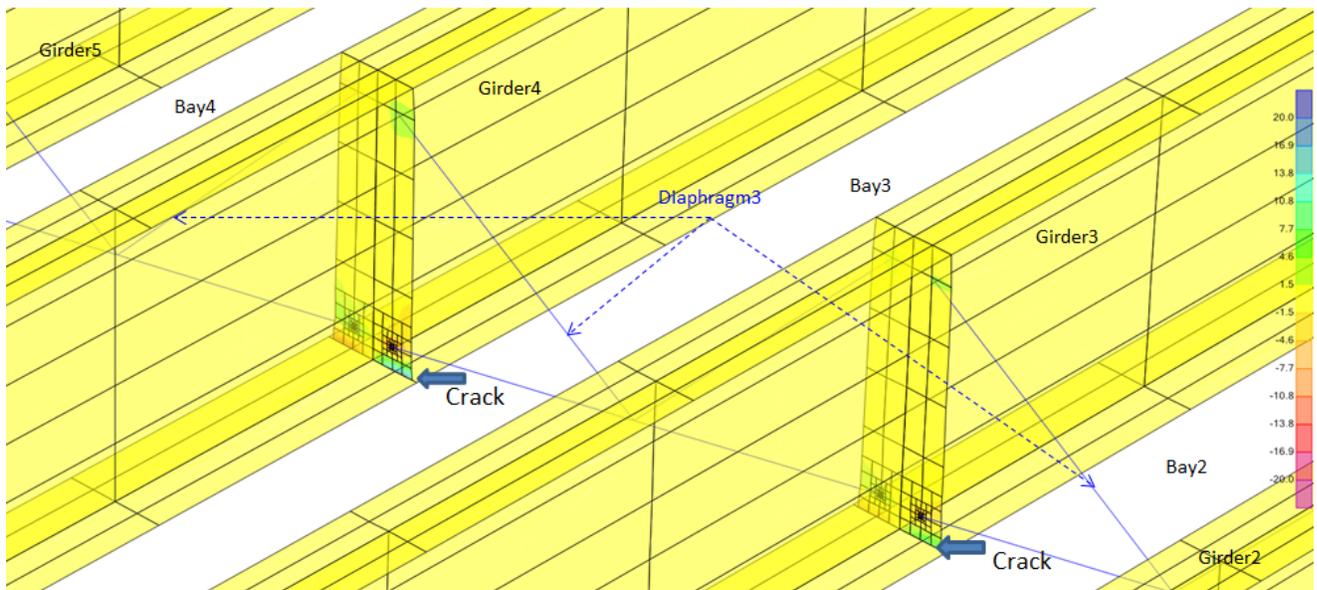
Figure 4 - Crack Locations

Graphic results are shown below. Figure 4 shows the crack locations on Girders 3 and 4 on the bridge model. Figures 5 and 6 show zoom-in stress contours of connection plates on Girder 3 Diaphragm 3 at T=597second and on Girder 4 Diaphragm 3 at T=283second, respectively.

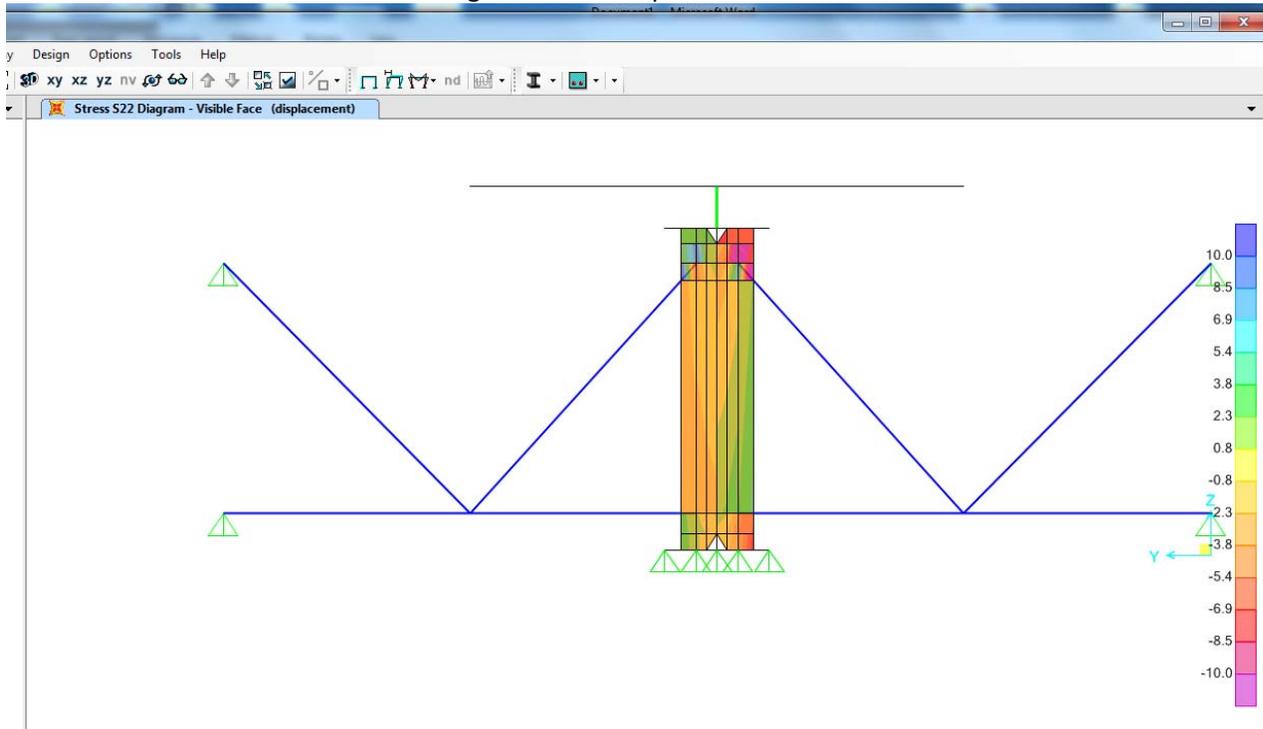
- 1) Local Model – portion of girder with K-type crossframes on both sides (Figure 10)
- 2) Boundary condition - pin supported (Figure 10)
- 3) Loading - 0.2in downward displacement on the left end and 0.4in upward displacement at the right end were applied (Figure 10)
- 4) Maximum stress around bottom chord and connection plate connection (Figure 11)
 - 1.7ksi compressive stress on the left connection plate
 - +4.07ksi tensile stress on the right connection plate

Figure 11 - Local model stress contour on connection plate

It can be concluded that among all types of cross-frames, X-type with top and bottom chords is the stiffest of all, then the K-type with top and bottom chords, then the X-type with bottom only and the flexible one is the K-type with bottom chord only. Differential displacement between girders will cause one diagonal in tension and one in compression. Since the working point of the diagonal is not at the junction of girder web and top flange plus no help from the top chord, one side of the connection plate will be under tension and one under compression. Measured 16.1 ksi in tension is not surprising with the flexibility of the cross-frame and the girder system (with up to 0.5" to 0.75" vertical deflections due to live load observed.)

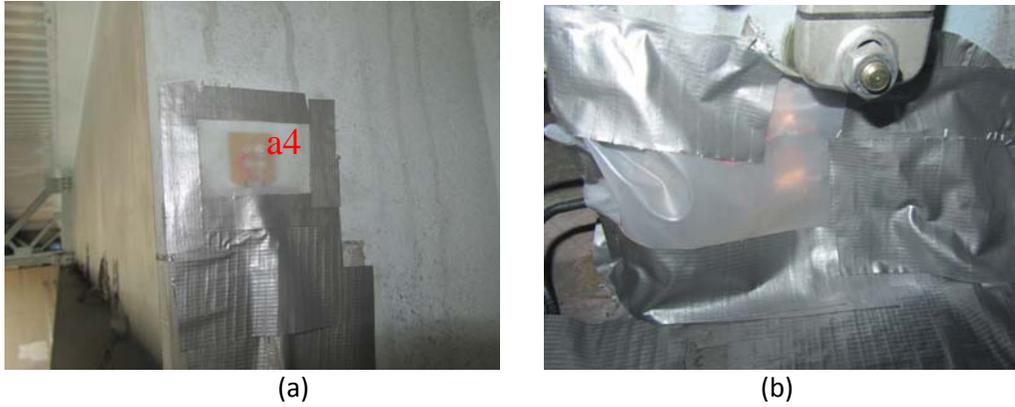
Figure 6. Newly installed sensor covered by plastic film: (a) guard sensor; (b) sensors near the fatigue crack.

All the sensors are replaced including the guard sensor in this test. The newly replaced sensors are illustrated in Figure 4. Sensor a0 and a1 are AE sensors made of PZT5A and both have the same diameter-5mm. For sensor a2 and a3, they are made of piezo paint and they have a 1/2" diameter. Their relative positions are shown in Figure 5. In order to further protect the sensors from humidity, a layer of polyurethane coating was applied on the sensors for extra protection besides the plastic film protection as shown in Figure 6.

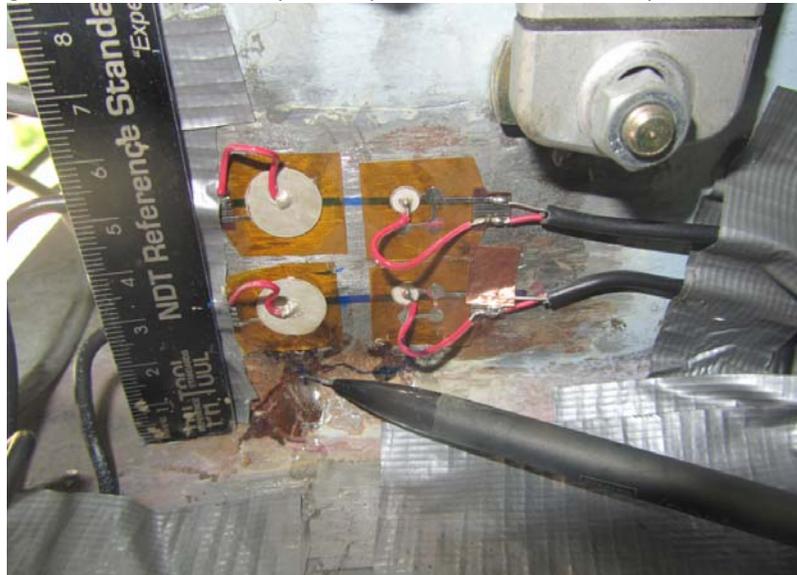
Figure 7. Pencil lead break test at the middle point of the fatigue crack.

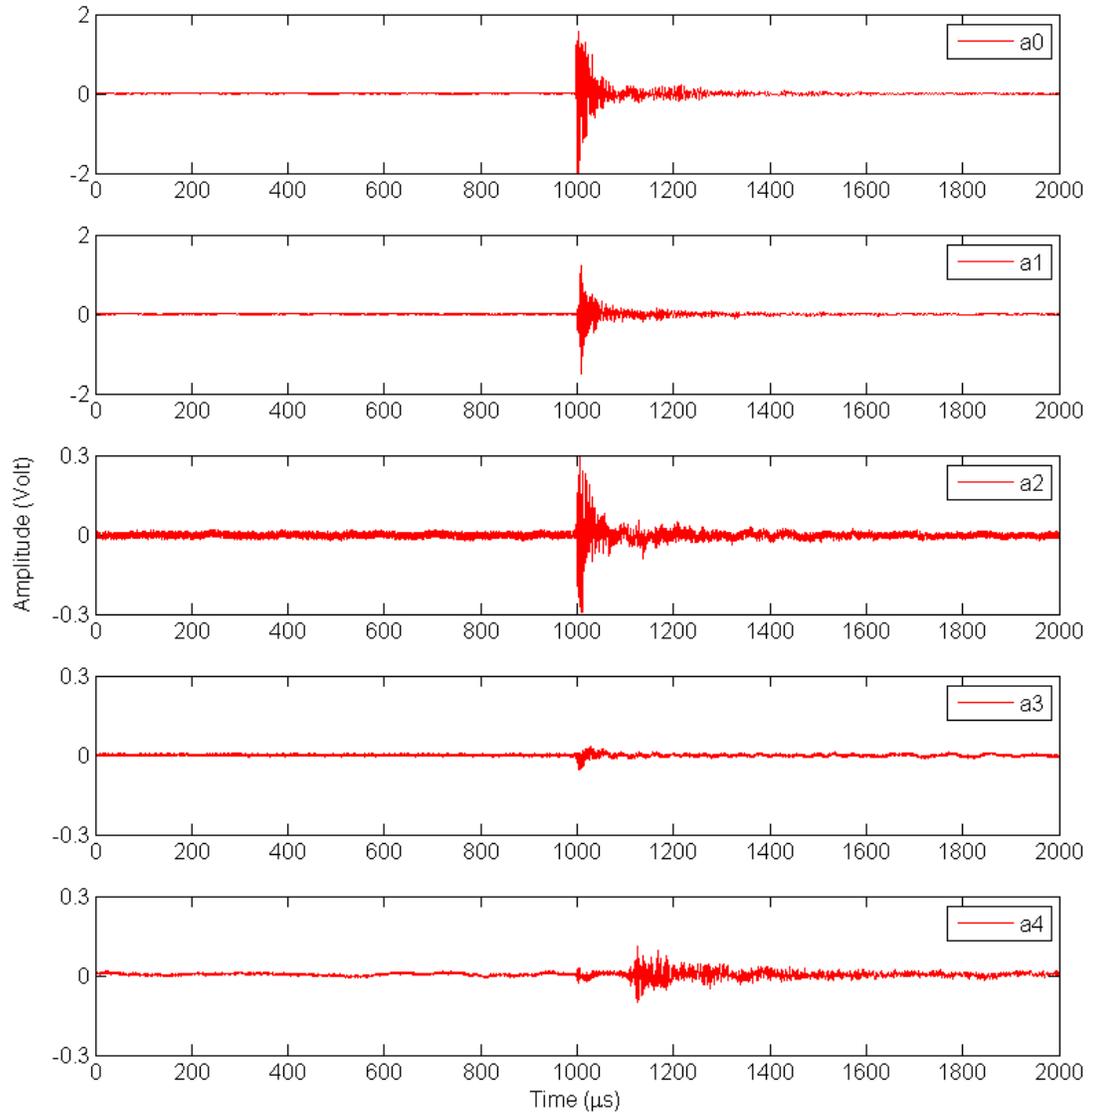
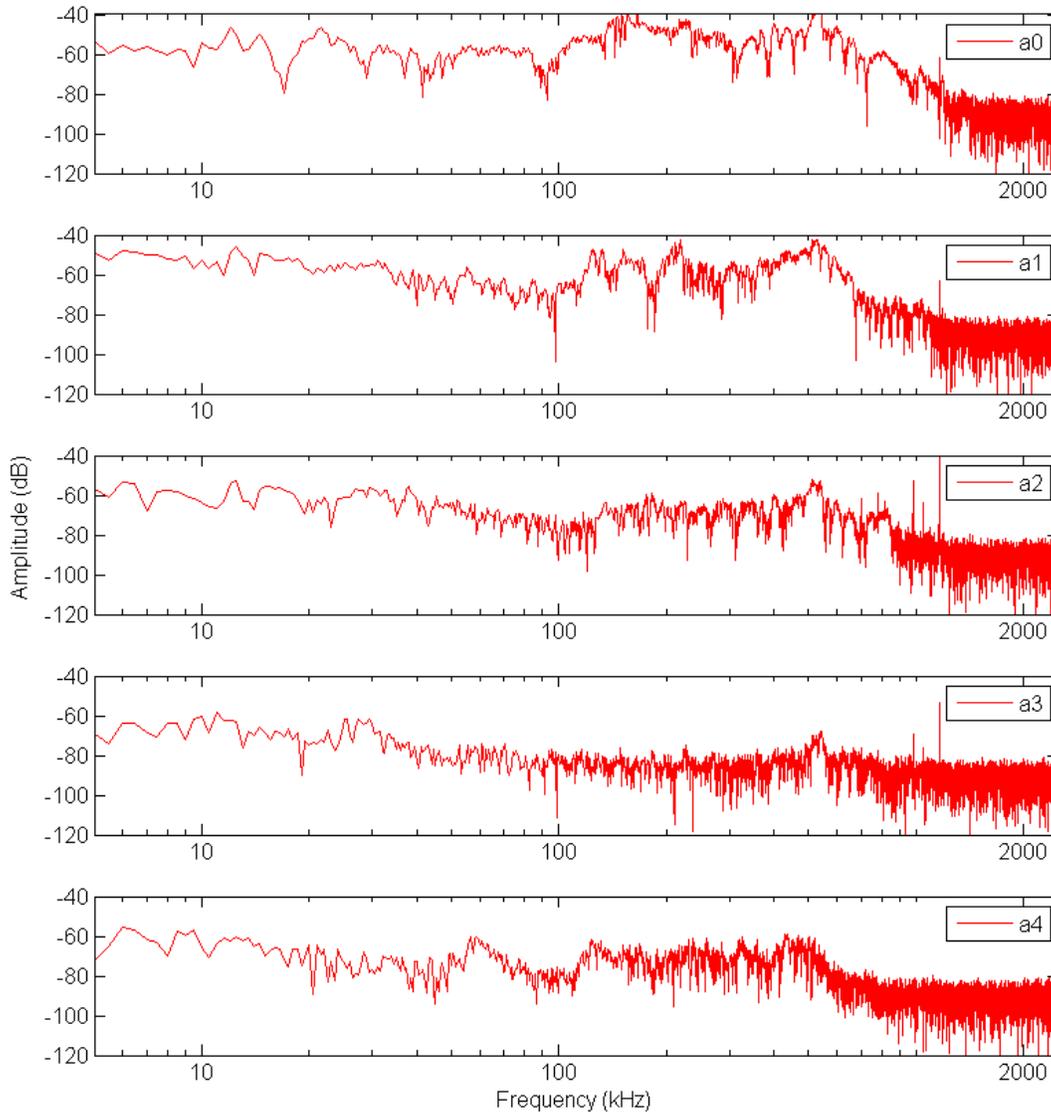
As a standard simulated AE source, pencil lead break tests were carried for calibration purpose. The test set up is shown in Figure 7. Figure 8 shows the signals and their frequency spectra due to a pencil lead break event captured by all the five sensors including the guard sensor. It can be seen that the guard sensor has nearly no response since it's far away from the simulated source.

Figure 8. Sensor signals due to pencil lead break test at the middle point of the fatigue crack: (a) signal waveform; (b) frequency spectrum
